NORTH BASIN SHORELINE EROSION CONTROL STUDY

CAPITOL LAKE

NOVEMBER 1990

ENTRANCO ENGINEERS, INC.

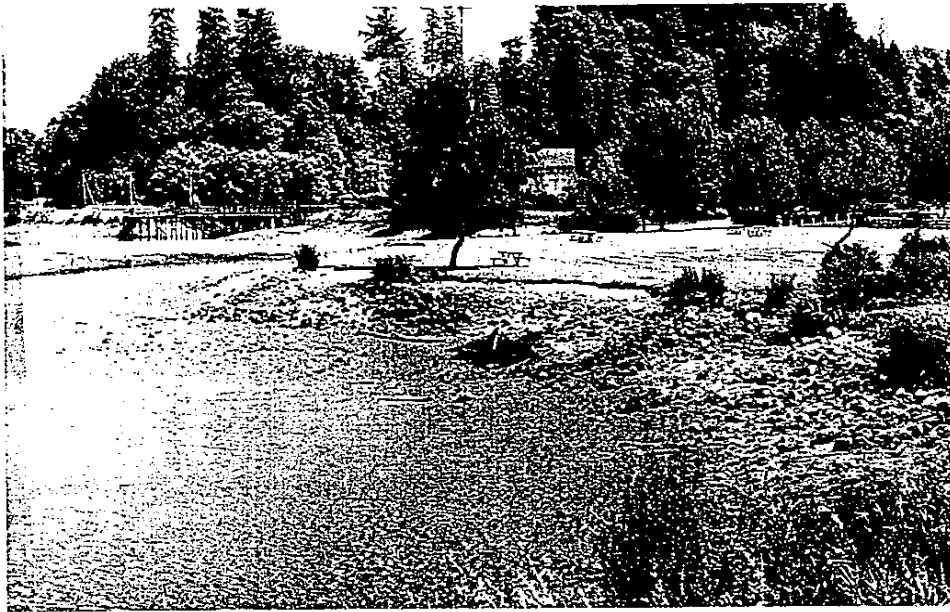
Photo 1
Zone 1
Marathon Park
shoreline

Existing Condition. The shoreline is characterized by an eroded grass or shrub bed upland, riprap sloped at approximately 3:1 to 4:1 dropping to a flat sand:mud bottom at a depth of about 10 feet (photo 1, Appendix B). The riprap adjacent to the eroded shoreline has been buried and shifted downslope and therefore is partially failing. Waves have overtopped riprap and eroded lawn (photos 2, 3, and 4). Over time the waves have continued to erode the shore by undercutting lawn resulting in a loss of approximately 30 to 40 feet of shoreline.

Recommendation. Develop a perched gravel beach (Concept E-1) to reclaim park area lost to erosion. The toe of gravel beach should be locked in with riprap placed below normal low water to lessen the slope and avoid the need for large amounts of gravel. The beach needs to be reestablished by placement of landscape gravel (7 8 inch & or 1-1 2 inch minus drain rock is preferred).

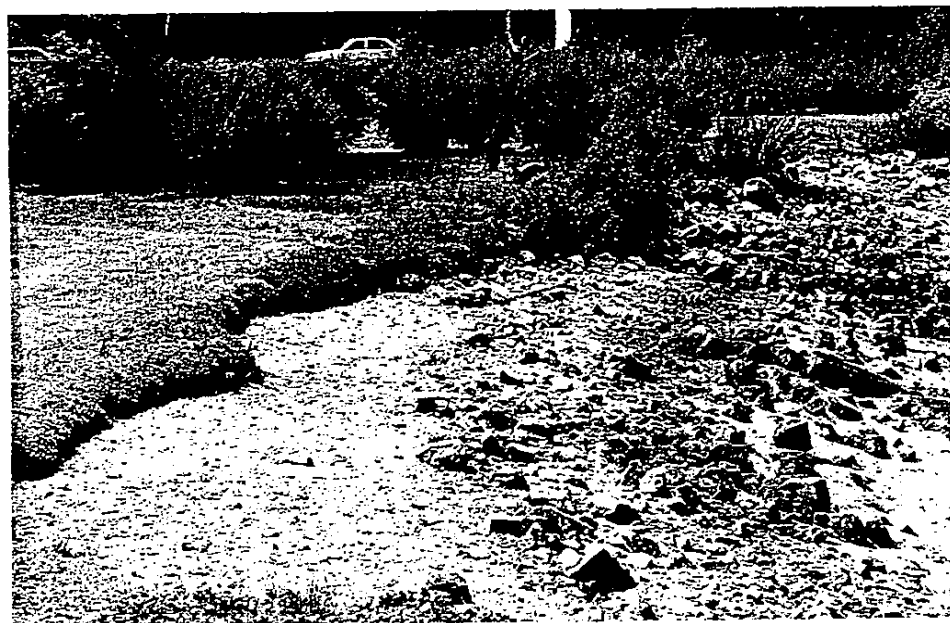
Photo 3
Zone 1
Beach erosion at
Marathon Park

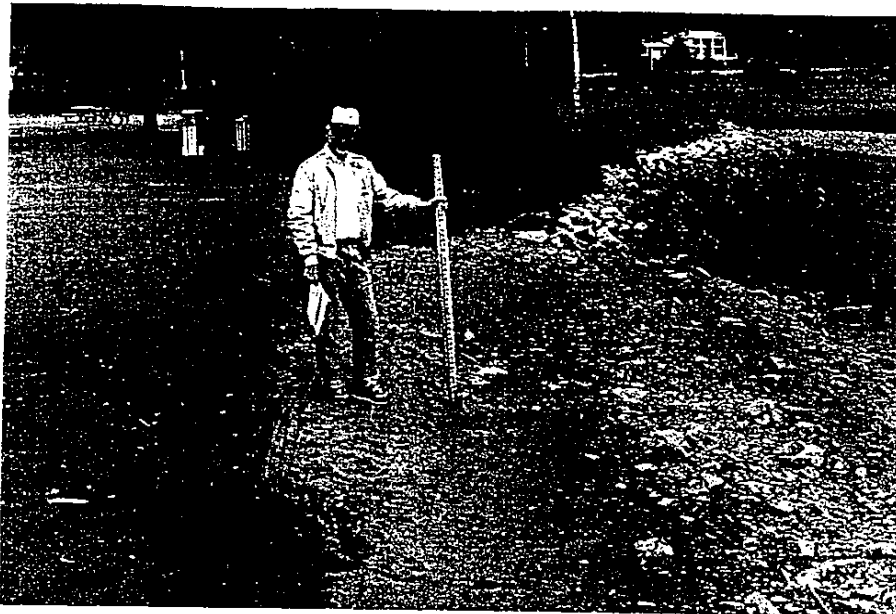
Photo 4
Zone 1

East side of
Marathon Park

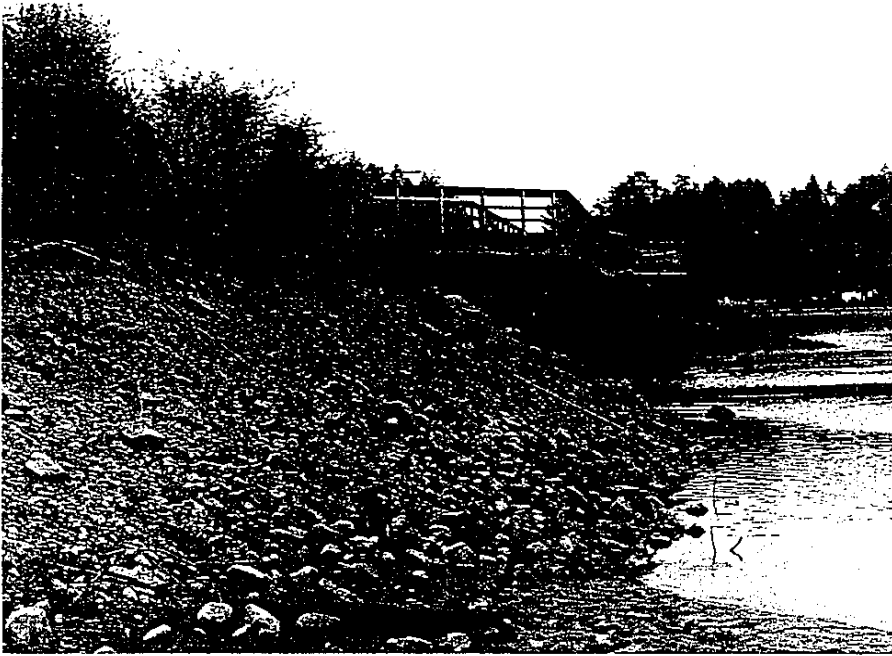
Photo 7
Zone 3

Priority. This zone has been rated as a high priority due to concern over the fill slope instability of the embankment on the east side of the trestle on the north basin side—downstream (photo 7). Embankment cracks were observed and the soil was unstable near the water's edge (photo 9). It is important to note this instability occurred after rapid drawdown of the lake. These slopes are probably only marginally stable with the lake at normal levels. The current through the railroad trestle was directed into the east bridge pier during drawdown observations on July 5, 1990. This deserves further investigation as described below.

Unstable shoreline during drawdown, east of north basin inlet

Recommendation. Heavy riprap placed at the toe of the present slopes on both sides of the channel and extending east, would probably be adequate to correct any problems that may be present.

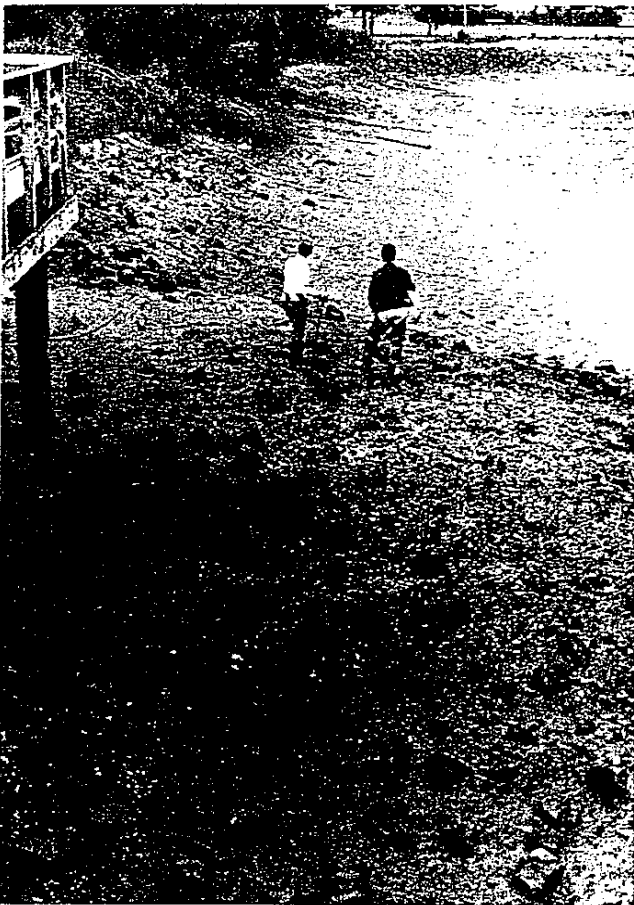
Photo 8
Zone 3

Existing Condition. Light riprap is present on shoreline areas on each side of the north basin inlet channel (photos 7 and 8). There exists a railroad bridge with a concrete abutment/pile cap (photo 10). There is also a wood pile supported pedestrian bridge (photo 11).

Shoreline at west side of pedestrian walkway

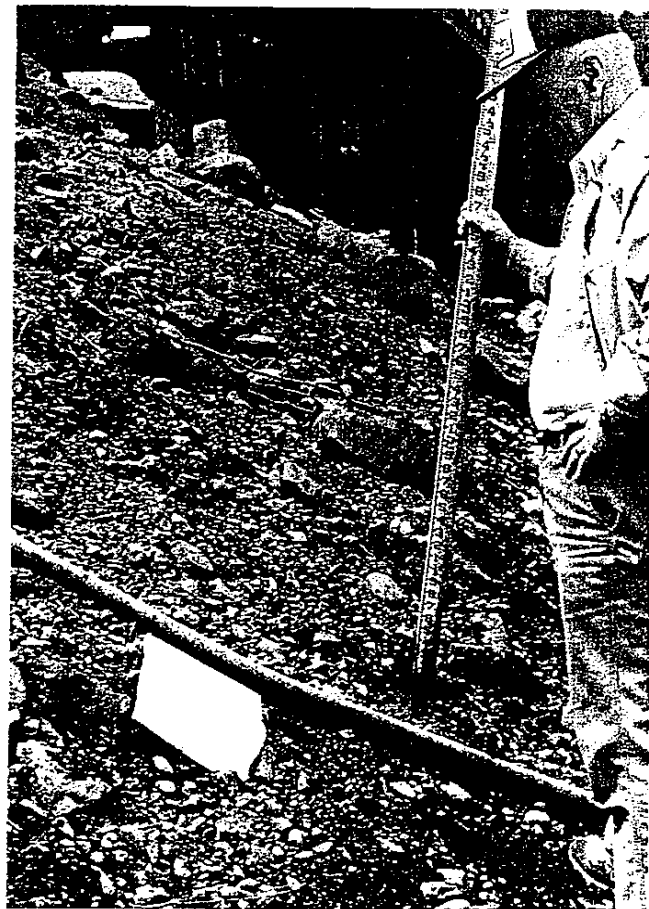
Photo 9
Zone 3

Cracks in slope during drawdown at shoreline east of north basin inlet

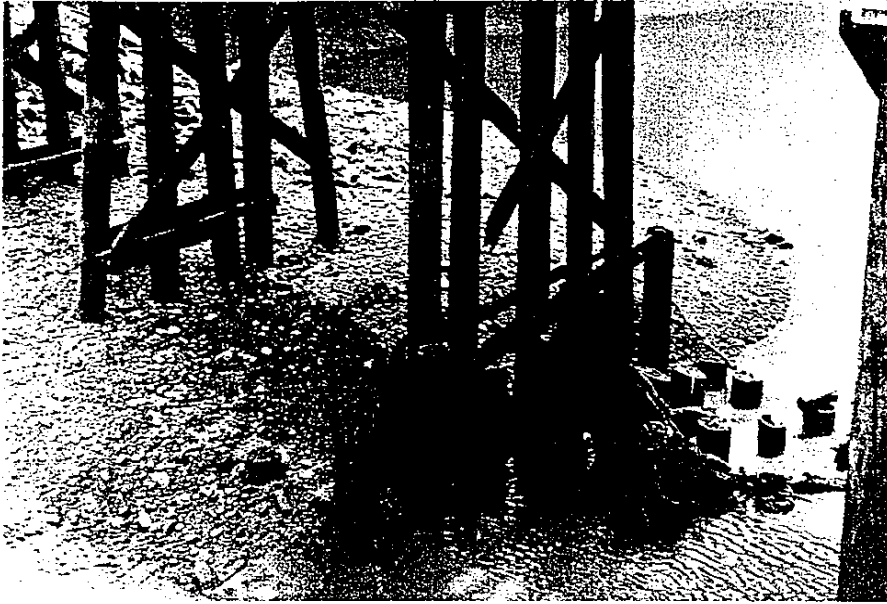
Photo 10
Zone 3

Because of the river currents in this area during lake drawdown, scour may be occurring, especially adjacent to the east bridge pier. If the piers are pile-supported, they likely are in no danger. We recommend sounding the lake bottom near the piers. Any scour holes that are deeper than the existing bottom grade should be backfilled with rock spalls and capped with riprap.

Railroad trestle at
north basin inlet

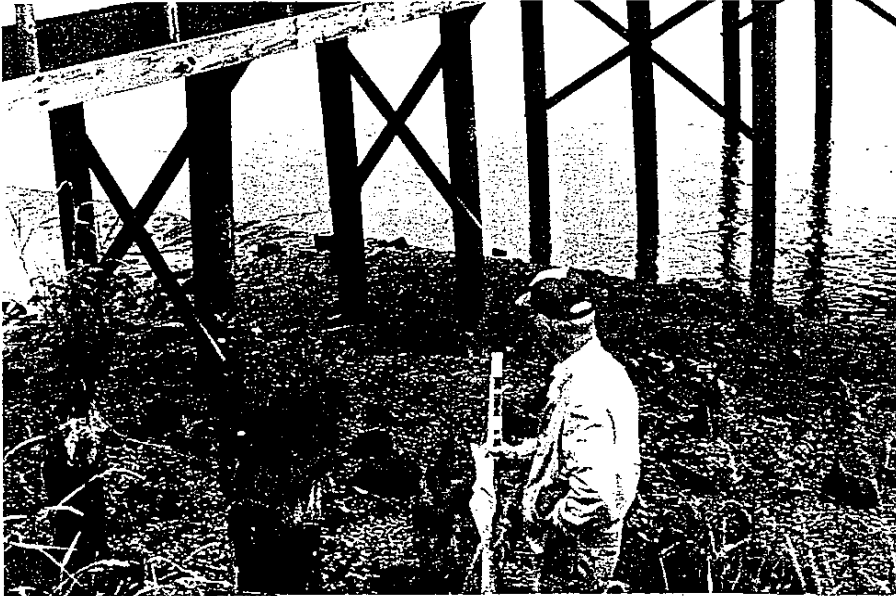
Photo 11
Zone 3

Pedestrian walkway
supports at north
basin inlet

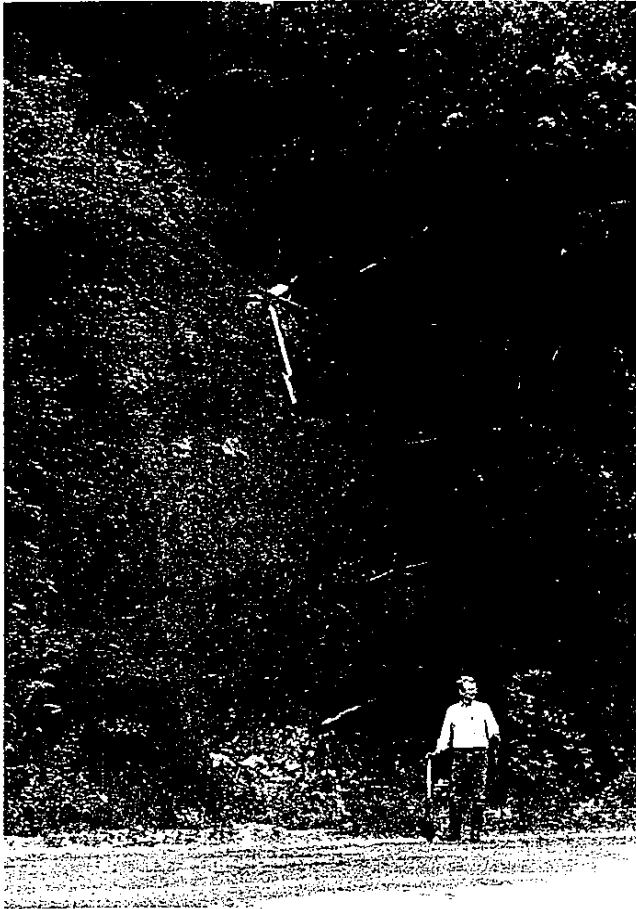
Photo 13
Zone 4

Priority. This has been assigned a low priority since there are no observed shoreline problems. Upland areas appear prone to further instability, which could affect the lake shore.

Upland slide area,
east of north basin
inlet

Recommendation. Monitor riprap for signs of failure.

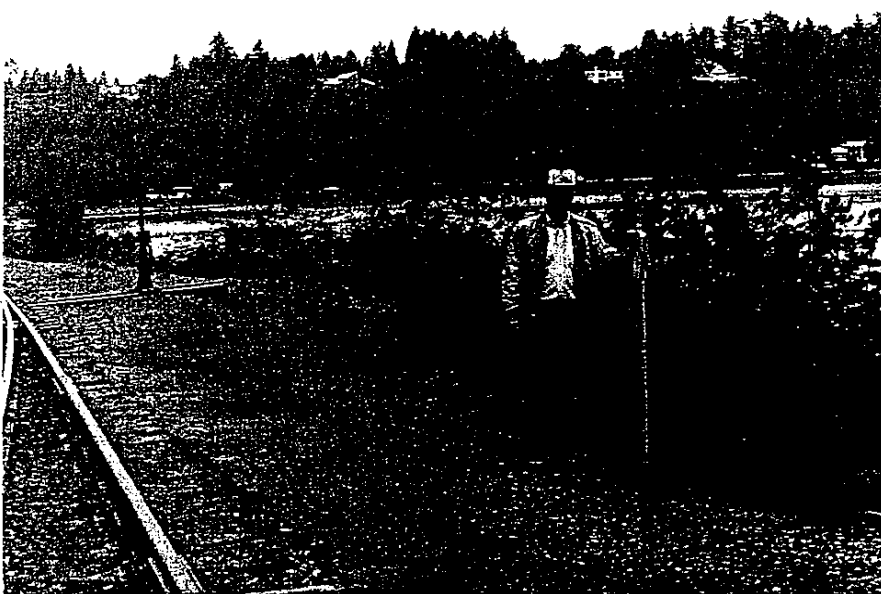
Photo 14
Zone 4

Railroad tracks
adjacent to photo
13 slide area

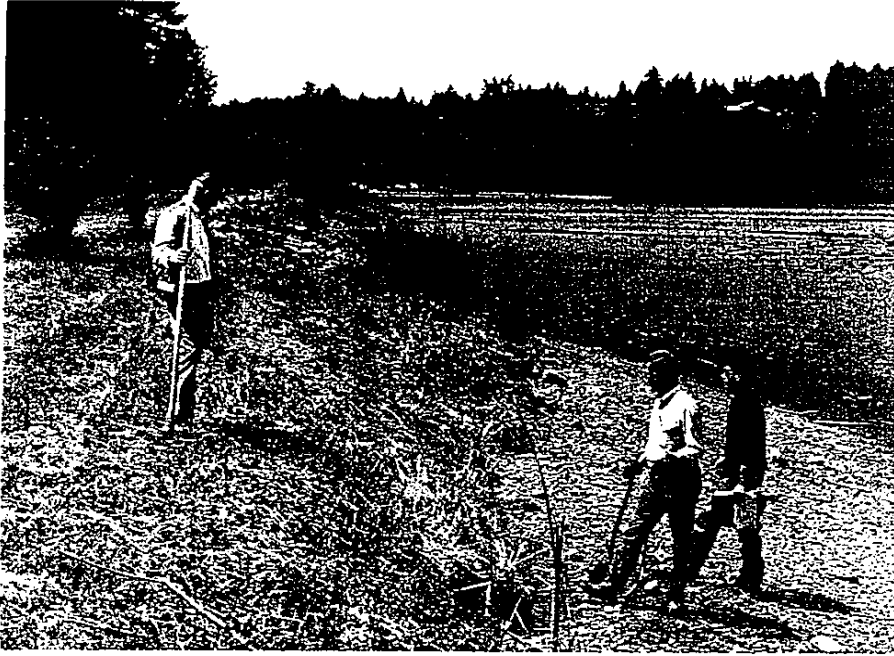
Photo 15
Zone 5

Existing Condition. The vegetated shoreline slopes gently (2 to 5 percent) toward the water adjacent to Powerhouse Road. The upland portion is field grass meadow. The shore edge consists of aquatic vegetation with some exposed soil. The beach slopes gently and is mostly gravel. Beach material gets finer moving toward deeper water.

Recommendation. Although two concepts (riprap and minimal beach) were considered here, the recommendation is placement of minimum riprap against the toe of the beach slope (Concept B). At this time, only spot areas need repair.

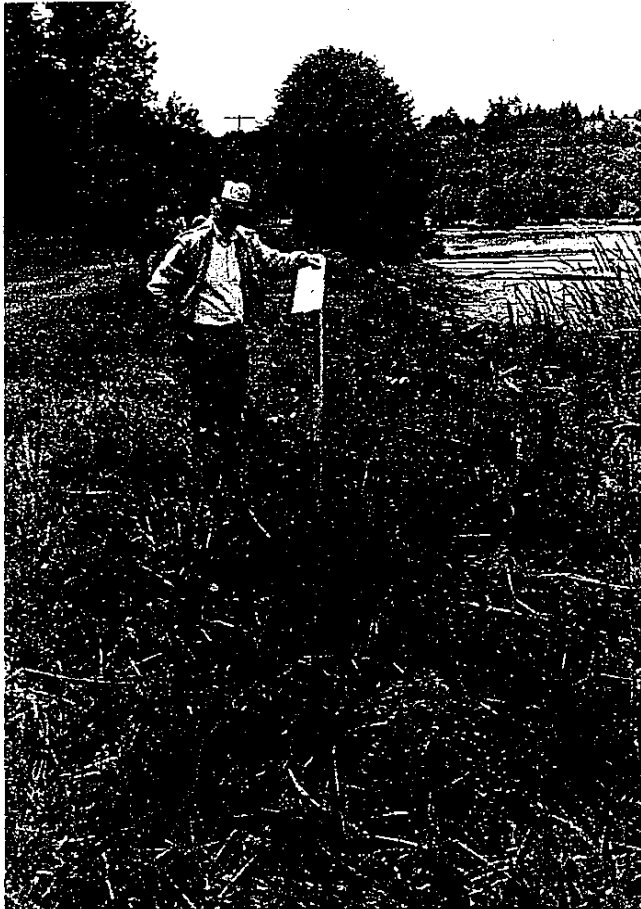
Photo 16
Zone 5

There is some evidence that small slumps (photo 16) extending nearly to the pavement on Power Plant Road have occurred in this area. The road condition at the present time appears satisfactory (photo 17). Future repairs may be necessary.

Areas of shoreline
soil movement
along Powerhouse
Road

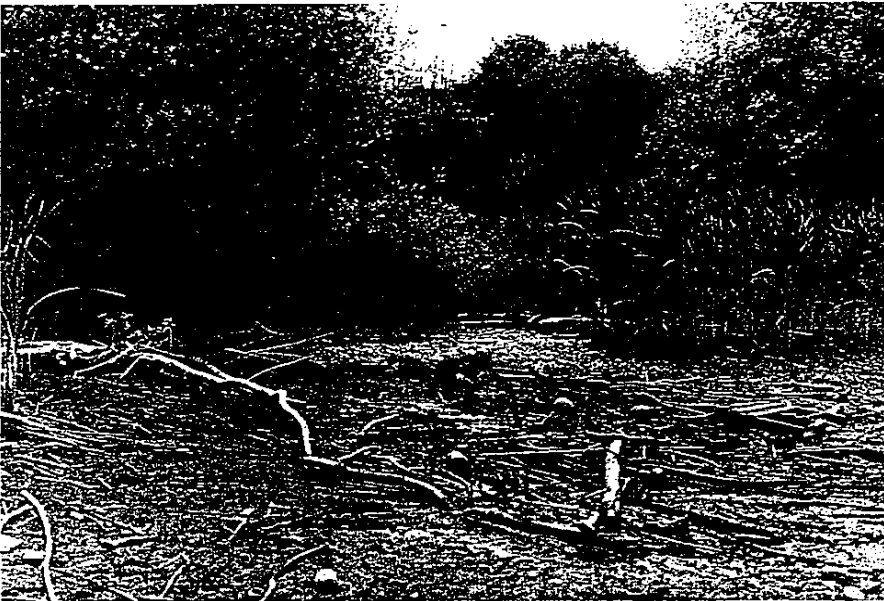
Photo 18
Zone 6

Existing Condition. The natural shoreline is in good condition (photo 18). The upland portion consists of lush native vegetation. The shoreline edge is well established marsh vegetation.

Natural shoreline,
North Powerhouse
Road

Recommendation. Save and protect the natural shoreline. Recreate this shoreline condition in other parts of the lake. Natural shoreline creates excellent fish and wildlife habitat. This segment of the shore also provides relief from intensive riprap edge on other shoreline areas.

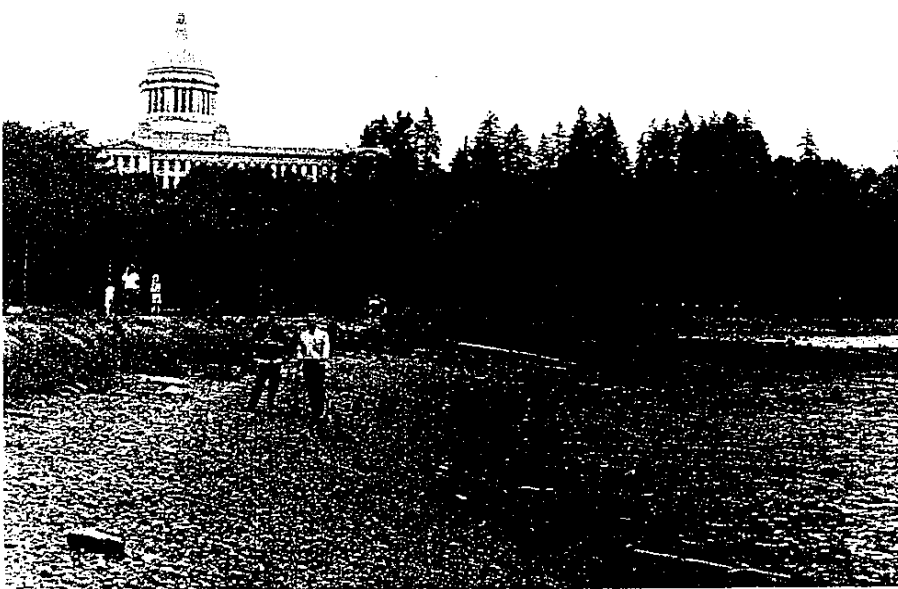
Photo 19
Zone 7

Existing Condition. The slope is vegetated with field grass, and slopes at about 3:1 to the lake edge (photo 19). A gravel beach then slopes at about 5:1 or less.

Shoreline erosion
south of parking lot

Recommendation. Provide the bioengineered shoreline using brush layering (Concept C-1) to slow shore erosion.

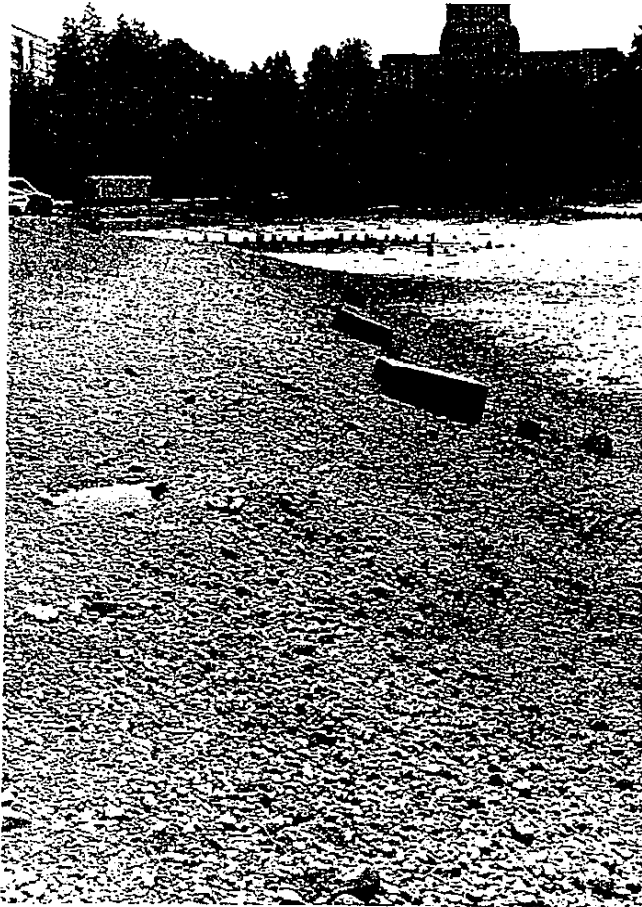
Photo 20
Zone 8

Existing Condition. The existing gravel beach is at about a 3:1 slope. A temporary crushed rock dike has been placed at the edge of the parking lot to limit flooding. The gravel beach slope levels off on a mud bottom (photo 20). This area is within the Capitol Lake Park; plans are underway for the redesign of the park by the City of Olympia. The landscape architect firm of Jones & Jones is preparing the master plan.

Recommendation. Develop a minimal gravel beach as a temporary shoreline erosion control measure. The intent of this treatment is to reduce erosion and help restore its use as an interim (i.e. 3 to 5 year) measure until park redevelopment occurs.

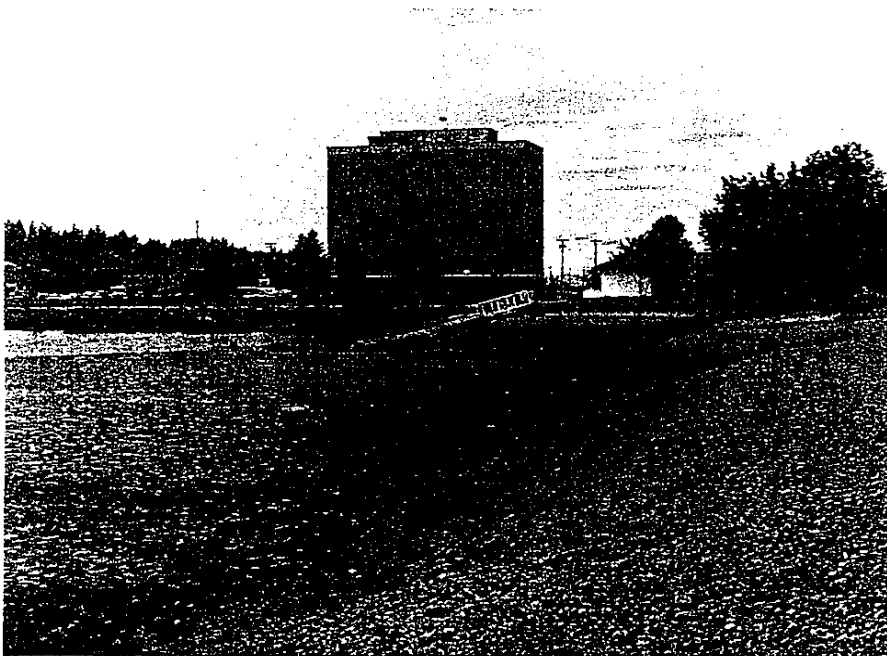
Photo 21
Zone 8

Existing Condition. This area has substantial erosion of firmly compacted till fill. The eroded soil face at the shoreline ranges from one to two feet (photos 21 and 22). Beach-building presently is underway using both older till-like areal fills and more recent loose gravel fills. There is an existing floating dock and small boat house near the point. The concrete walkway between the house and dock has deteriorated and is undermined. The upland planting is predominantly lawn. The Jones & Jones plan shows the water walk in this area that will connect with the "Lake Fair Circle"—a pile supported concrete platform to be located near the existing point.

Recommendation. The shoreline erosion can be arrested temporarily, prior to the anticipated park reconstruction, by building a minimal gravel beach using rock spalls or coarse gravel, and sand. Some regrading of the shoreline edge and revegetation of upland areas is recommended. This placement of gravel fill of appropriate size would serve as an interim solution to limit wave impact on the shoreline.

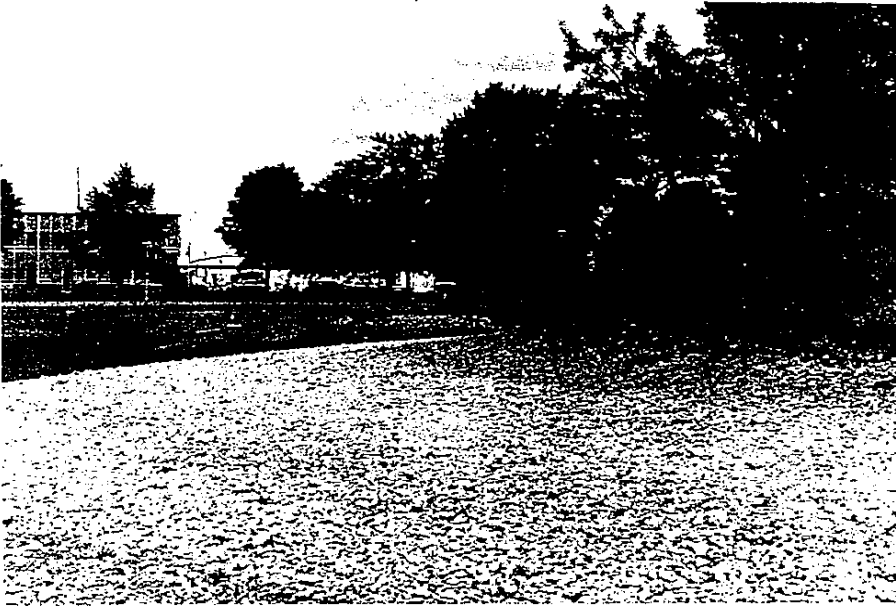
Photo 22
Zone 9

Shoreline dropoff at
Capitol Lake Park

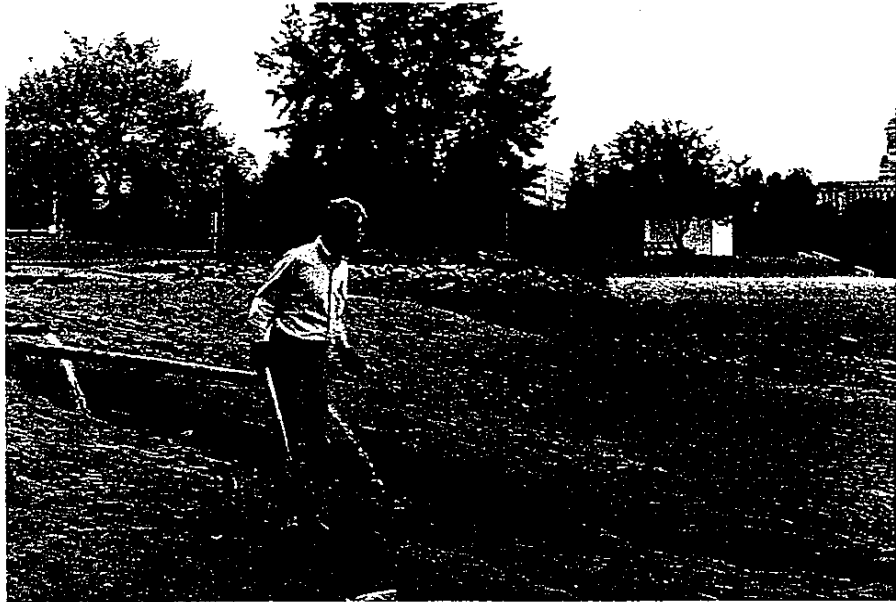
Photo 23
Zone 10

Existing Condition. This portion of the shoreline consists of a sandy swimming beach (photo 23) and a concrete lake wall. The area will be filled as part of the Jones & Jones plan.

Swimming beach at
Capitol Lake Park

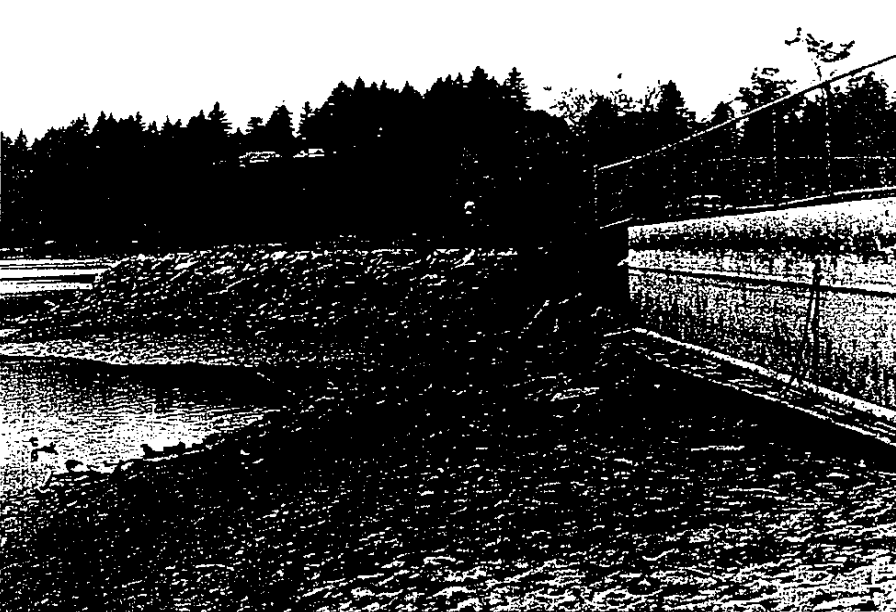
Photo 24
Zone 10

Retaining wall needing
riprap

Recommendation. The undermined wall footing at the northeast corner of the basin can be protected from further erosion by placing rock spalls at the toe of the wall (see Concept G, Appendix A). The rock spalls should be placed on a slope of about 4:1, beginning from a depth about two feet at the face of the wall.

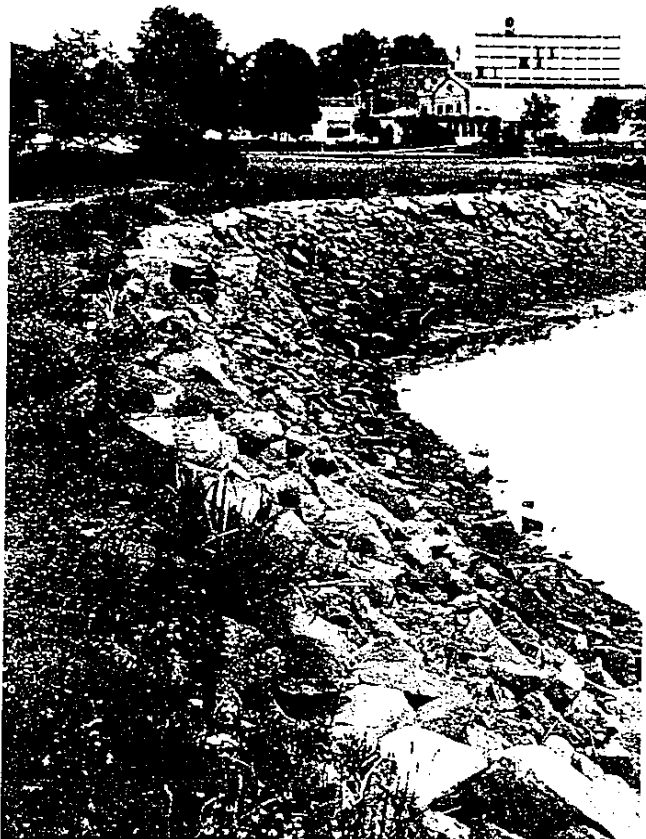
Photo 25
Zone 11

Existing Condition. The riprap is generally quite stable (photos 25 and 26). A path follows the top of the riprap. There is very little vegetation established on the riprap. Upland vegetation above the riprap is predominantly lawn. Some areas have eroded from waves overtopping the riprap and exposing landscape drains (photo 27).

Recommendation. Increase the height of the riprap in areas where wave overtopping has been a problem. Provide vegetation that will green riprap in time and will be less prone to erosion than lawn. This vegetation would also improve habitat potential while increasing visual diversity. Cracks in the parking lot should be sealed to prevent drainage from further eroding the shoreline. In particular areas where the path has been eroded, consider moving the path upland.

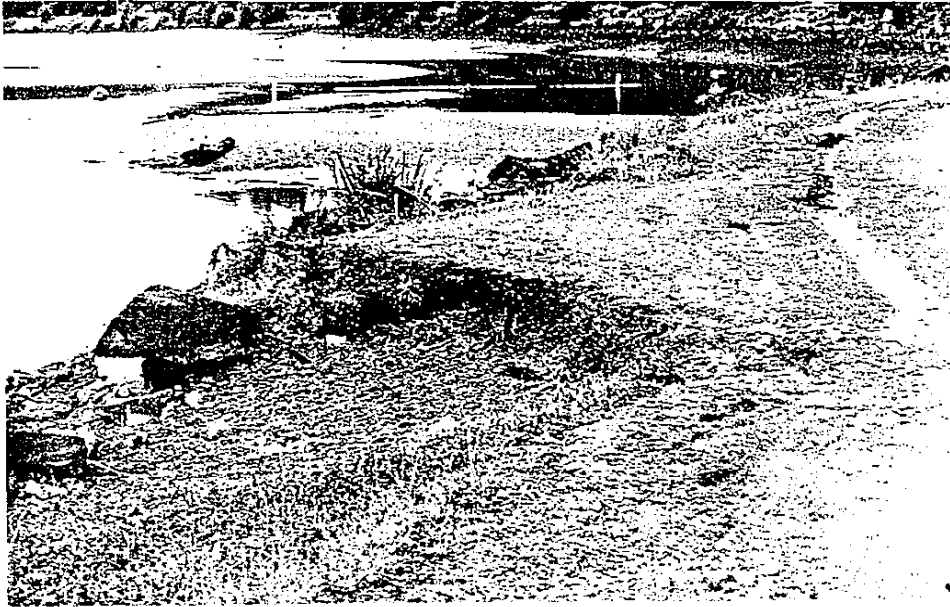
Photo 27
Zone 11

Shoreline erosion
near path and north
parking lot

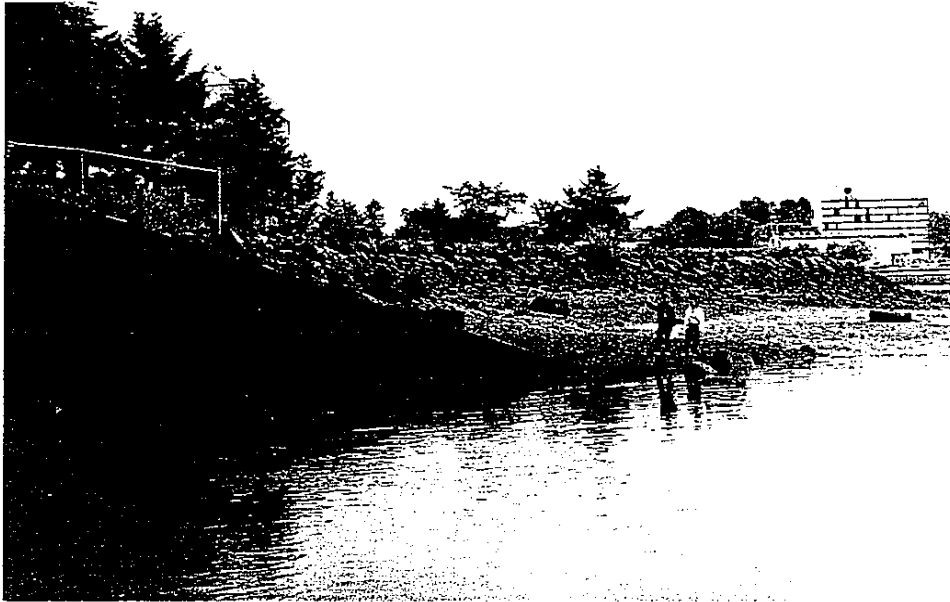
Photo 28
Zone 12

Existing Condition. Drawdown water levels on June 5 and 6 did not expose the entire wing walls (photos 28 and 29); only the middle and top of the structure was exposed. All areas except the east side of the east wing wall appeared to have stable vegetated riprap. Although the east wing wall appeared stable, some placement of riprap was recommended by the Washington State Department of General Administration (GA).

Priority. This area has been rated medium because of the uncertainty of underwater conditions and the east wing wall observations by GA.

Recommendation. Since water levels on June 5 and 6 did not expose the entire wing wall, we suggest that depth soundings be made to reveal scour along the wing walls, if any.

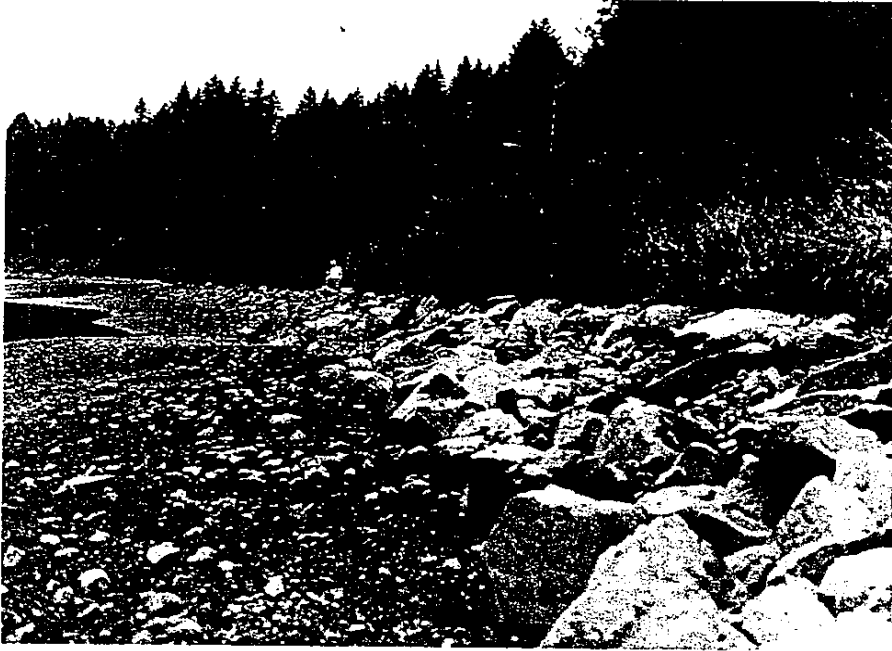
Photo 30
Zone 13

Existing Condition. The shoreline is defined by a stable vegetated riprap (photo 30) with an approximate 4:1 slope. A gravel slope starts at the toe of the riprap and drops to a flat muddy bottom. Slopes are generally steeper toward the tide gate.

Recommendation. Monitor the riprap condition for deterioration.

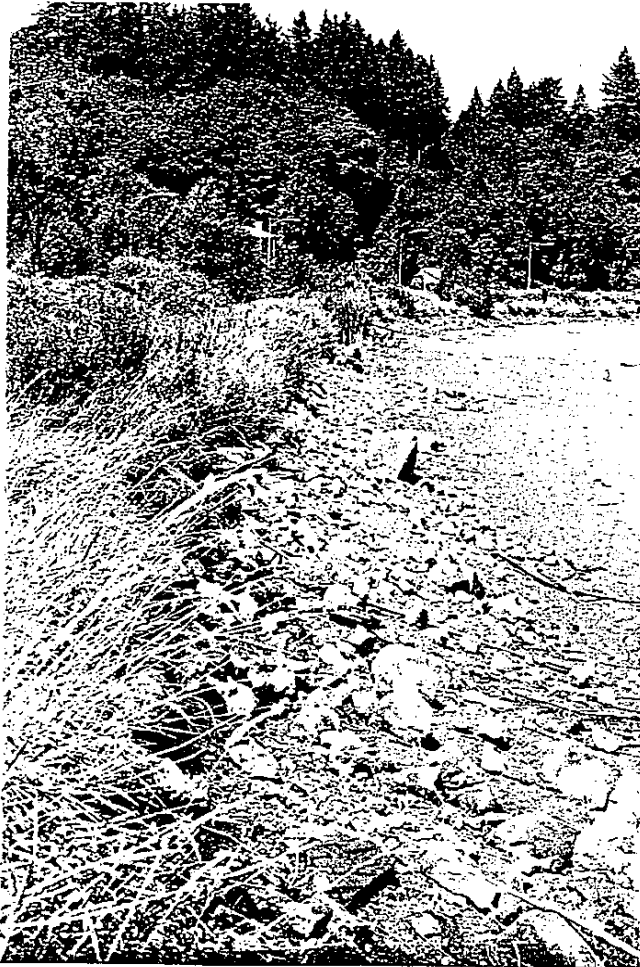
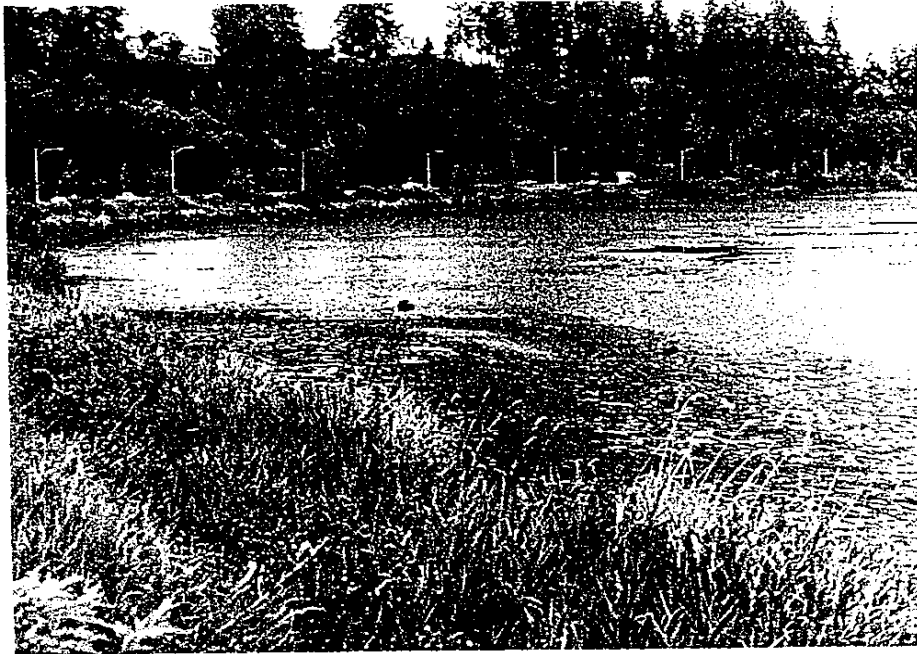
Existing Condition. This vegetated riprap shoreline is less steep than the riprap to the north (photos 31 and 32). As with the riprap to the north, the shoreline is stable.

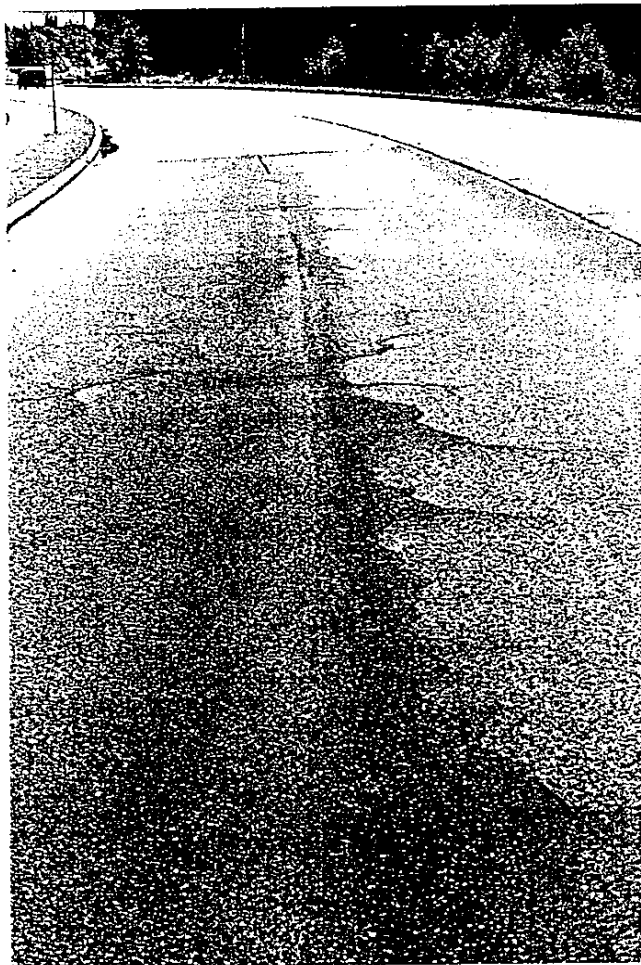
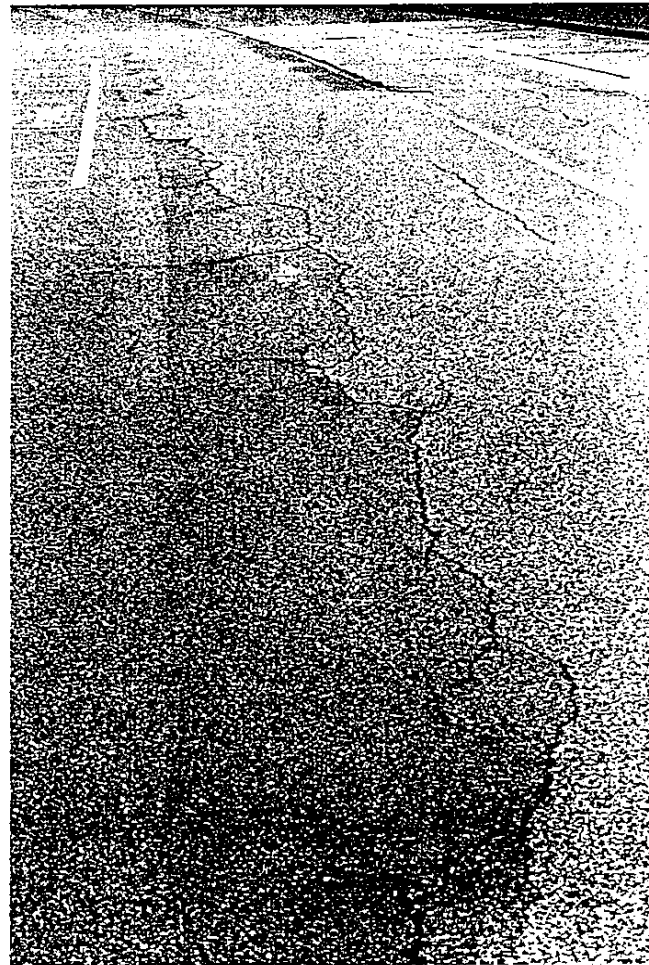
It should be noted that this area suffered earthquake damage in 1965. The soil conditions prone to earthquake failure have not changed. Roadway cracks (photos 33 and 34) are evidence of instability. These areas off the western shoreline (and the east shore along Powerhouse Road) are likely to be damaged in future significant earthquakes.

Recommendation. No further action except roadway crack repair.
