Capitol Lake

Adaptive Management Plan 1999 to 2001

Phase One - Task 3 Hydraulic Scour Analysis

Prepared For
Washington State Department of General Administration

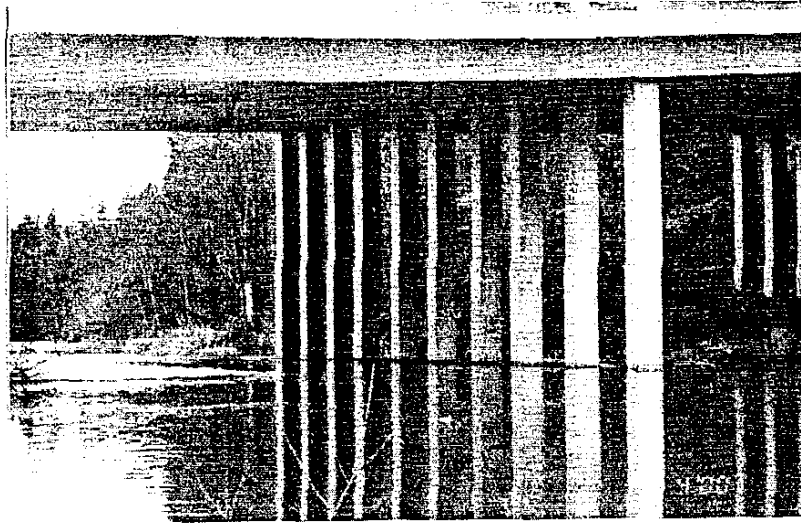
Photograph 1: I-5 Bridge - Looking Downstream

The analysis found that the maximum predicted scour with the tide gate open occurred during the 500-year peak flow with 9.5 feet of scour. Approximately 1.6 feet would be contraction scour, and the remaining 7.9 feet would be pier scour. Figure 2 illustrates the scour results for this scenario.

The analysis of the likely scour with a large channel opening (500 feet) between Capitol Lake and Lower Budd Inlet yielded results similar to the open tide gate. The worst-case scour condition occurred during the 500-year peak flow. It was found that the total scour would be 10.9 feet. Approximately 1.3 feet would result from contraction scour and 9.6 feet would result from local pier scour.

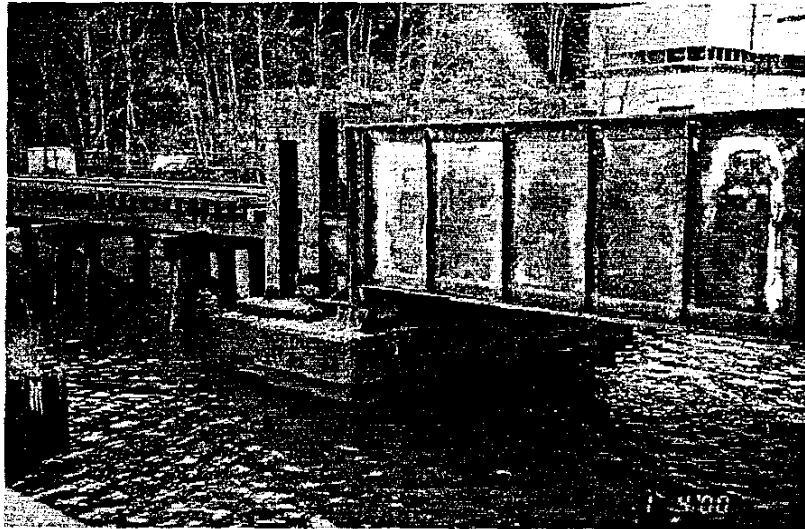
Photograph 2: BNSF Bridge - Looking Upstream

The analysis found that the maximum predicted scour occurred during the 500-year flood with the 500-foot opening. It was found that these conditions would produce 26.7 feet of scour—10.3 feet of contraction scour and 16.4 feet from pier scour. If the existing dam is retained with the gates open, the combined scour depth would be 25.3 feet, or 6 percent less. Figure 3 illustrates the scour results for the 500-year flood scenario with an open tide gate.

The BNSF Bridge is expected to experience a significant amount of bridge scour. It is recommended that this bridge be studied further to determine if scour

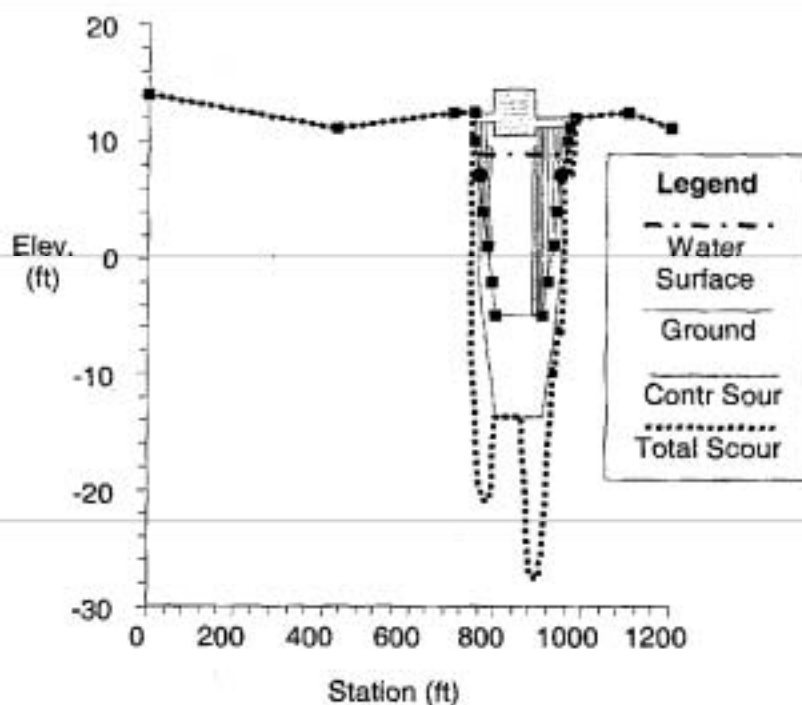
Figure 3
BNSF Bridge, 500-Year Flow with Open Tide Gate

Large flows did not overtop the bridge or cause a pressure flow, but the rise in the water surface outside the normal channel, constricted the flow through the bridge section. As indicated in the I-5 Bridge analysis, the BNSF Bridge causes a significant rise in the water surface. During low flows, the majority of the flow can pass through the bridge section without being constricted between the banks. However, during higher flows all flood water is restricted to flowing through the bridge section only. This condition slows the upstream water velocity and raises the upstream water surface elevation. In addition, the constriction causes an accelerated flow through the bridge section, creating significant amounts of local pier scour.

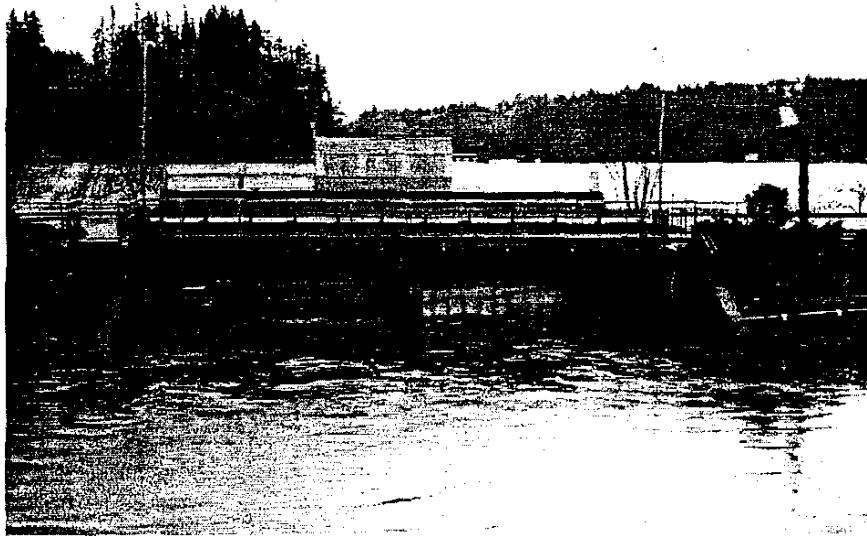
Photograph 3: 5th Avenue Dam - Looking Upstream

On the upstream side of the dam there is a formation known as the Tide Gate Crater. Surveys conducted between the crater's inception and today indicate that the crater has a depth of -30 feet MSL¹. This is approximately 20 to 25 feet lower than the surrounding lake bed elevations. "The crater has apparently formed as a result of the hydraulic forces generated when the lake is backfilled with marine water."²

It was found that for tidal flow, the resulting scour depth below the bottom of the dam (considered to have a bottom elevation of -17 MSL) is 22 feet or -39 MSL. Contraction scour accounts for 10 feet and the remaining 12 feet is

from the vortices formed during local scour. This corresponds well with the scour that has been found in that area to date. Note that the bottom of the dam is lined with concrete, so scour is not expected here, but it serves as an indicator of the magnitude of scour found immediately upstream or downstream of the dam. Table 4 presents the analysis results.

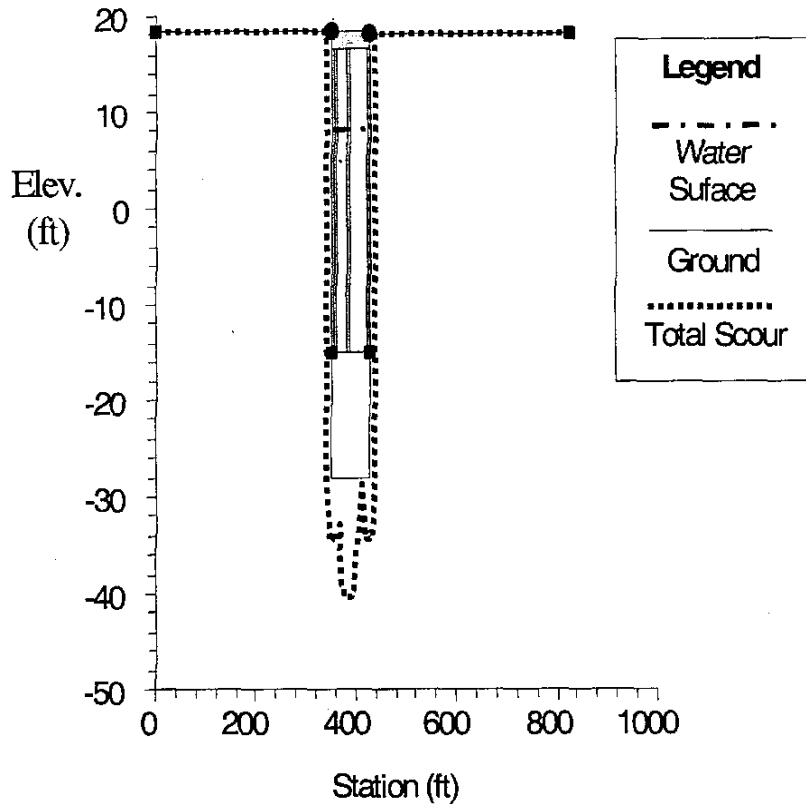
Figure 4
5th Avenue Dam, 500-Year Flow with Open Tide Gate

The analysis for leaving the dam in place found that the maximum case scour occurred during the 500-year peak flow, which would produce a total scour of 31.9 feet. Approximately 20 feet would be contraction scour and the remaining 12 feet would be pier scour. Figure 4 illustrates the analysis results with the tide gate open.

The maximum combined bridge scour depth is predicted to be 31.9 feet with the tide gate open. This scour depth could occur on either side of the dam structure. The present tide gate crater has not impaired performance of the dam. The bottom of the dam is concrete, so scour is not expected there. However, it is our opinion that if significant scour features are allowed to develop and deepen on both sides of the dam, a point could be reached where damage may occur to the dam/bridge structure. Additional analysis would be required to quantify the potential scour impacts on the dam structure under this alternative, and to develop appropriate mitigation measures if needed.

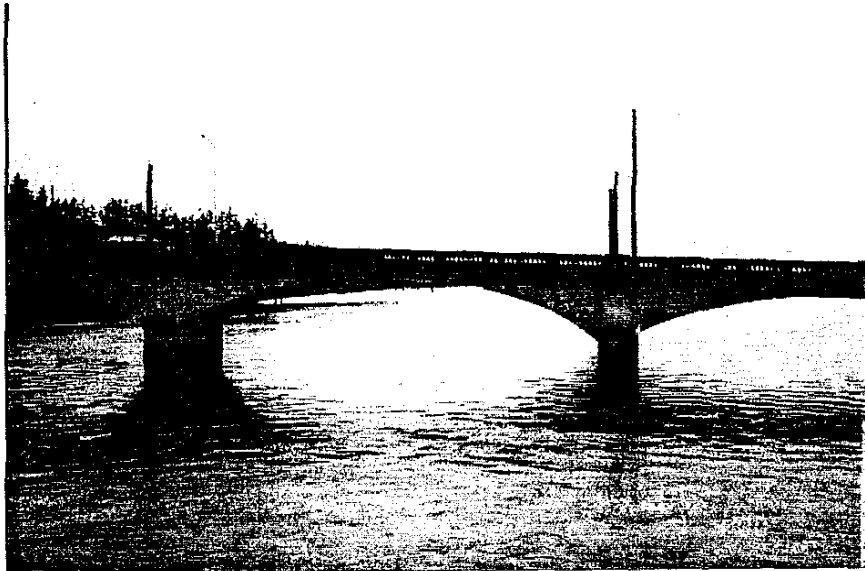
Photograph 4: Existing 4th Avenue Bridge - Looking Downstream

Analysis of the existing bridge found that the maximum predicted scour occurred during the 500-year flood with the 500-foot opening. It was found that these conditions would produce 15.4 feet of scour (**table 5**). The predicted scour is a result of local bridge pier scour. If the existing dam is retained with the tide gate open, the combined scour depth would be 13.4 feet or 15 percent less for the

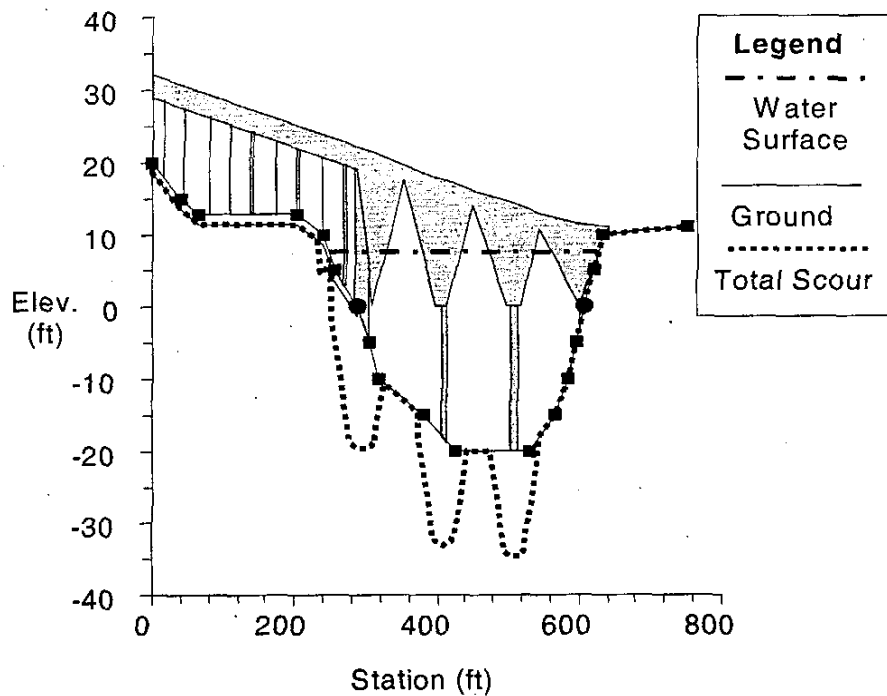
Figure 5
Existing 4th Avenue Bridge, 500-Year Flow with Open Tide Gate

The scour elevations for the 500-foot opening and the open tide gate scenario were anticipated to be similar for this bridge. The bridge is located downstream of the dam, and therefore is not subject to increased water surface elevations or decreased velocities caused by the limited capacity of the dam. The difference in the amount of scour is caused by the slight difference in flow between the two scenarios, which can be traced back to the limited capacity of the open tide gate.

Large flows did not overtop the existing bridge or cause pressure flows. However, some flows did touch the bottom chord at the lowest point on the arches.

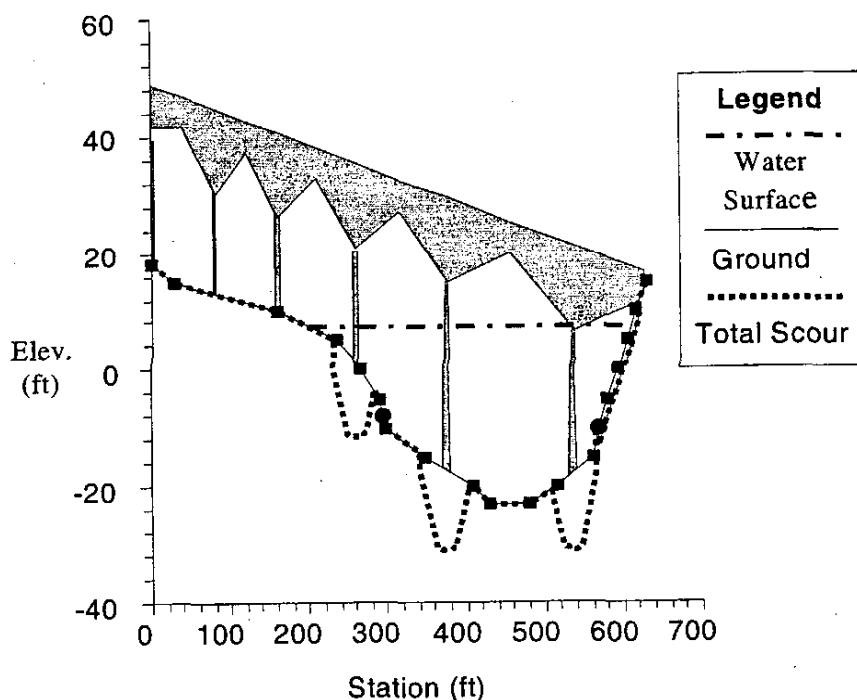
Figure 6
Proposed 4th Avenue Bridge, 500-Year Flow with Open Tide Gate

The analysis found that for the proposed bridge the worst-case bridge scour, 14.5 feet, occurred during a 500-year event with the 500-foot opening. It is predicted that there would be 13.9 feet of scour during a 500-year event with the open tide gate scenario. The scour is a result of local bridge pier scour. **Figure 6** illustrates the scour results for the 500-year flood with the open tide gate scenario. The proposed replacement bridge does not encroach in the channel, so contraction scour is not an issue as flows move out to sea. However, as tides rise and flows move toward Capitol Lake, a slight amount of contraction scour will occur, as can be seen from the summer flow results (table 6).

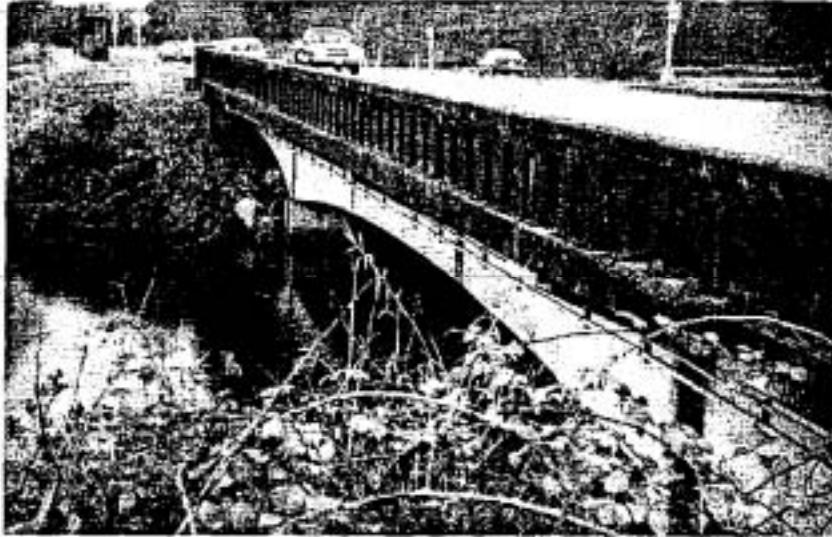
Photograph 5: Percival Bridge - Looking Upstream

The main factor affecting the velocities and scour beneath Percival Creek is the tailwater in the Middle Basin caused by the constriction at the BNSF Bridge. The water backing up behind the BNSF Bridge has a slow velocity and high water surface elevation. Consequently, the flow entering Capitol Lake during a large storm event is slowed down before it passes underneath the Percival Creek Bridge. Furthermore, the opening underneath the Percival Creek Bridge is sufficiently wide to prevent any contraction scour. Table 7 presents the scour analysis results.

The local pier scour at Percival Creek Bridge was found to be between 1 and 1.2 feet for all flows.

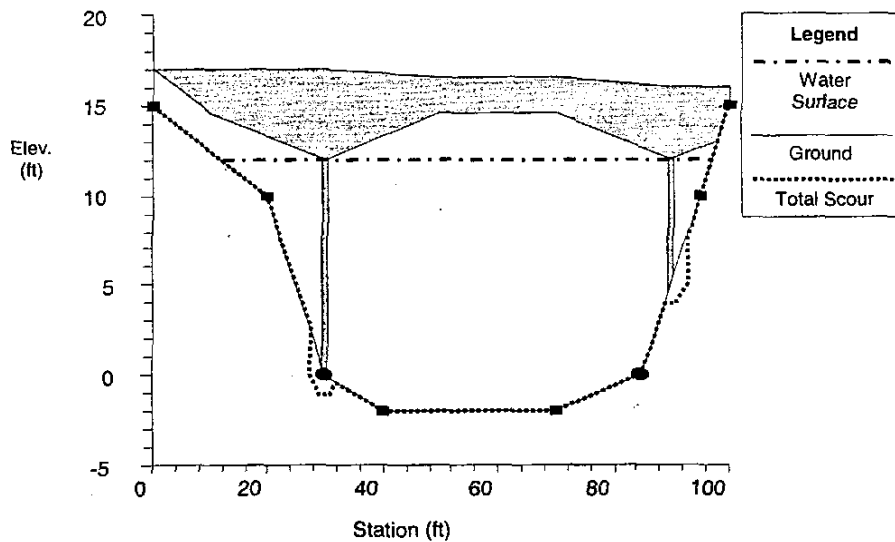
Figure 7
Percival Creek Bridge, 100-Year Flow with Open Tide Gate

The BNSF Railroad has such a significant impact on the flow underneath the Percival Creek Bridge that there is no difference in the amount of scour between opening the 5th Avenue Dam permanently or removing the dam to create a 500-foot-wide channel. Figure 7 illustrates the scour results with the open tide gate.

The maximum combined bridge scour depth is predicted to be 1.2 feet. In our opinion, this scour depth does not present a significant impact to the existing bridge. No further geotechnical evaluation is recommended. The 500-foot estuary opening scour results are same essentially the same as for the existing dam and the tide gate open.
