**1997 CAPITOL LAKE  
DRAWDOWN MONITORING RESULTS**

**Capitol Lake Adaptive Management Plan**

Prepared for  
Capitol Lake Adaptive Management Plan  
Steering Committee

Prepared by  
**ENTRANCO**  
10900 NE 8th Street, Suite 300  
Bellevue, Washington 98004  
(425) 454-5600

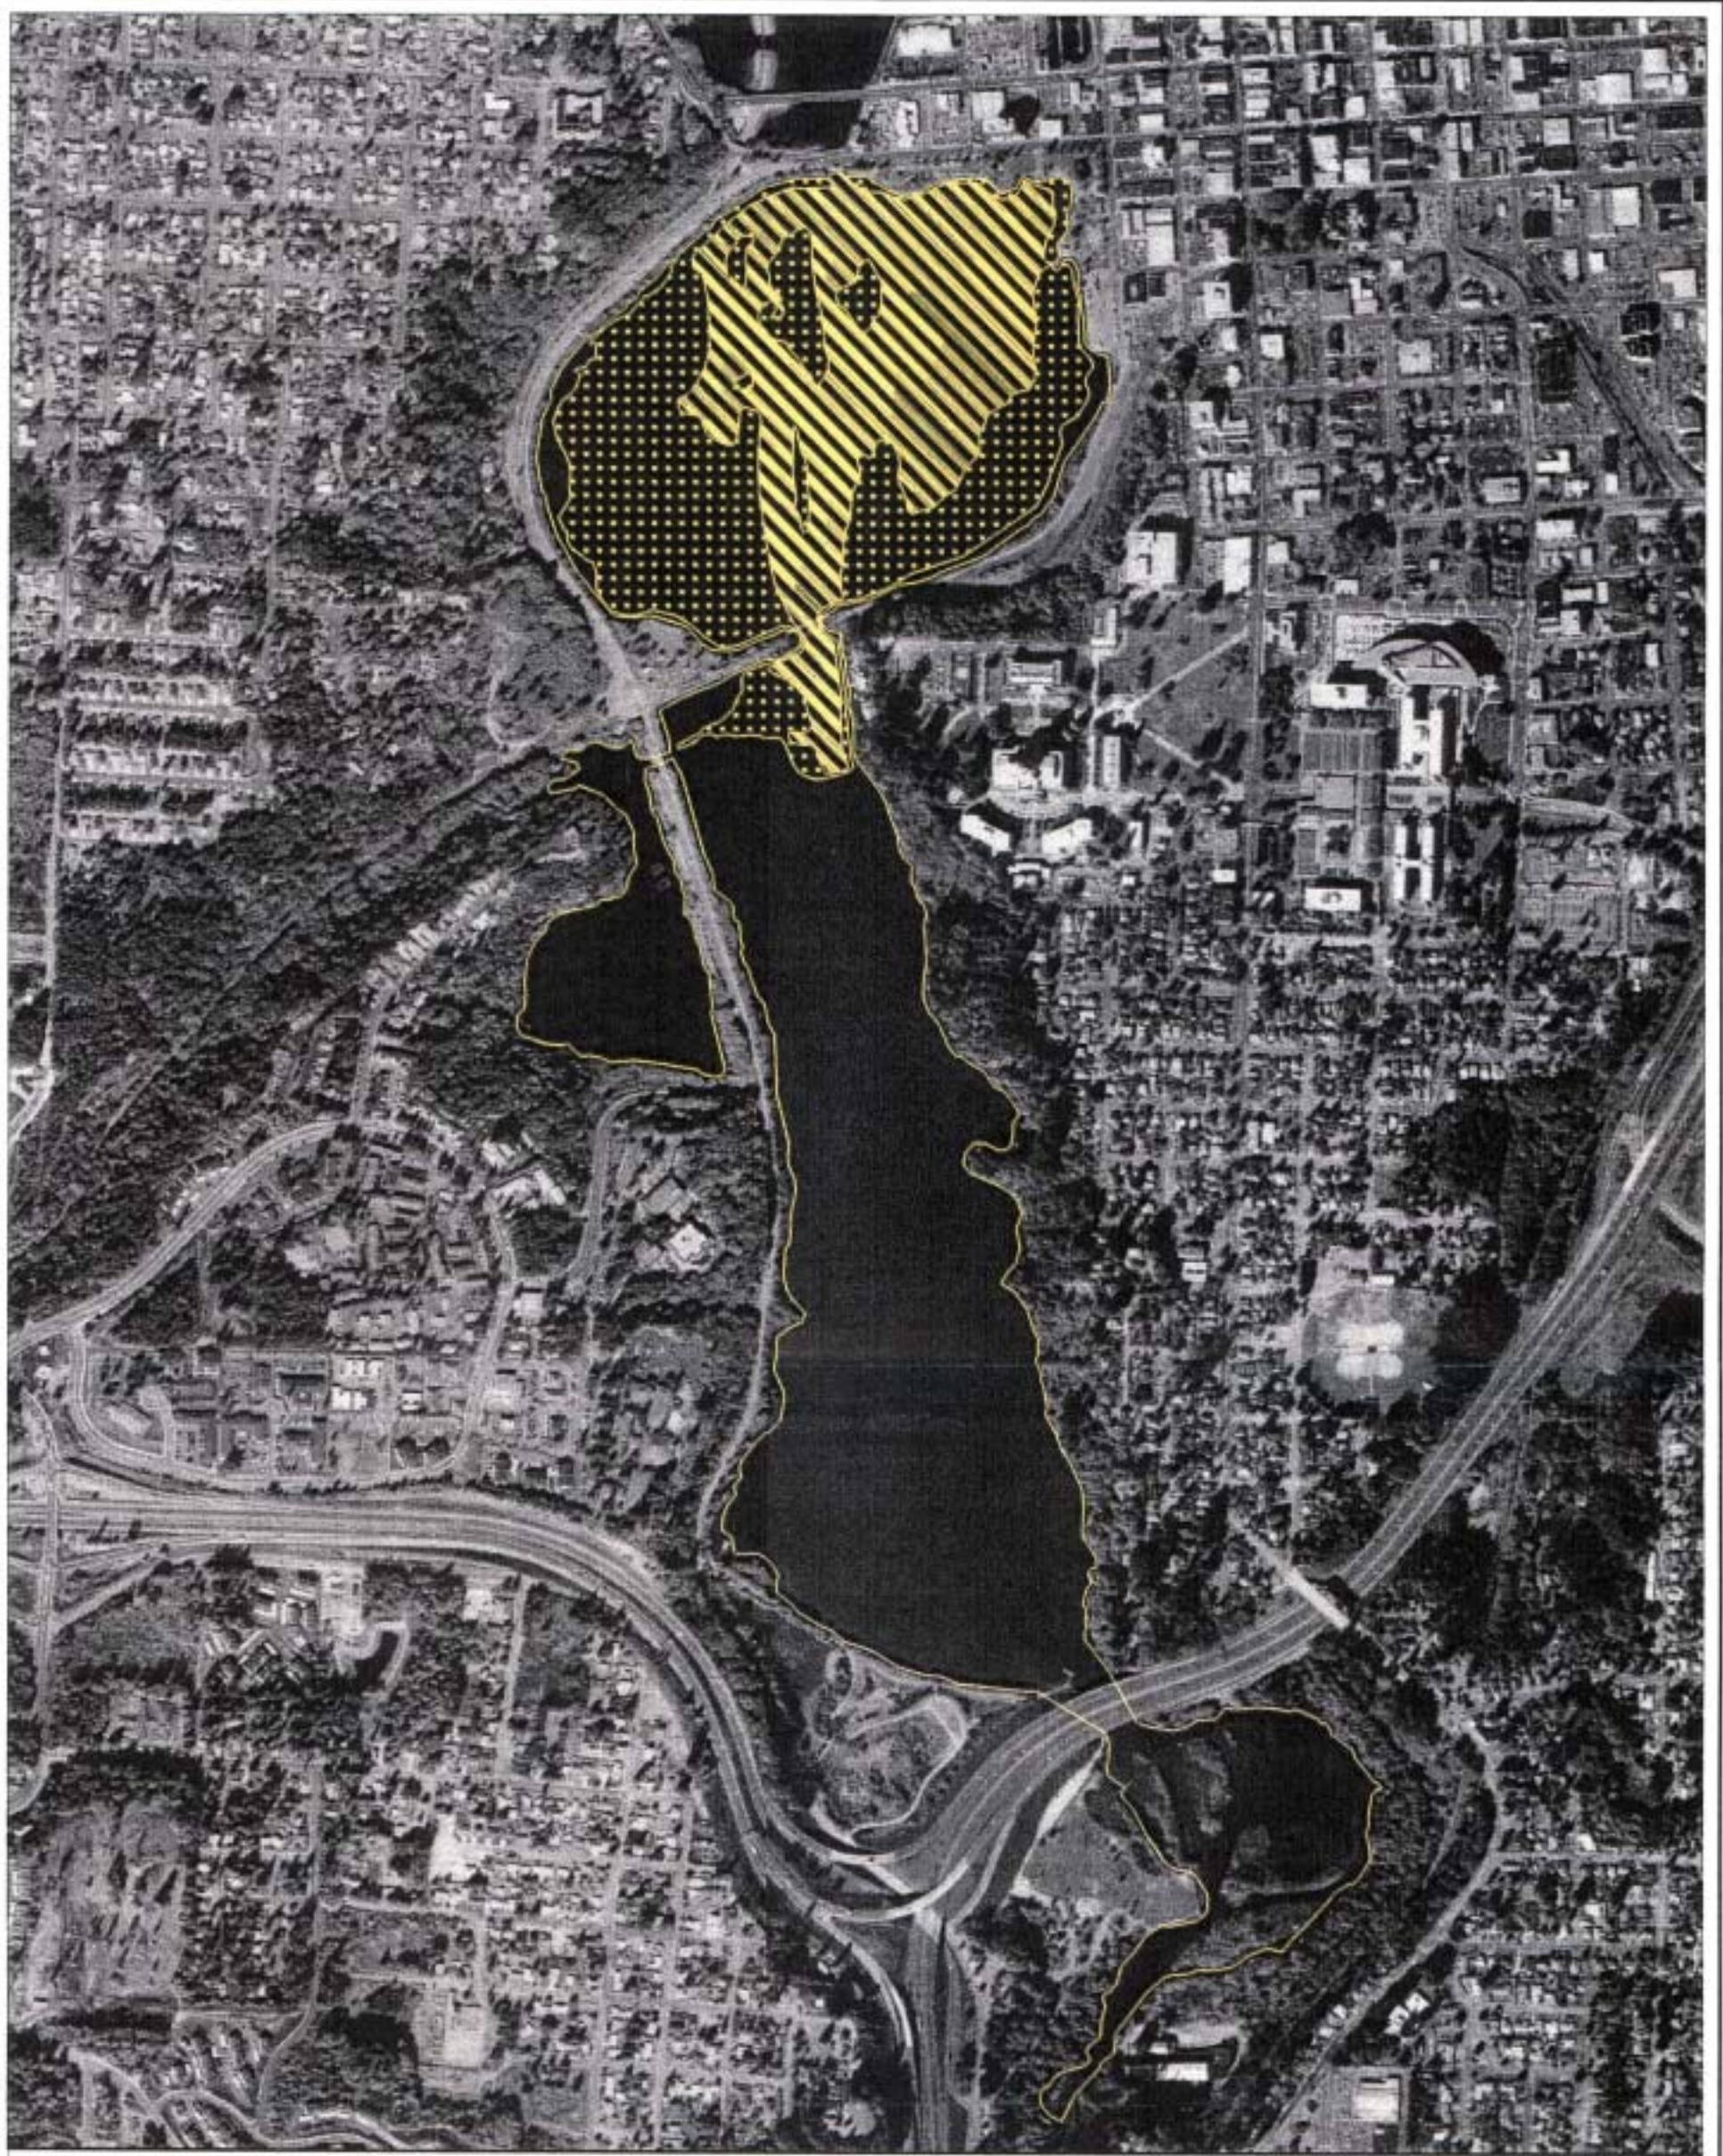
# 1997 DRAWDOWN -- SALINITY ZONES AFTER 1 DAY \*

The results from the 1997 drawdown are markedly different from those for the 1996 drawdown. For viewing purposes, **figures 4** and **5** are comparable. As shown in **figure 5**, there was no freshwater layer in the North Basin as a result of the drawdown procedure in 1996, even one week after refilling (August 7, 1996). In 1996, the North Basin contained primarily brackish water one week after refilling (**figure 5**). In contrast, an extensive freshwater layer was observed in the North Basin as a result of the modified drawdown procedure used in 1997.

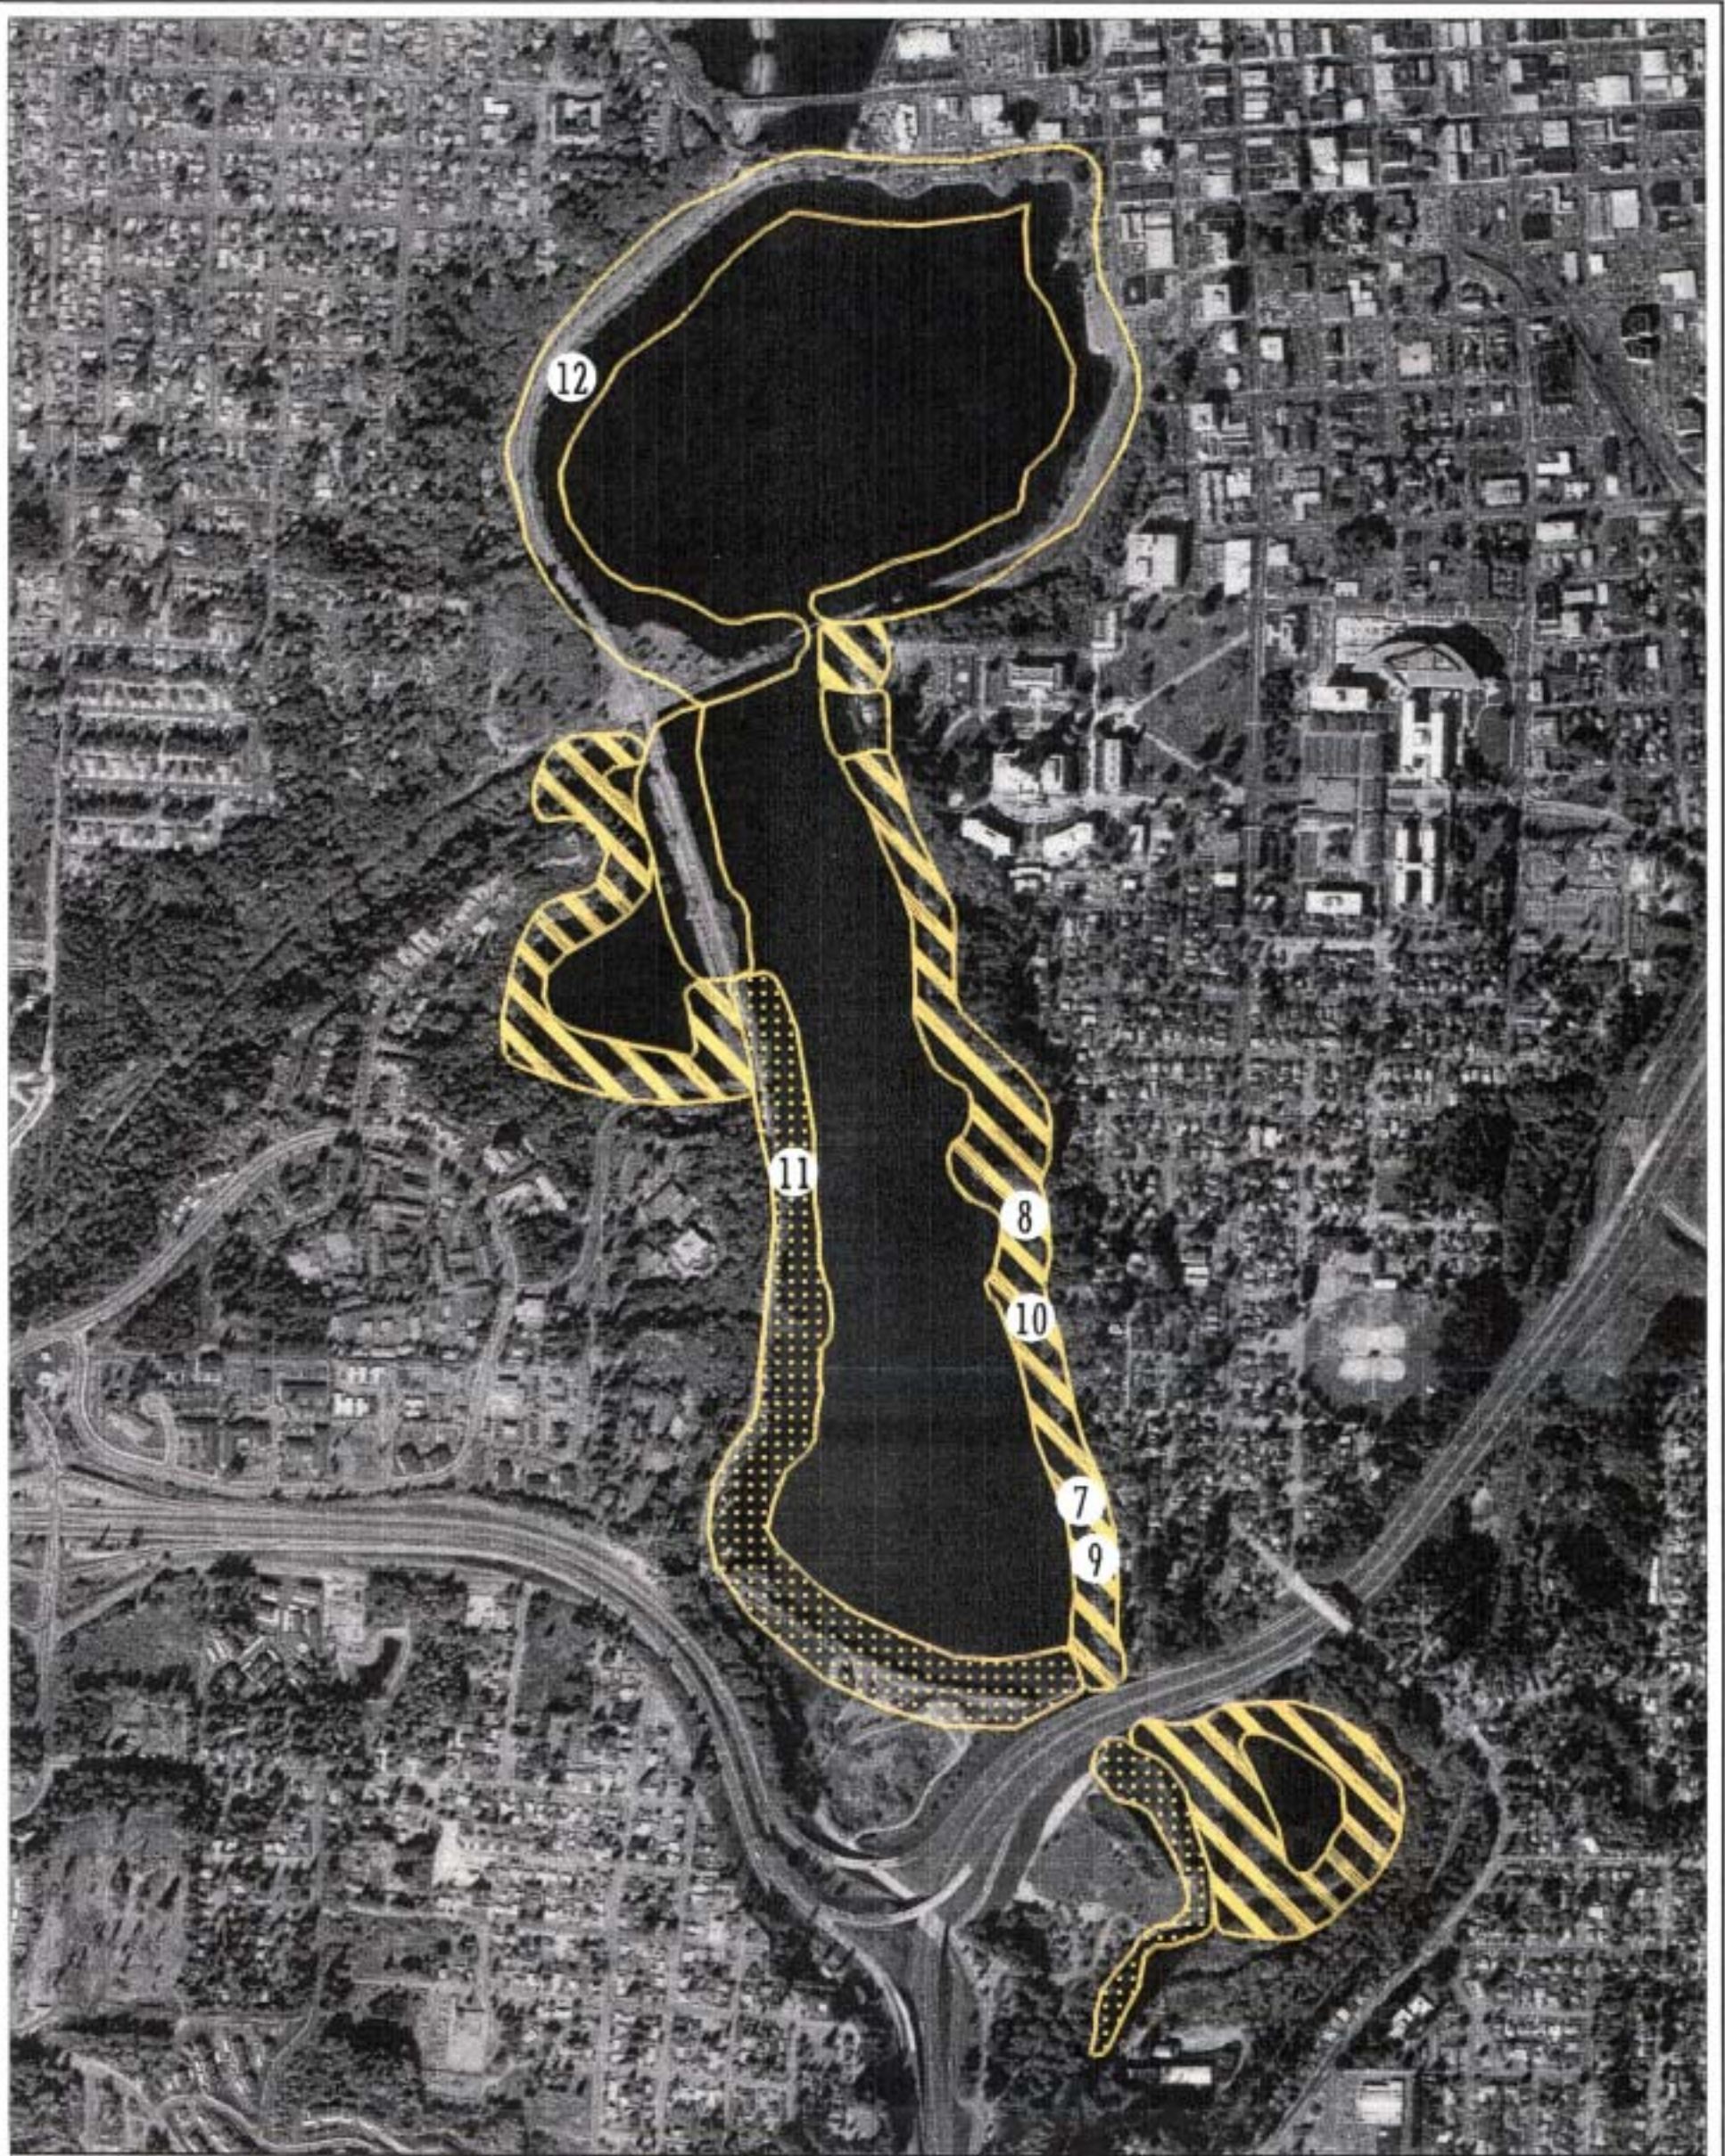
Figure 6

## 1997 DRAWDOWN -- SHORELINE HABITAT ZONES

As shown in **figure 6**, the entire north basin shoreline and the northern third of the west side of the middle basin is considered low habitat value. Vegetation along these shorelines is dominated by a combination of wetland and shoreline grasses and there are few trees (**figure 12**). In the vicinity of Marathon Park and the City of Olympia Park, natural grasses have been replaced by landscaped lawns and ornamental shrubs. Elsewhere, along limited shoreline reaches, the habitat is more similar to the medium value habitat zone—such as the narrow wetland edge along the southeast shore of the north basin (wetland S - **Washington State Department of General Administration 1997**).

A visual and photographic survey of lake shoreline conditions was performed on July 23 and 24, 1997 to assess shoreline habitat quality. This included a reconnaissance level survey of shoreline vegetation, erosion, and large woody debris. Both ground level and aerial photographs were used to characterize the shoreline as having high, medium, or low shoreline functional habitat (**figure 6**). Ground level photographs were taken when the lake was drawn down approximately 1–3 feet lower than normal (**figures 7 through 12**). Each habitat zone is defined below.

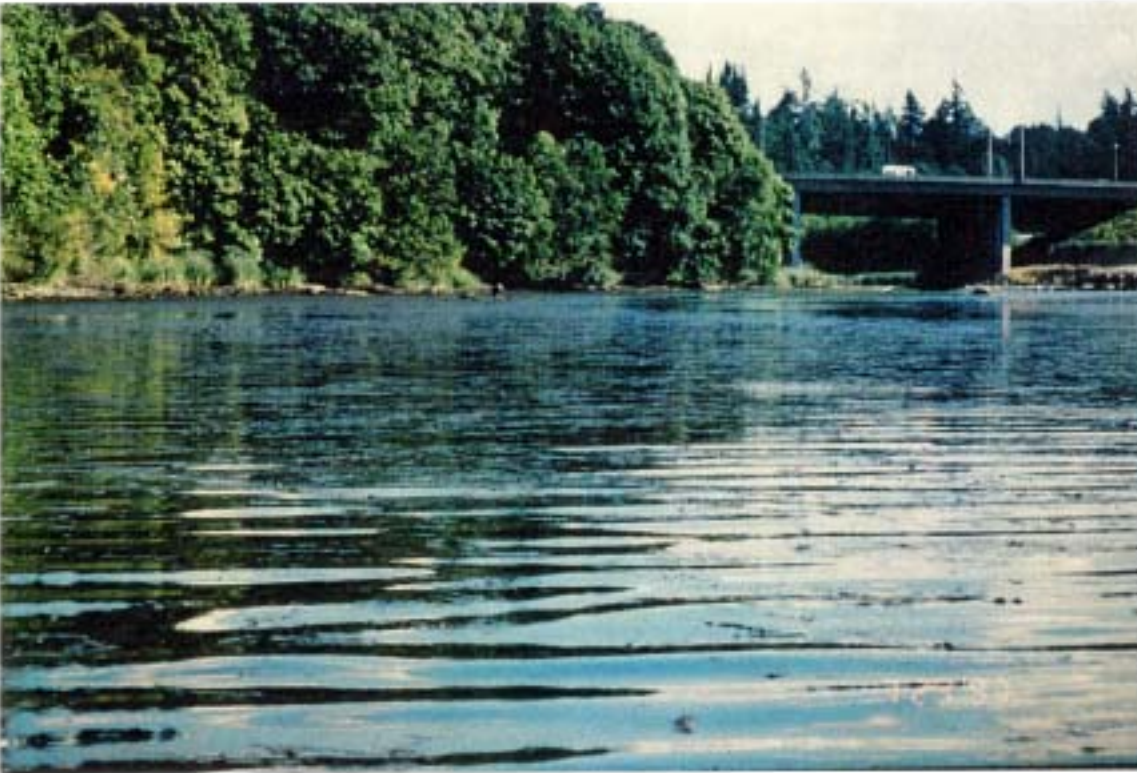
**Figure 7 - High Functional Shoreline Habitat**  
Heavily vegetated east shoreline of the middle basin.  
View to the south and I-5 Freeway.

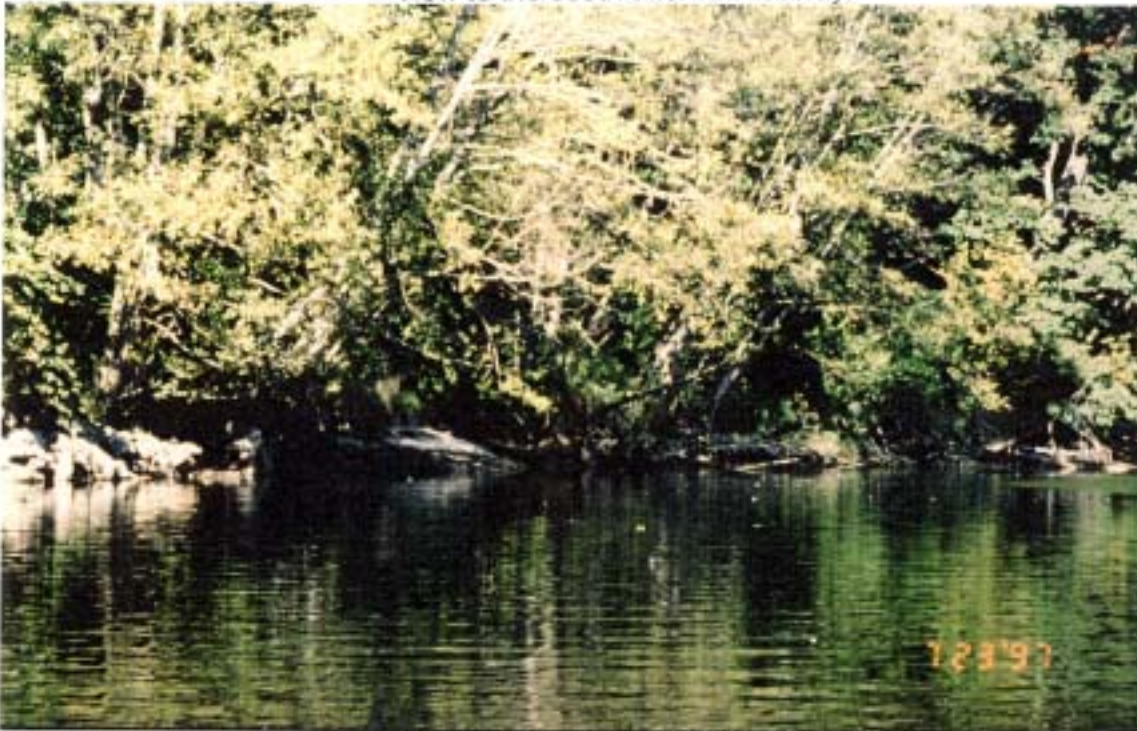
**Figure 8 - High Functional Shoreline Habitat**  
Typical habitat along east shore of the middle basin. Mature deciduous trees  
overhanging water with large woody debris along shoreline edge.

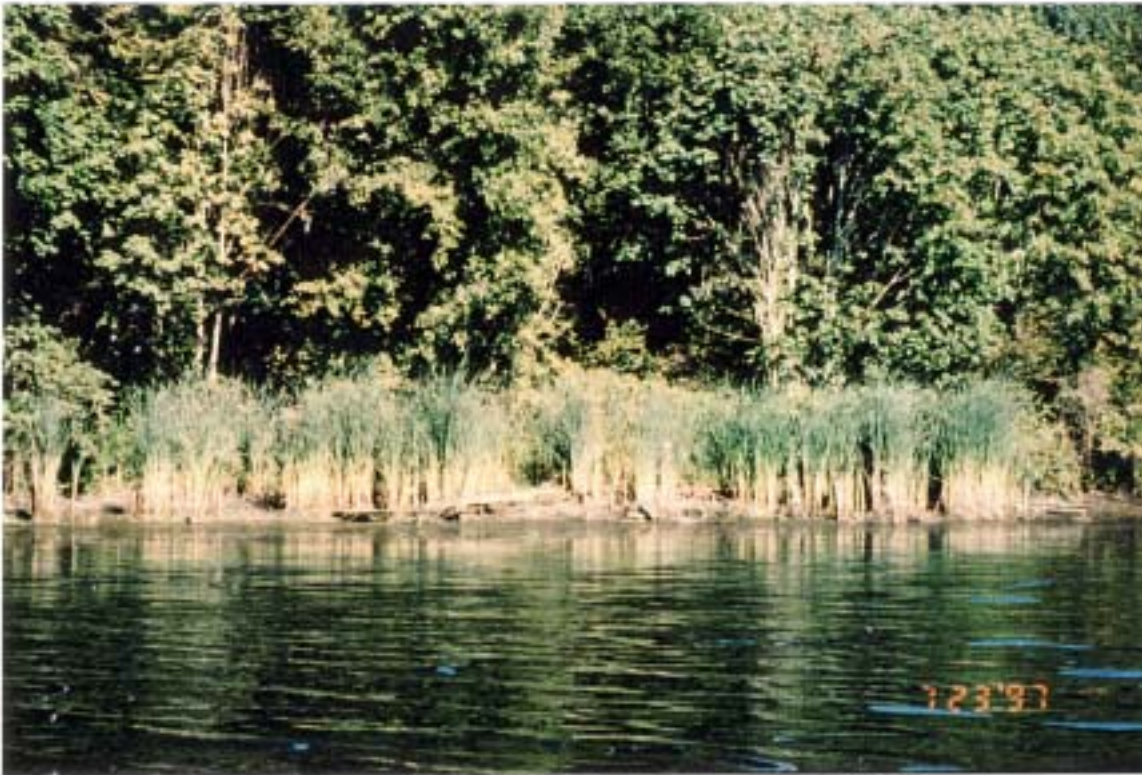
**Figure 9 - High Functional Shoreline Habitat**

Another view of habitat along the east shore of the middle basin. Cattails at shore's edge with mature shrubs and deciduous trees beyond.

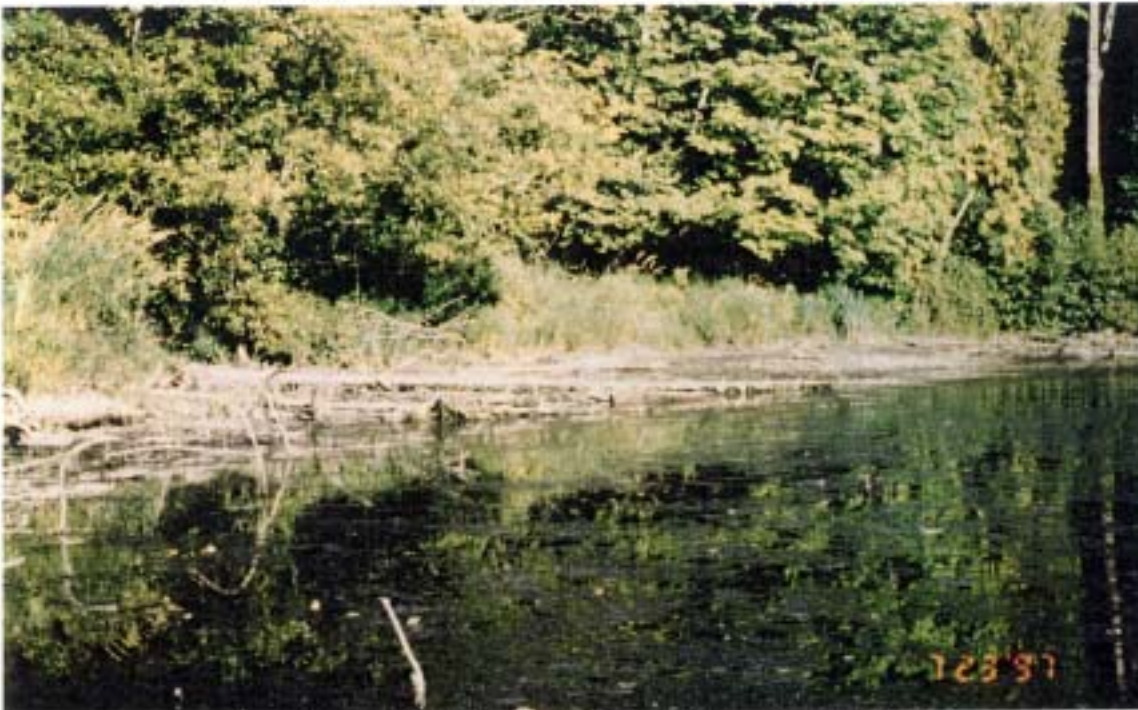
**Figure 10 - High Functional Shoreline Habitat**

East shore of the middle basin showing nearshore wetland grasses with mature shrubs and deciduous trees beyond.

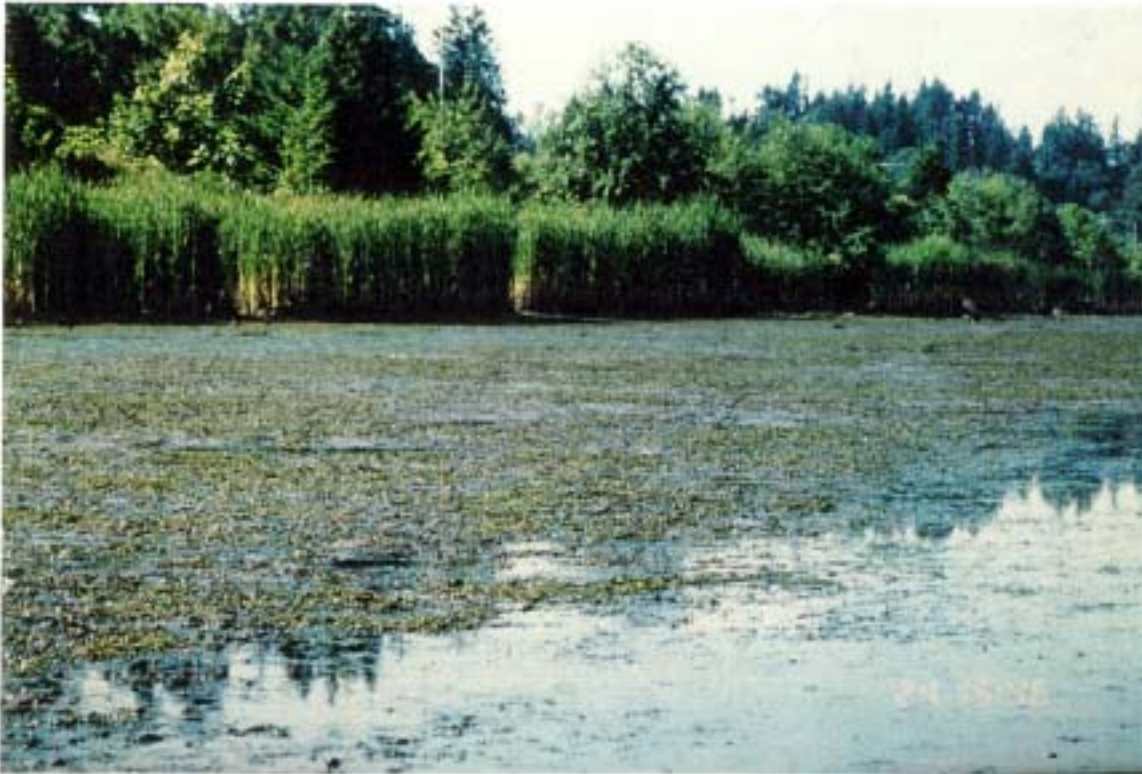
**Figure 11 - Medium Functional Shoreline Habitat**

Shoreline habitat along western shore of the middle basin showing nearshore cattails. Off-shore aquatic plant beds and immature trees in the background,

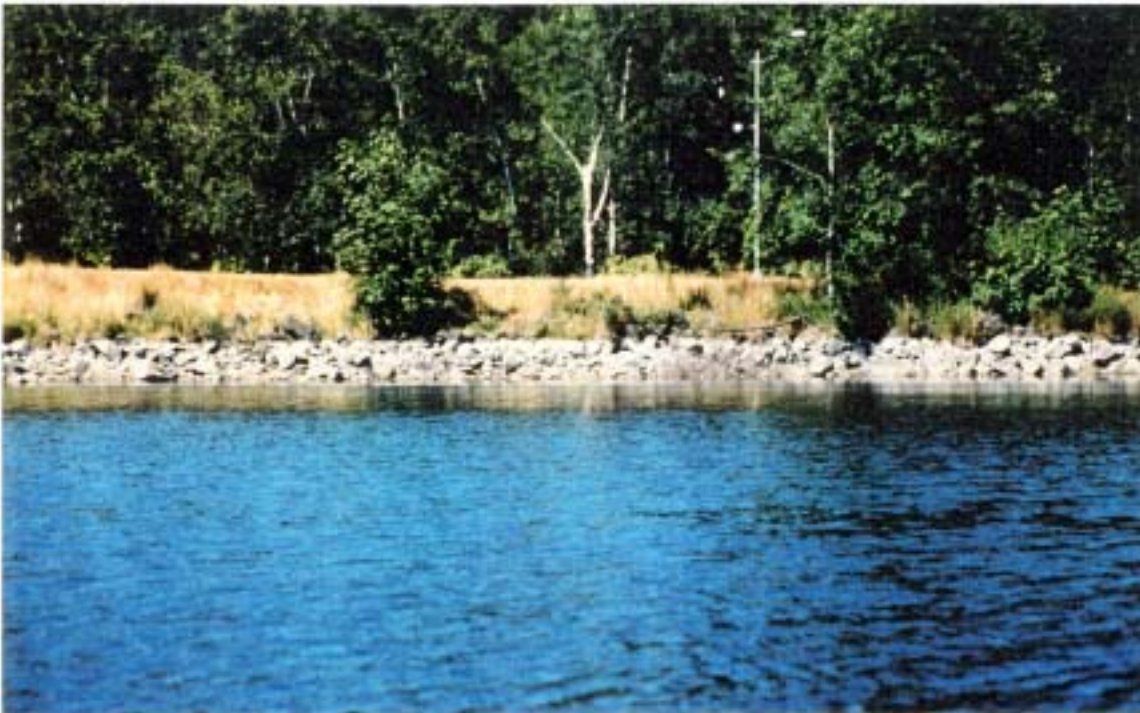
**Figure 12 - Low Functional Shoreline Habitat**

Shoreline condition along the north basin showing riprap with upland grasses and sporadic immature deciduous trees.

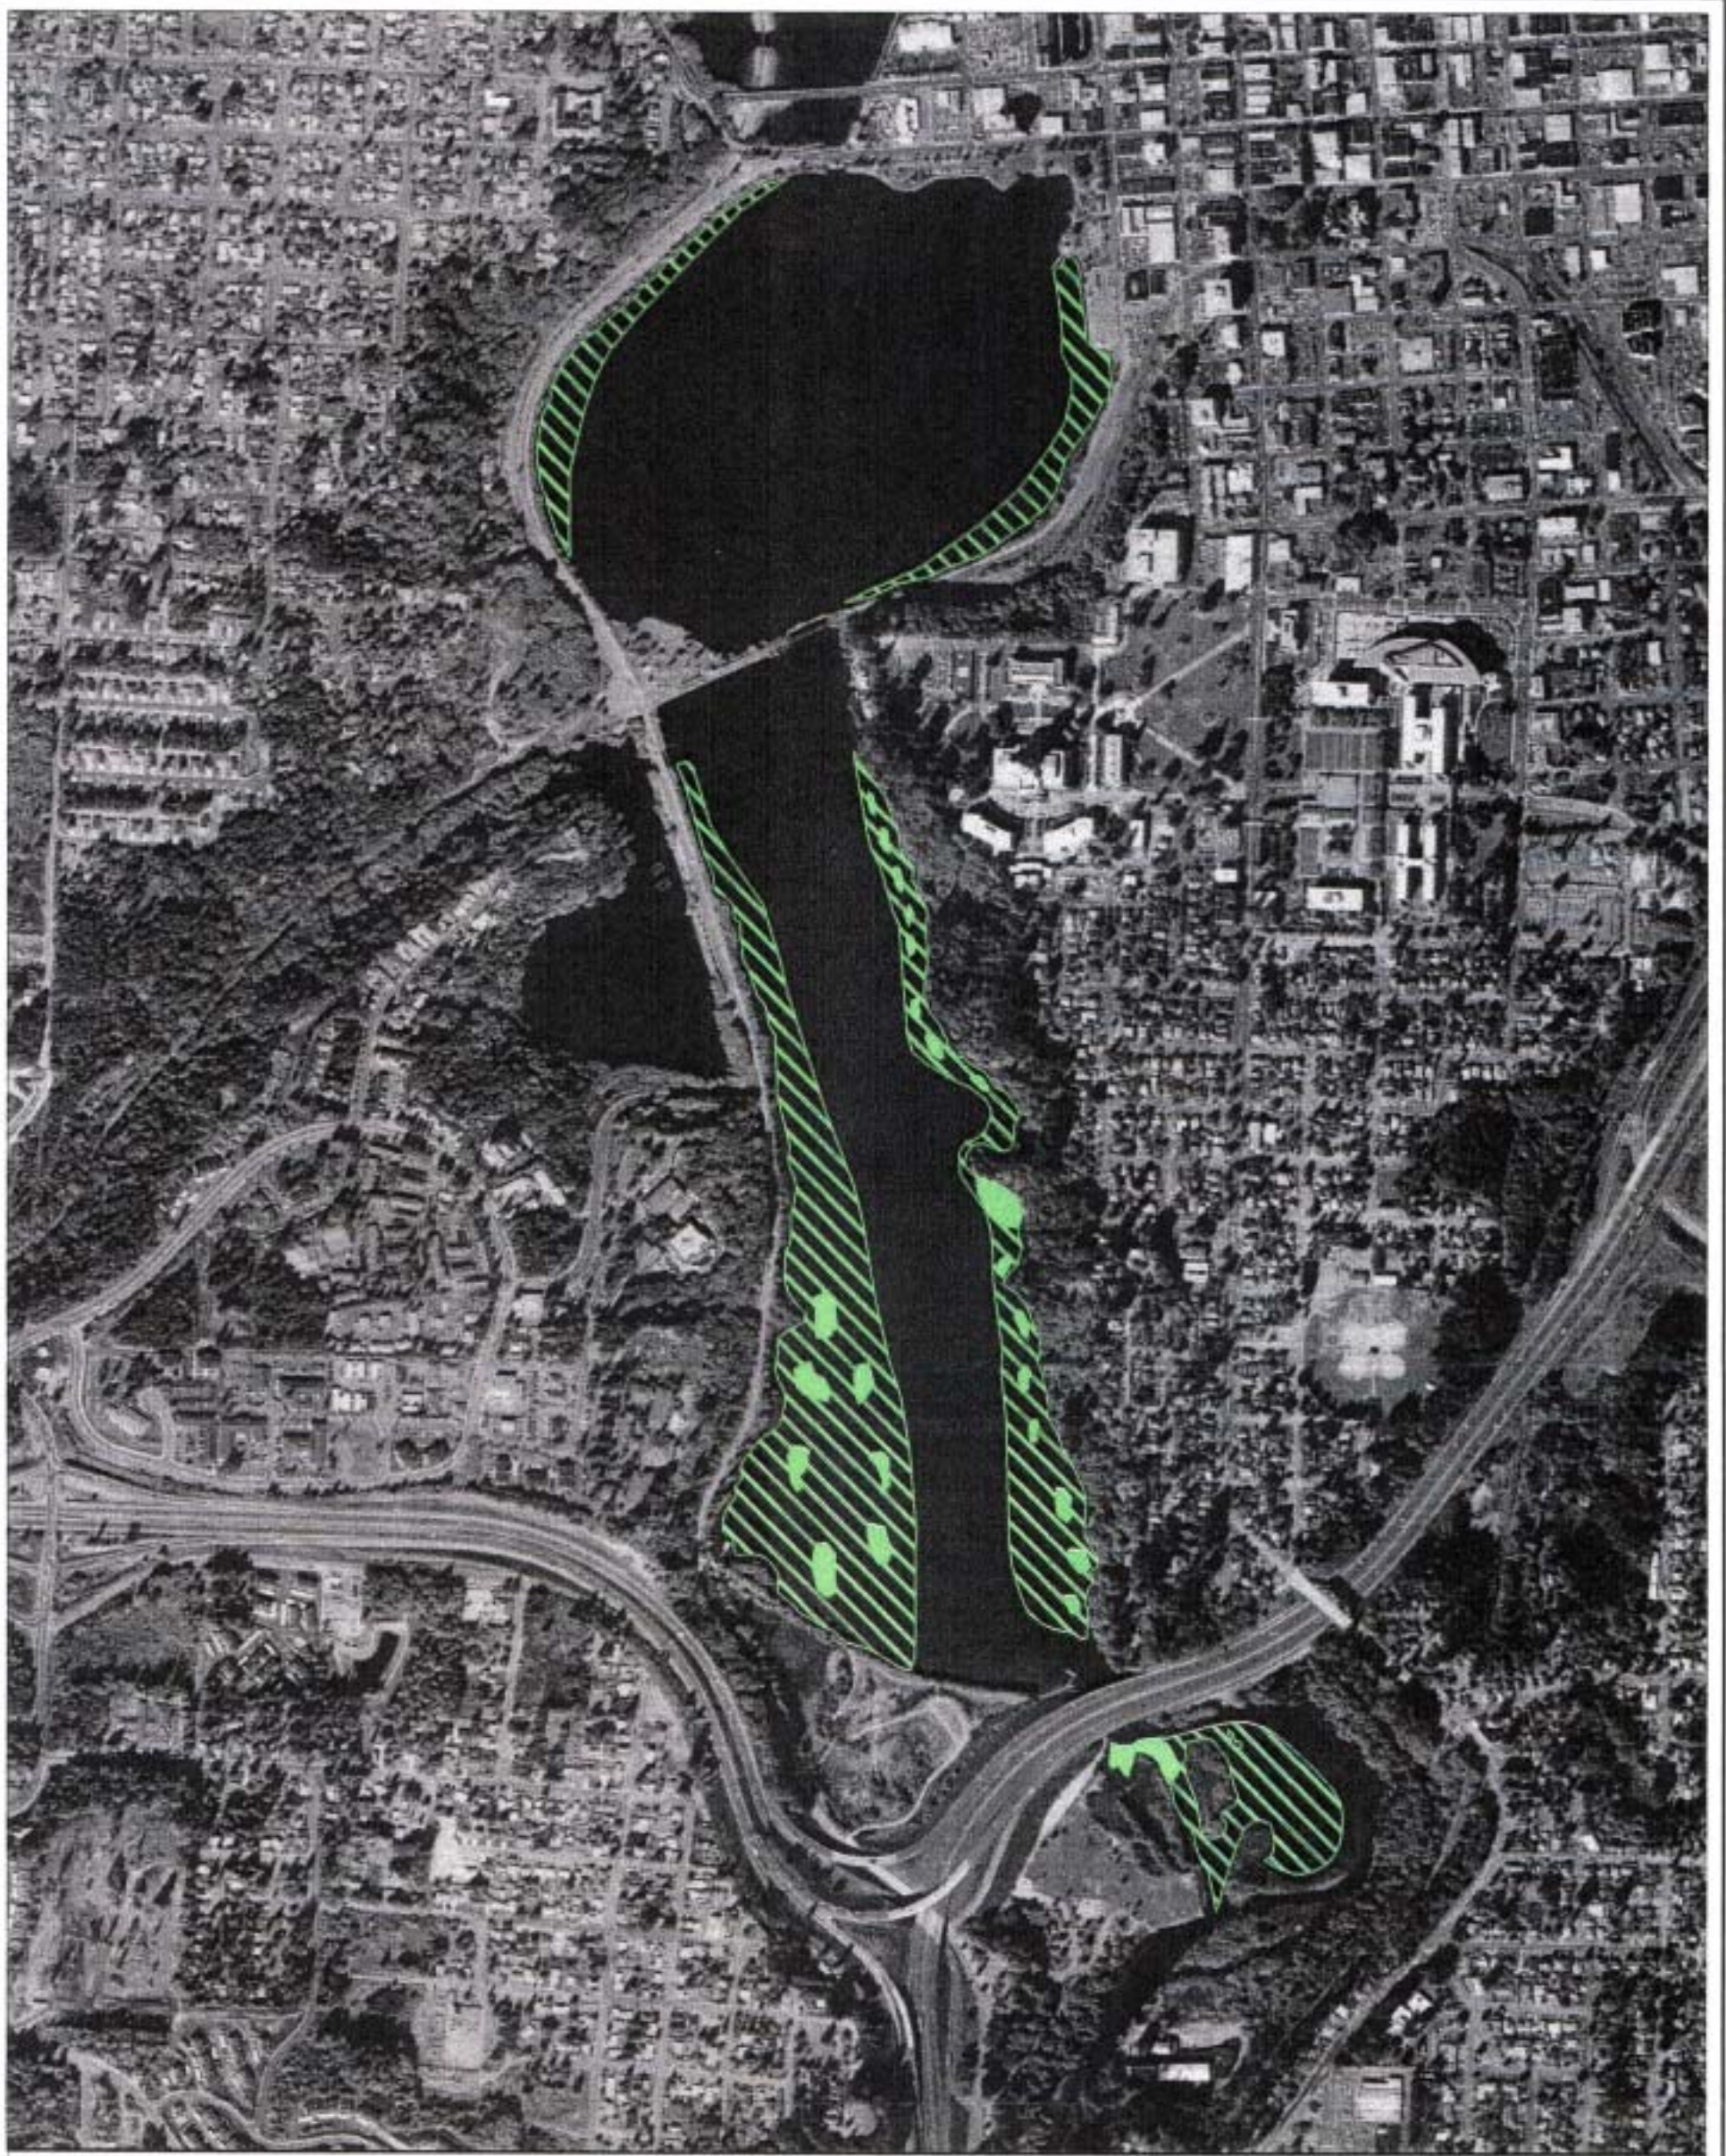
## ROOTED AQUATICS: 1971 & 1972

The Capitol Lake Restoration and Recreation Plan Environmental Impact Statement (DGA 1977) indicated that saltwater flushing reduced the area colonized by aquatic plants (see figure 15). Due to the lack of recent quantitative data of aquatic plant distribution, however, the effectiveness of saltwater flushing in controlling aquatic plants cannot be confirmed. Plant density data were recently collected by Thurston County, however, there are no historic data on plant densities.

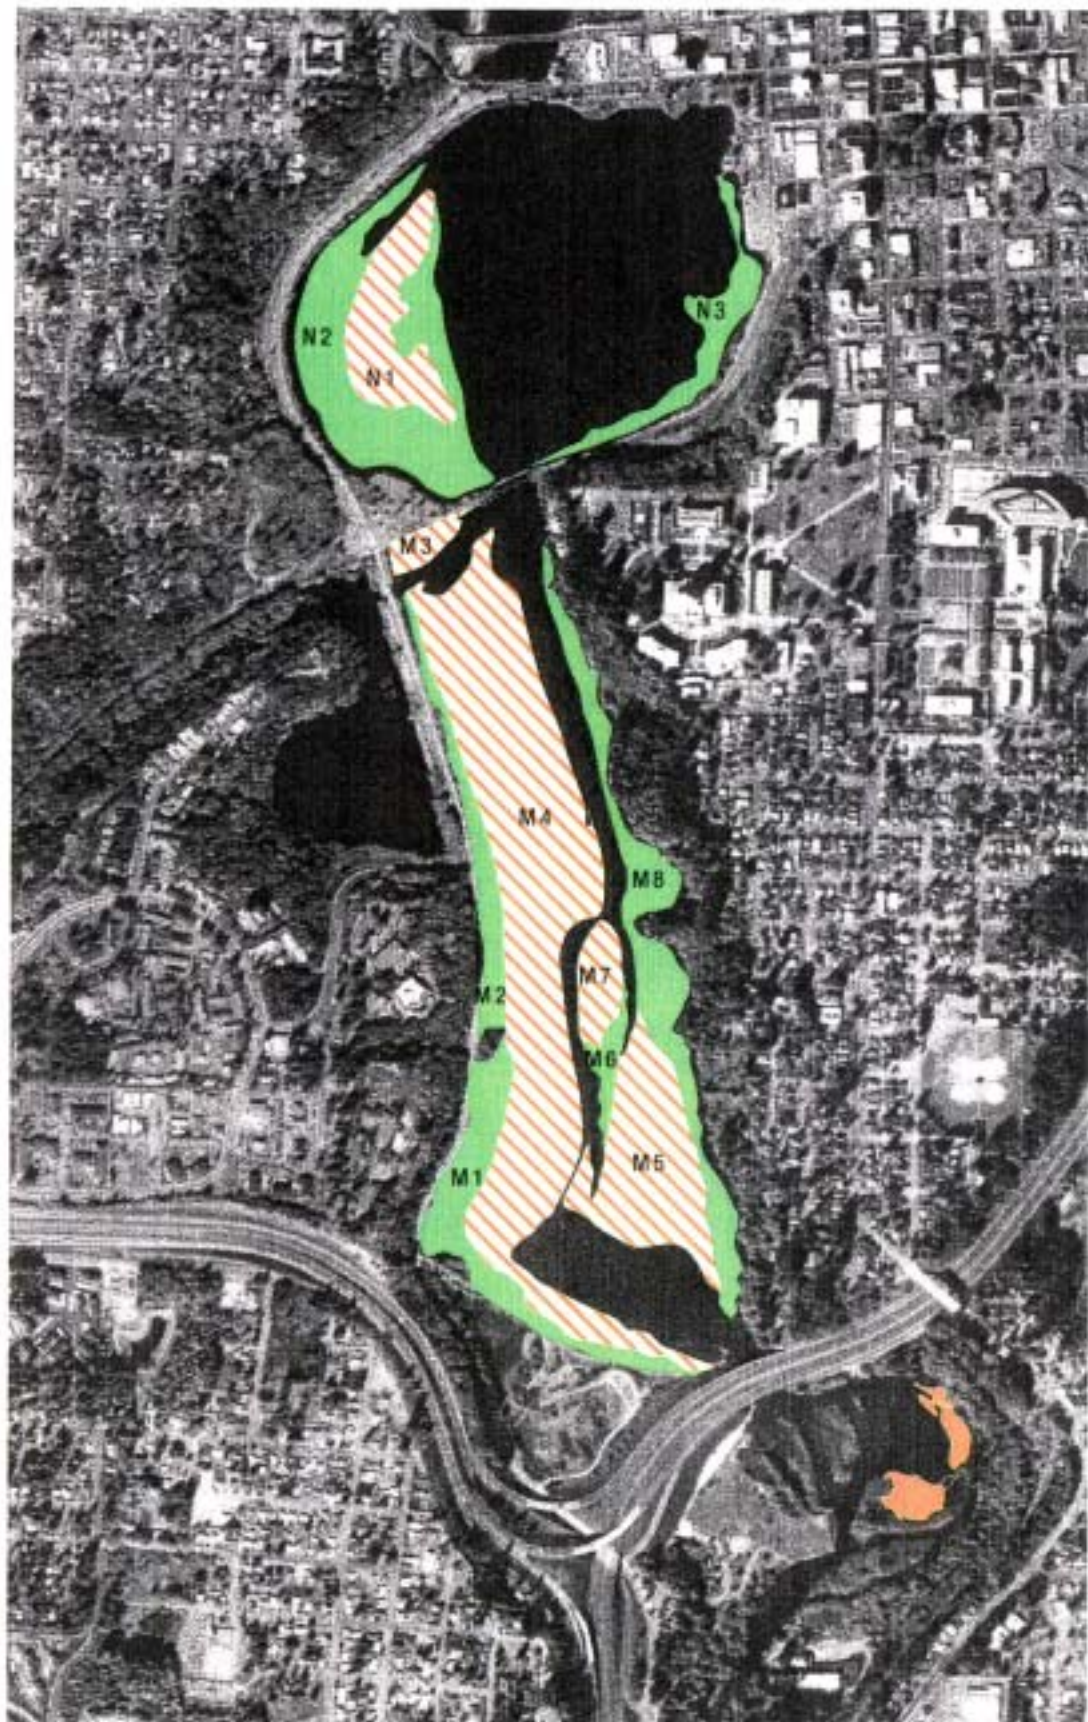
**Figure 16**  
**1997 Aquatic Plants**

The most significant characteristic of the aquatic plant community in Capitol Lake is that it is nearly made up entirely of one species. Common waterweed (*Elodea canadensis*) comprised almost 100% of the plant community in both the middle and north basins, with occasional sparse occurrences of a thin-leaved Pondweed. This may indicate that common waterweed is relatively tolerant of the higher salinity levels caused by the annual back flushing with saltwater.
