Capitol Lake – How It Functions and What Water Quality Issues It Faces

May 2000

**for the State of Washington General Administration
by Thurston County Public Health Department,
Environmental Health Division**

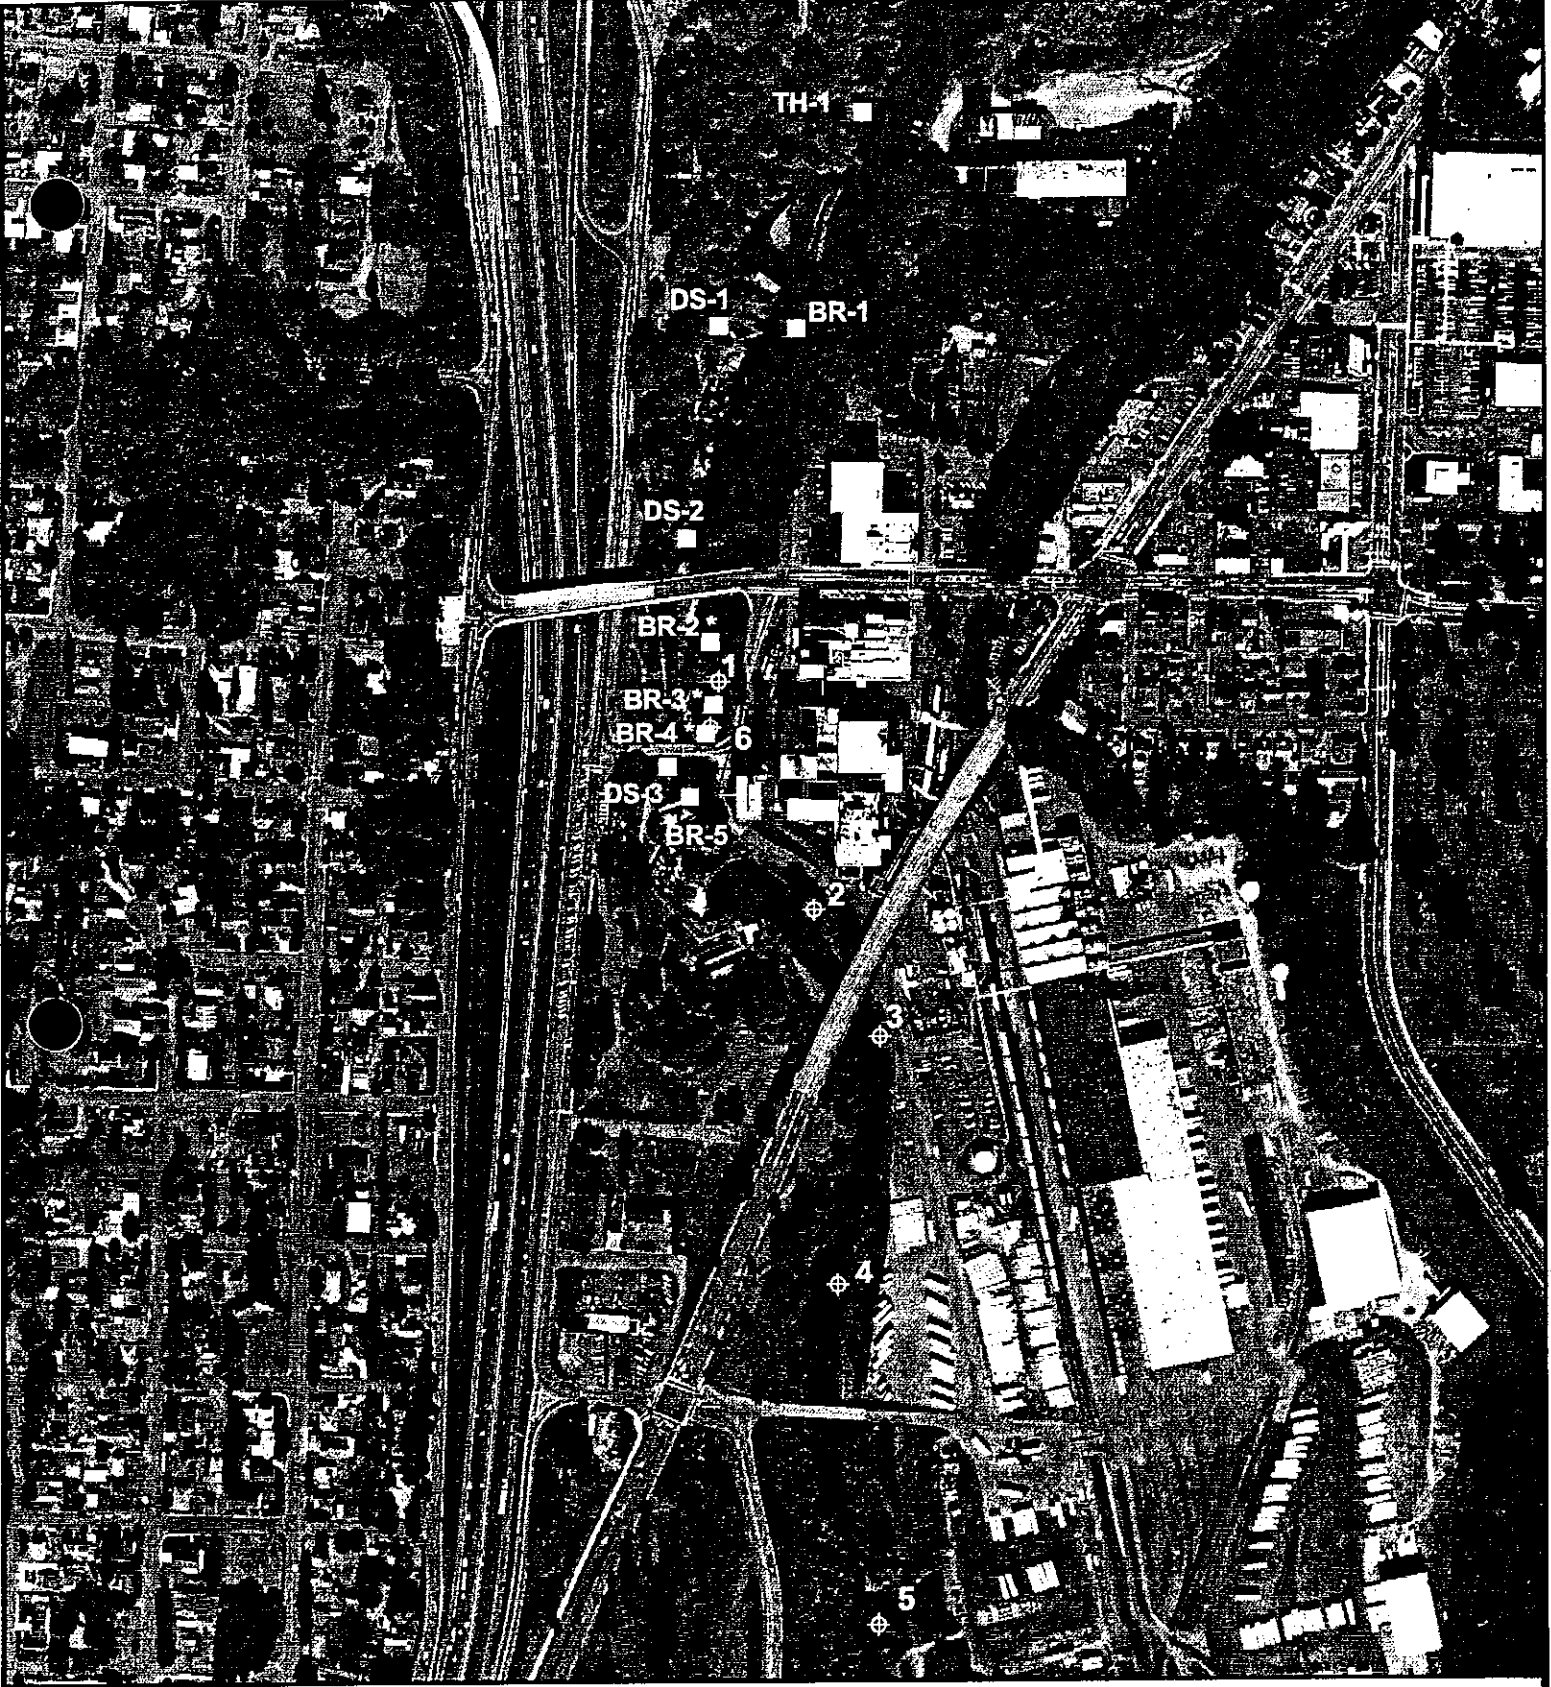
DESCHUTES RIVER OUTFALL SAMPLING SITES

- ⊕ Permitted Brewery Discharges
- ⊕ Outfall Sampling Sites

* Note: These 3 samples probably represent the same discharges identified on the NPDES permit as #1 and #6.

The table below reflects all data collected from each site and the rainfall amount for the day of the sampling. The attached map shows the location of the sampling sites.

- DS-1 12" Corrugated metal pipe discharging into a concrete gutter along the foot path. The primary contributing area to this discharge pipe is a section of I-5, although a very small area of Deschutes Parkway run-off also flows to this pipe. Basin size is 2 acres.

- DS-2 12" corrugated metal culvert discharging to river just north of the Custer Way overpass. The contributing area is 16.8 acres and encompasses portions of Division St., 2nd Avenue, 3rd Avenue, and West "B" Street on the west side of I-5. The contributing area also includes a section of I-5.

- DS-3 12" concrete culvert discharging south of the Division Street bridge. The contributing area is the section of Deschutes Parkway from "C" Street north to the Division Street bridge. The basin size is 1.9 acres.

- TH-1 18" culvert discharging to Capitol Lake at the south end of Tumwater Historical Park. The basin is 120 acres and includes the residential area west of the freeway up to Tumwater Hill. It also includes run-off from a small section of Deschutes Parkway and probably part of I-5. Part of the conveyance system for the run-off is through a natural creek channel named DeSoto Creek.

- BR-1 through BR -5 These are all cooling water discharges from the brewery which free flow over the bedrock on the east side of the river between the top and the bottom of Tumwater Falls.
