A Study of Rates and Factors Influencing

CHANNEL EROSION

DESCHUTES RIVER, WASHINGTON

**Report Prepared by:
Brian Collins
Seattle, WA**

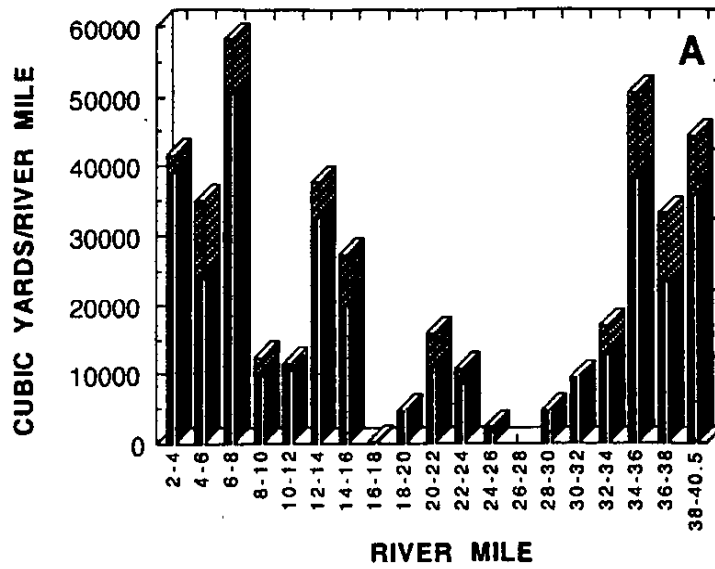
Figure 4-5. For 1981-1991: (A) Amount of fine sediment (solid bar) and coarse sediment (patterned bar) per 2-mile-long stream segments, and (B) amount of coarse sediment per 2-mile-long segment.

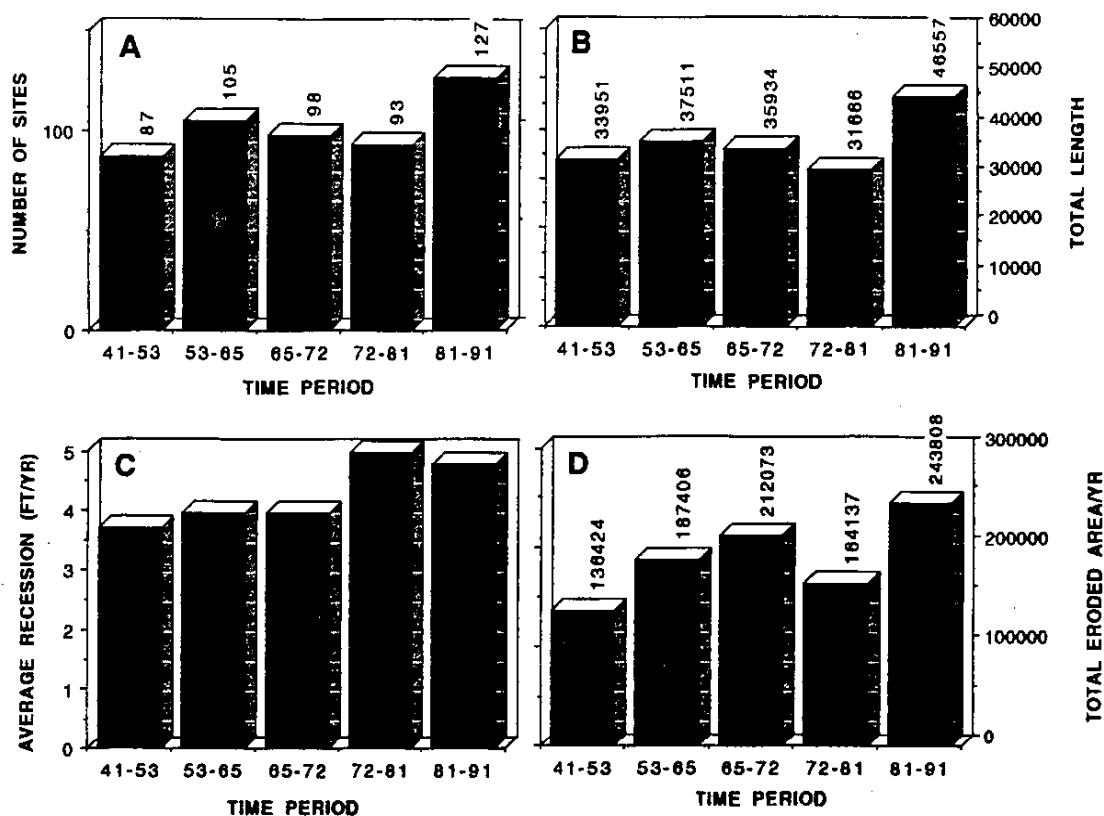
Figure 4-7. For each of five time periods bracketed by aerial photographs: (A) Number of erosion sites; (B) Total length of eroding bank; (C) Average annual recession rate; (D) Aerial extent of eroded bank.

Variation in the Rate of Erosion, 1941-1991. To determine whether there was significant change in erosion rate in the 50-year period of analysis, Figure 4-7 compares recent bank erosion with erosion in previous decades, as measured on the aerial photographs. Because we did not have bank height estimates from earlier periods, areal erosion is computed but not volumetric erosion. Figure 4-7A shows that the number of eroding banks ranged from 93 to 105 between 1953 and 1981. There were slightly fewer (87) in the 1941-1953 period, and more in the 1981-1991 period (127). Some of this

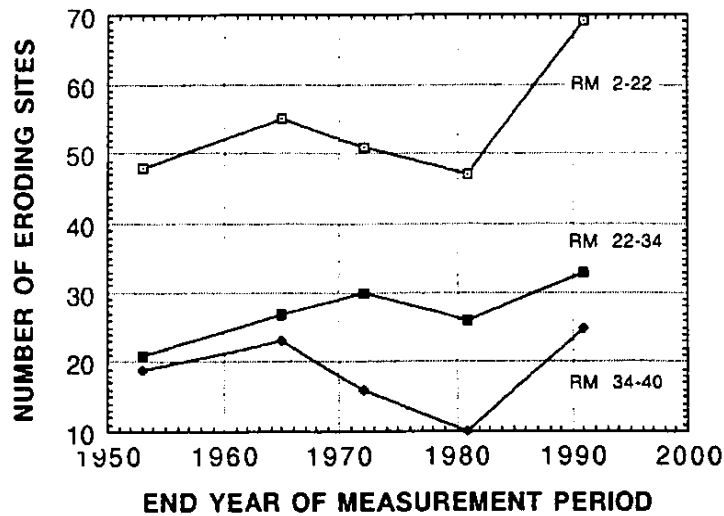
Figure 4-8. Variation in number of eroding banks, 1941-1991, in three stream reaches.
