Restoring the Unseen River: The Viability of
Hyporheic Zone Restoration for Improving Groundwater
and Surface Water Exchange in an Urban Watershed

A Thesis
Submitted in partial fulfillment
of the requirements for the degree
Master of Environmental Studies
The Evergreen State College
June 2015

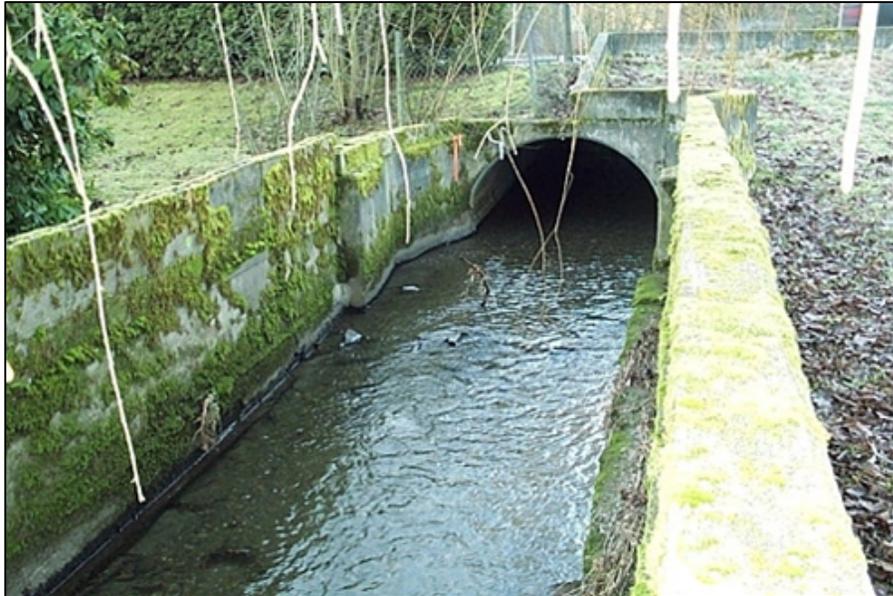
Figure 1: Shows a pre-project photograph of the South Fork of Thornton Creek flowing through a culvert underneath 35th Ave. N.E. in Seattle, WA. Photograph provides an excellent example of channel armoring and the absence of floodplain connectivity. Source: Seattle Public Utilities (<http://www.seattle.gov/util/EnvironmentConservation/Projects/MeadowbrookThornton/Details/index.htm>)

floodplain, which further intensifies stream flows and can lead to streambed erosion and channel incision (Figure 1) (Bernhardt and Palmer, 2007; Lawrence et al., 2013).

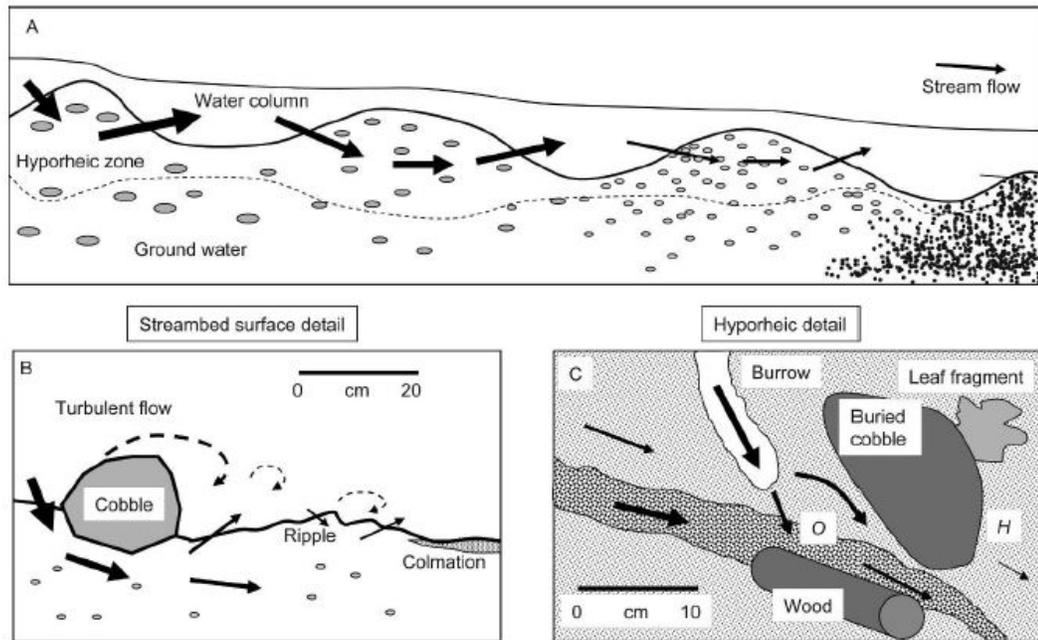
Figure 2: Shows the flow of water through the hyporheic zone at different scales. Streambed topography and size of sediment can influence surface and subsurface flow characteristics. The thickness of the arrows indicates the magnitude of HZ exchange. Graphic (A) shows how HZ exchange is driven by changes in pressure through a riffle-pool sequence. The broken line in graphic (A) represents the groundwater zone. The oval shapes in graphic (A) represent sediment size with a transition (right to left) from coarse sediment to compacted fine sediment. Notice that the magnitude of HZ exchange is greatest in areas of coarse sediment. Graphic (B) illustrates how streambed surface irregularities (i.e. cobble and sediment ripples) cause turbulent HZ flow. Graphic (B) also shows how areas of colmatation (fine sediment clogging) can restrict HZ flow. Graphic (C) shows a cross-section of the hyporheic zone, showing how water travels through the subsurface hyporheic zone. The darkened band that cuts through the graphic, indicates a section of coarser sediment. The submerged material such as, cobble, wood, and leaf fragments can also change the direction of flow. The areas with greater flow are usually areas of oxygenated sediment, indicated by the letter O. Areas with lesser flow are usually areas of hypoxic conditions, indicated by the letter H. Source: Boulton et al., (2010)

Exchange of water through the HZ is primarily influenced by channel features that cause discontinuity in slope (i.e. riffle, step-pools, debris dams, and sediment ripples), permeability of the sediment, and river bend and meanders (Figure 2) (Boulton et al., 2007, 2010; Hester & Gooseff, 2010).

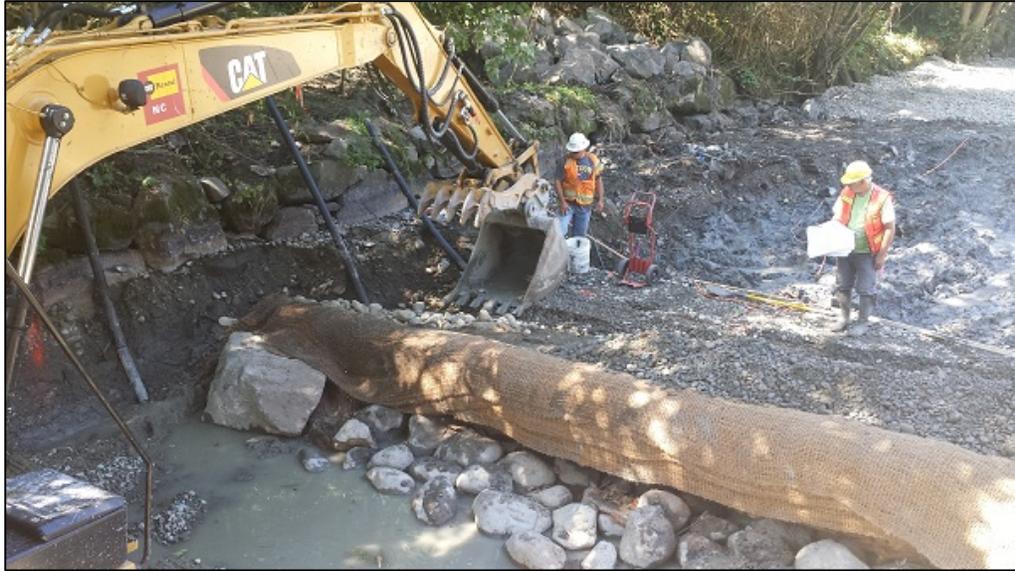
Figure 4: Photo shows the addition of a step-pool feature at the Knickerbocker treatment site. Also shows the constructed hyporheic substrate that consists of coarse sediment. Source: Seattle Public Utilities (<http://www.seattle.gov/util/EnvironmentConservation/Projects/KnickerbockerFloodPlain/index.htm>)

An important component of the restoration project was to also to restore the hyporheic zone. Seattle Public Utilities decided to try something entirely new by reconstructing the hyporheic zone at the two restoration sites. They achieved this by first excavating the original streambed that contained high amounts of fine sediment. They then added between 1-2 feet of coarse gravel and cobble. No sand or fine sediment was added during construction, due to the assumption that sediment would come naturally from erosion and sedimentation processes after project completion. The other major component of the restoration was the addition of in-stream physical structures along the streambed, such as boulders, large wood, and step-pool structures (Figure 4). The in-stream structures when combined with the added coarse gravel are expected to improve vertical connectivity between the groundwater and surface water zones.

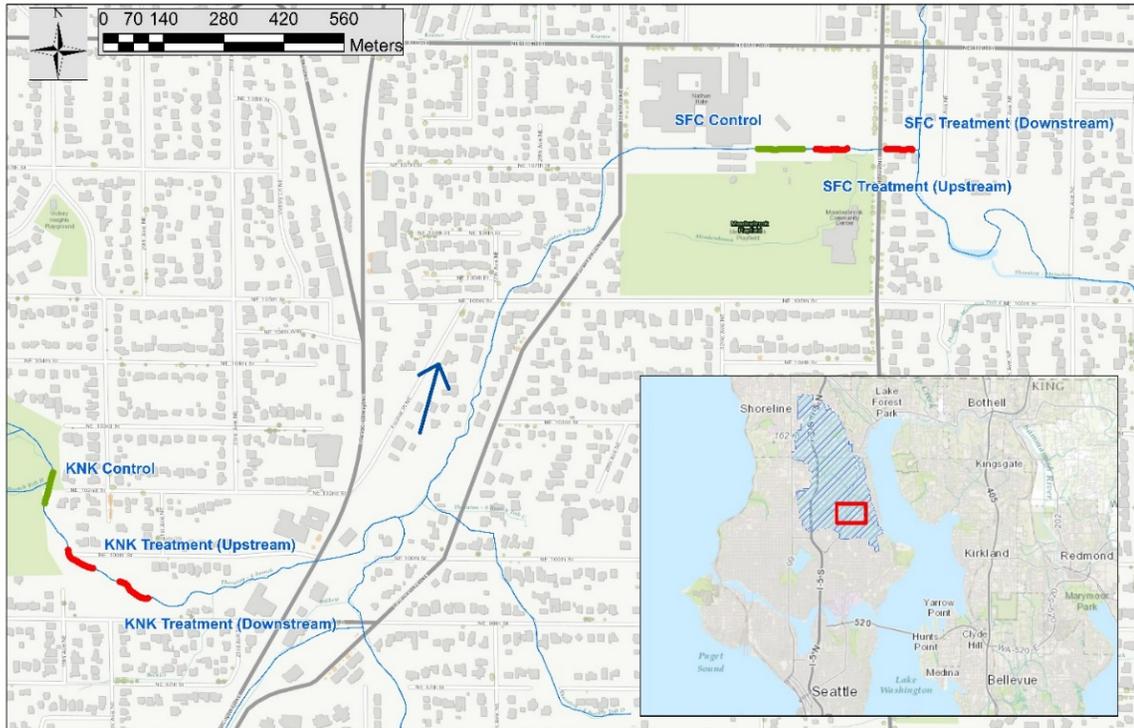
Figure 5: Above is a map showing approximate survey locations of each reach at both the Knickerbocker (KNK) and South Fork Confluence (SFC) sites located on Thornton Creek, in the city of Seattle. The blue arrow indicates stream flow direction.

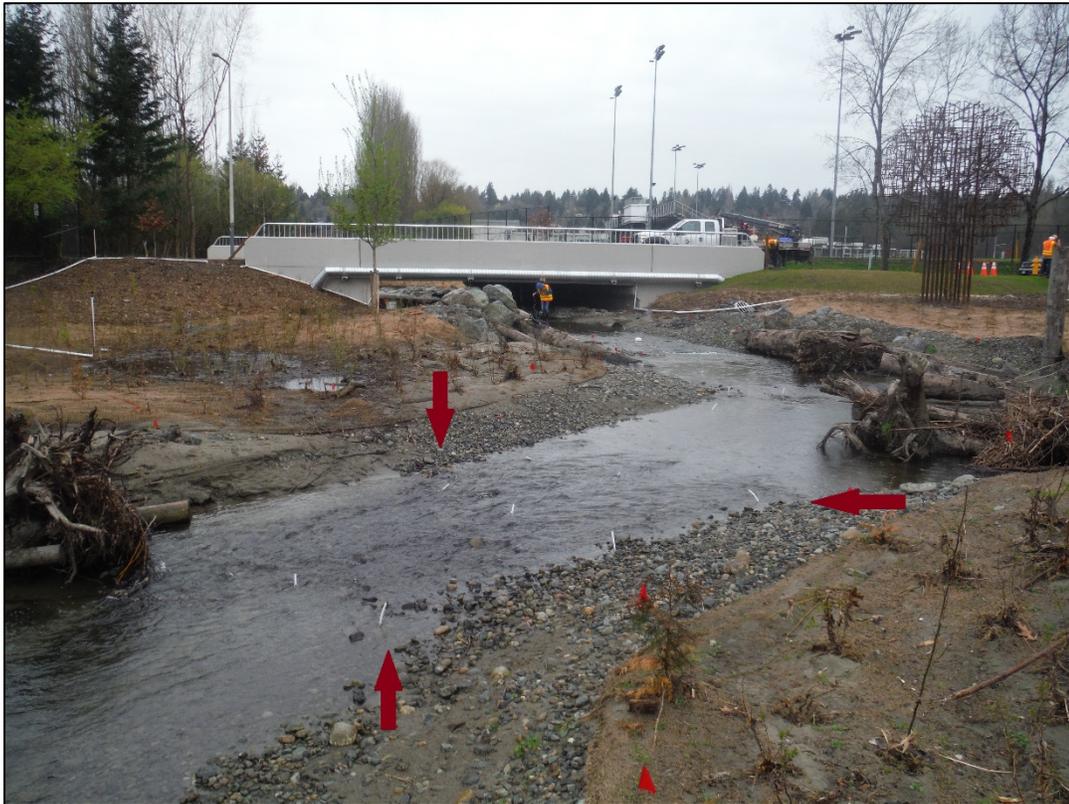
Figure 6: Photograph of South Fork Confluence treatment (downstream) study site. Shows the characteristic transect and tube arrangement used for all six surveys. The photograph shows transects placed at the upstream, middle, and downstream section of a riffle unit.

For the temperature surveys, 60-80 short, 0.375” inner diameter polyethylene tube segments were installed into the streambed. Multiple transects (12-17) consisting of 3-5 tubes were installed laterally from one stream bank to the other at each site (Figure 6). The number of tubes and transects used for each site varied based on stream characteristics and conditions at each site. For example, wider stream reaches typically required more tubes to ensure sufficient survey coverage. Transects were placed at the beginning, middle, and end of each habitat unit type (riffle, pool, and glide) (Figure 6), which were defined at the site by the surveyors. The spacing of transects varied from reach to reach, but transects were generally placed every 2-4 m longitudinally down the

reach. The tubes (approx. 33 cm in length) were inserted about 10 cm into the streambed using a soil probe. The distance between each tube also varied, but most of the tubes were placed 1 m to 2.5 m apart laterally across the stream channel. In certain situations, tubes were dislodged during the survey and were reinstalled in the original location.

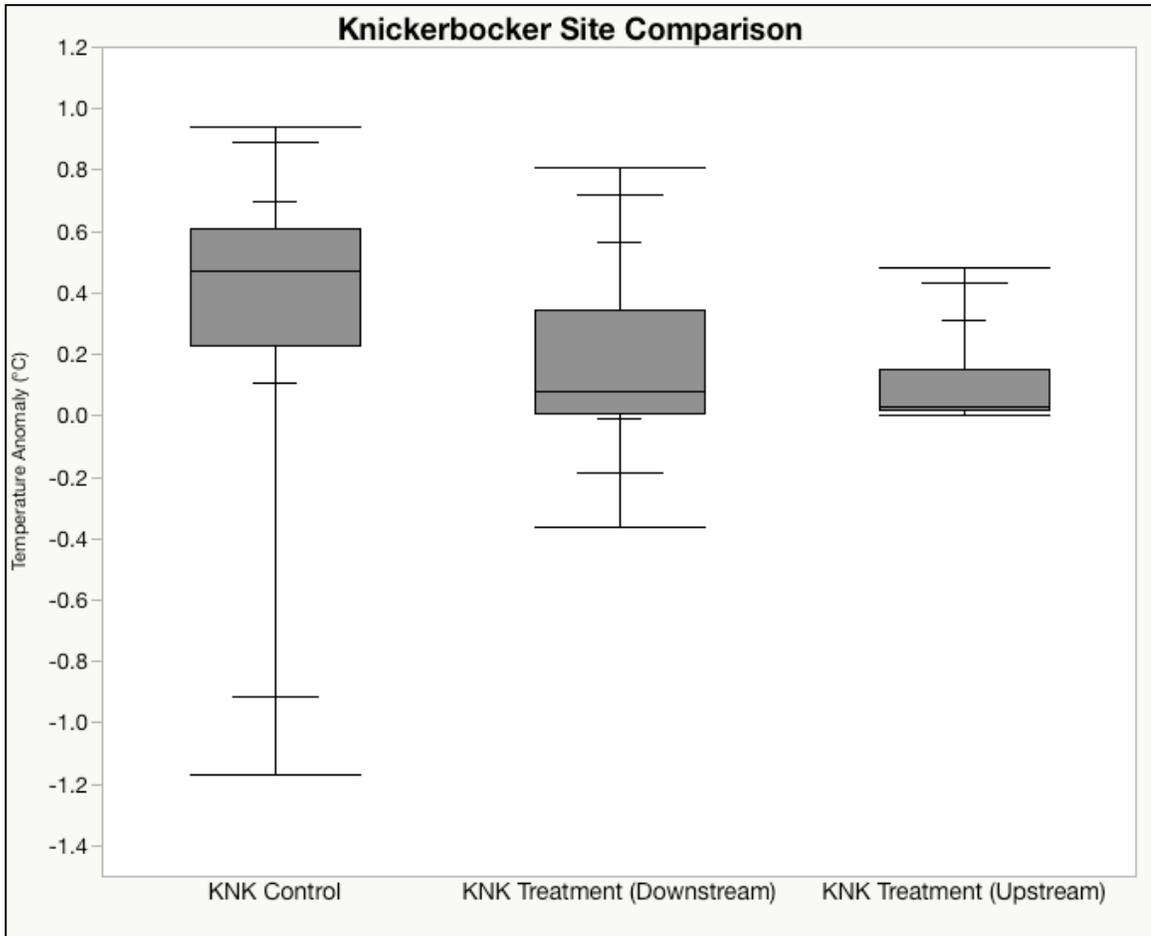
Figure 7: Shows box-and-whisker plots of temperature anomalies ($^{\circ}\text{C}$) at each of the Knickerbocker sites. Temperature anomalies are the difference in temperature between the water just below the streambed (10 cm) and the surface water. Anomaly values above zero indicate that the streambed was colder than the surface water and anomaly values below zero indicate the opposite. Includes results of surveys that were completed at the Knickerbocker (KNK) control reach, Knickerbocker (KNK) treatment upstream (US) reach, and the Knickerbocker (KNK) treatment downstream (DS) reach. The line in the middle of each box (interquartile range) represents the median (50th percentile). The upper boundary line of each box marks the 75th percentile and lower boundary marks the 25th percentiles. The whisker lines from top to bottom mark the 100%, 97.5%, 90%, 10%, 0.5%, and 0% quantiles.

The results of the streambed temperature surveys at the three Knickerbocker sites showed that the Knickerbocker control site had the greatest range of temperature anomalies followed by the Knickerbocker treatment (downstream) reach and then the Knickerbocker treatment (upstream) reach (Figure 7). A Kruskal-Wallis test showed that there was a statistically significant difference in average temperature anomalies between the different survey sites, ($\chi^2(2) = 50.921, p = <0.001$). Post hoc comparisons using the Steel-Dwass test indicated that the Knickerbocker control average anomaly values were significantly different than the Knickerbocker treatment (upstream) anomalies ($p = <0.001$) and also the Knickerbocker treatment (downstream) anomalies ($p = <0.001$). However, the anomalies at the Knickerbocker treatment (upstream) site did not significantly differ from the temperature anomalies at the Knickerbocker treatment (downstream) site ($p = 0.57$).

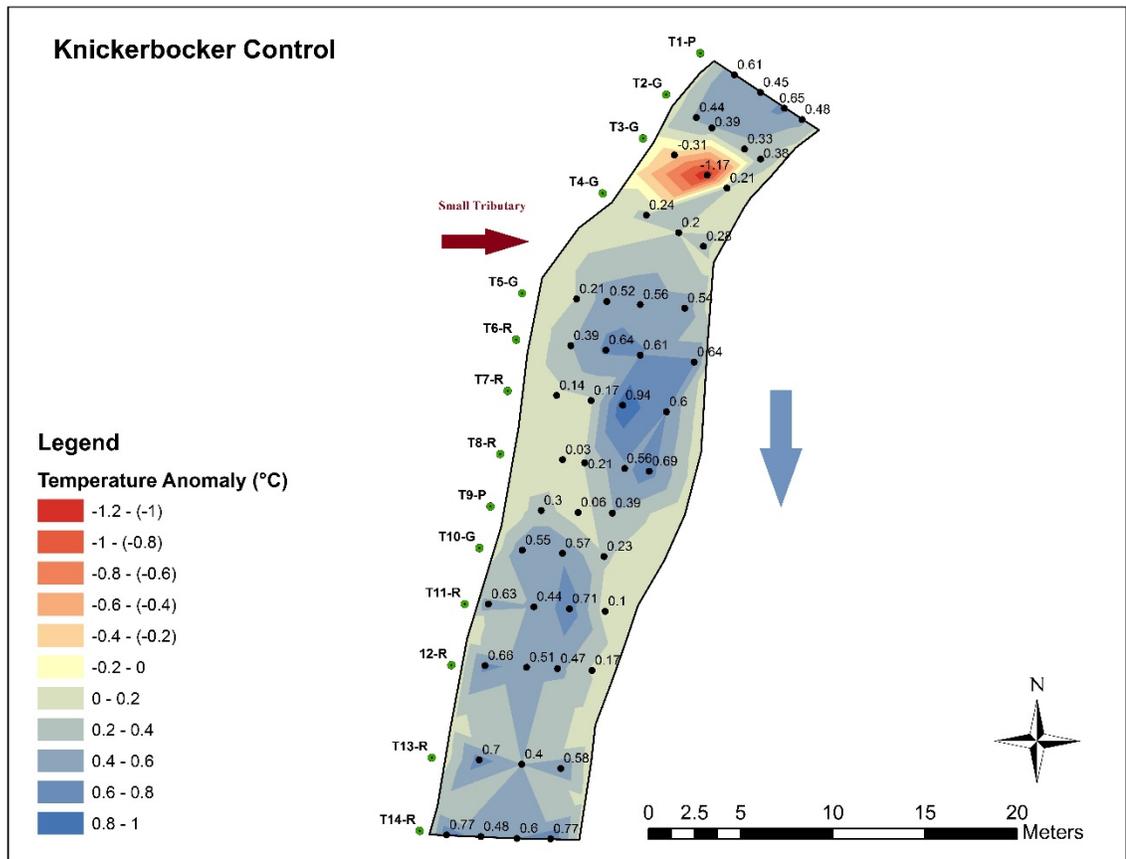
Figure 8: Plan-view map shows temperature anomaly patterns along survey reach and shows the average anomaly at each specific tube. Map also includes points, which are labeled with transect number (i.e. transect #1 [T1]) and also habitat type (pool [P], glide [G], and riffle [R]). The blue arrow indicates stream flow direction. Borders of stream reach indicate the approximate location of bankfull. Red arrow indicates location where small tributary enters the Knickerbocker control site. Notice that the streambed temperature transects are placed an extended distance away from tributary. This was done deliberately to reduce the impacts of the tributary on temperature anomalies.

As previously mentioned, there is a small tributary that enters the Knickerbocker control site in the upstream section of the stream reach (see figure 8). The plan-view map (Figure 8) shows that streambed temperature transects are located an extended distance (>2 meters) away from tributary. This was done deliberately to reduce the impacts of the tributary on temperature anomalies. However, it is possible that the tributary had some influence on temperature anomalies, and especially to the adjacent transects #4 and #5.

Furthermore, when looking at the Knickerbocker control plan-view map created for this study, some of the largest anomalies are observed nearest to the banks, which indicates cool groundwater may be entering the hyporheic zone laterally.

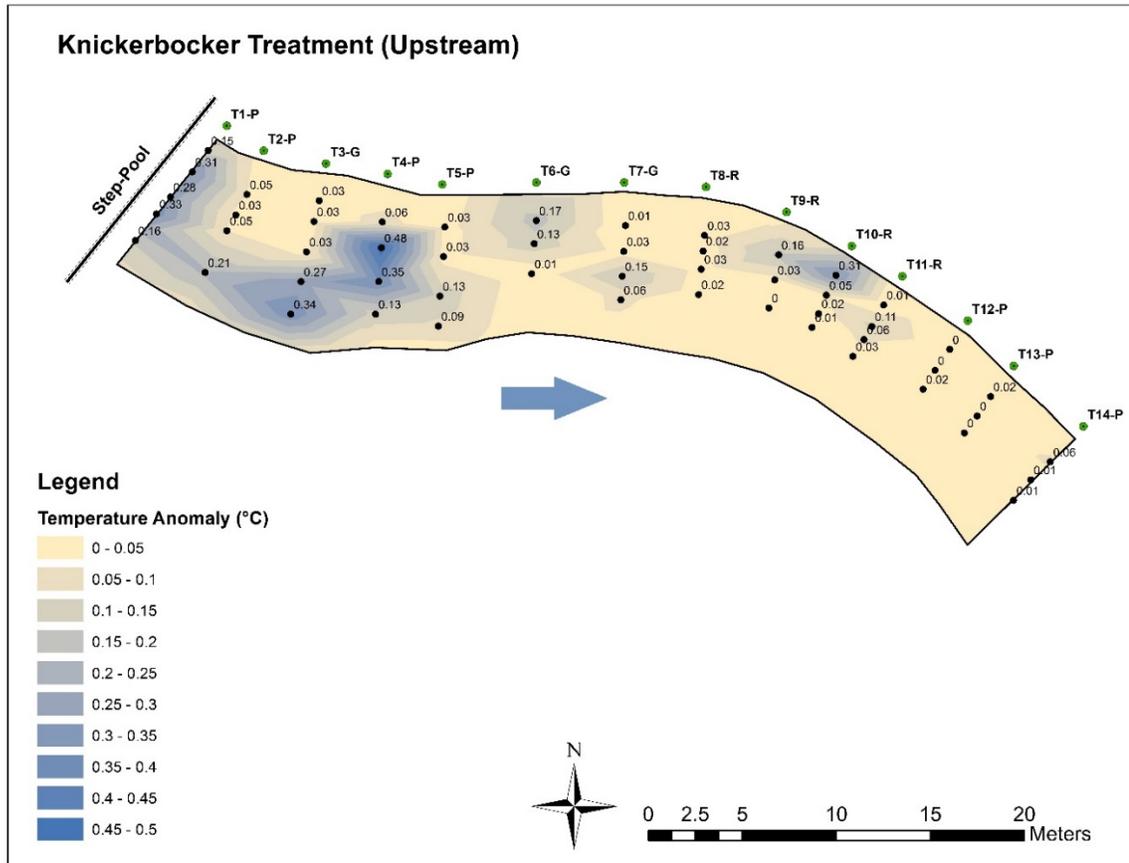
Figure 9: Plan-view map shows temperature anomaly patterns along survey reach and shows the average anomaly at each specific tube. Map also includes points, which are labeled with transect number (i.e. transect #1 [T1]) and also habitat type (pool [P], glide [G], and riffle [R]). Lines show approximate location of large restoration structures. The blue arrow indicates stream flow direction. Borders of stream reach indicate the approximate location of bankfull.

Total temperature anomalies between the streambed and surface water (n=138) at the Knickerbocker treatment reach (upstream) averaged 0.10°C (SEM= <0.01°C). Temperature anomalies of 0.15°C, 0.03°C, and 0.02°C represent the 75th, 50th, and 25th percentiles, respectively (Figure 7). The largest average anomaly values were observed at tube #2 (0.48°C) and tube #3 (0.35°C) along transect #4. These tubes were located in the center of the stream channel at the head of a pool (Figure 9). Large anomalies were also observed along transect #1, which was located just downstream of a step-pool restoration feature. Much of the reach consisted of low temperature anomalies. The lowest average temperature anomalies were found at transect #9 (tube #3) and transect #12 (tube #2), both at 0.00°C. Unlike the other reaches in this study, there weren't any tubes at the Knickerbocker Treatment (Upstream) site that had an average negative anomaly, which means that the streambed temperature was almost always colder than the above surface water.

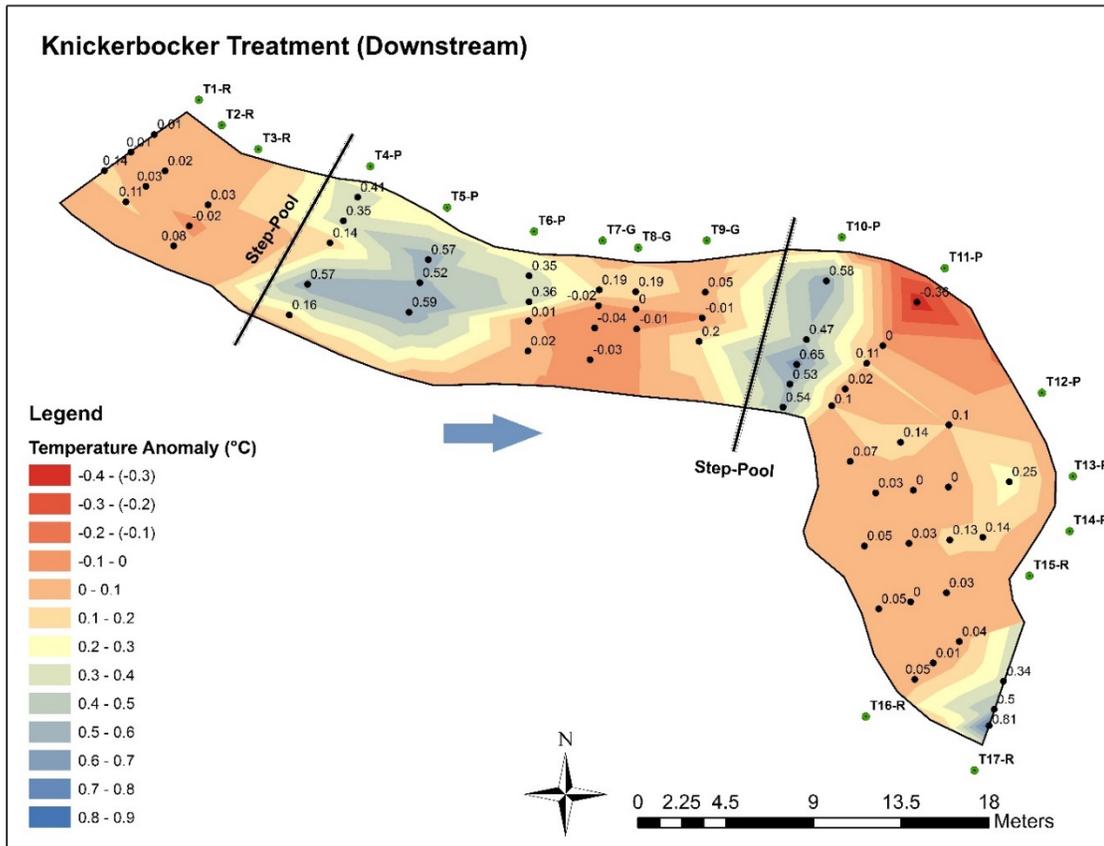
Figure 10: Plan-view map shows temperature anomaly patterns along survey reach and shows the average anomaly at each specific tube. Map also includes points, which are labeled with transect number (i.e. transect #1 [T1]) and also habitat type (pool (P), glide (G), and riffle [R]). Lines show approximate location of large restoration structures. The blue arrow indicates stream flow direction. Borders of stream reach indicate the approximate location of bankfull.

Total temperature anomalies (n=183) at the Knickerbocker treatment (downstream) reach averaged 0.17°C (SEM= 0.02°C). Temperature anomalies of 0.34°C, 0.08°C, and 0.01°C represent the 75th, 50th, and 25th percentiles, respectively (Figure 7). The largest temperature anomaly values were observed at tube #3 (0.81°C) along transect #17, which is located near the right bank at the end of a riffle (Figure 10). Other high average anomalies were recorded along transect #5 and transect #10, which are both located downstream of two different step-pool restoration features. Again, much of the reach had relatively low average temperature anomalies, such as that of transect #13 (tube #3) and transect #15 (tube #2), both with anomalies of 0.00°C. There were 7 tubes that had negative temperature anomalies, meaning the streambed temperature was warmer than the surface water temperature. The largest negative temperature anomaly occurred at transect #11 (tube #3) with a value of -0.36°C.

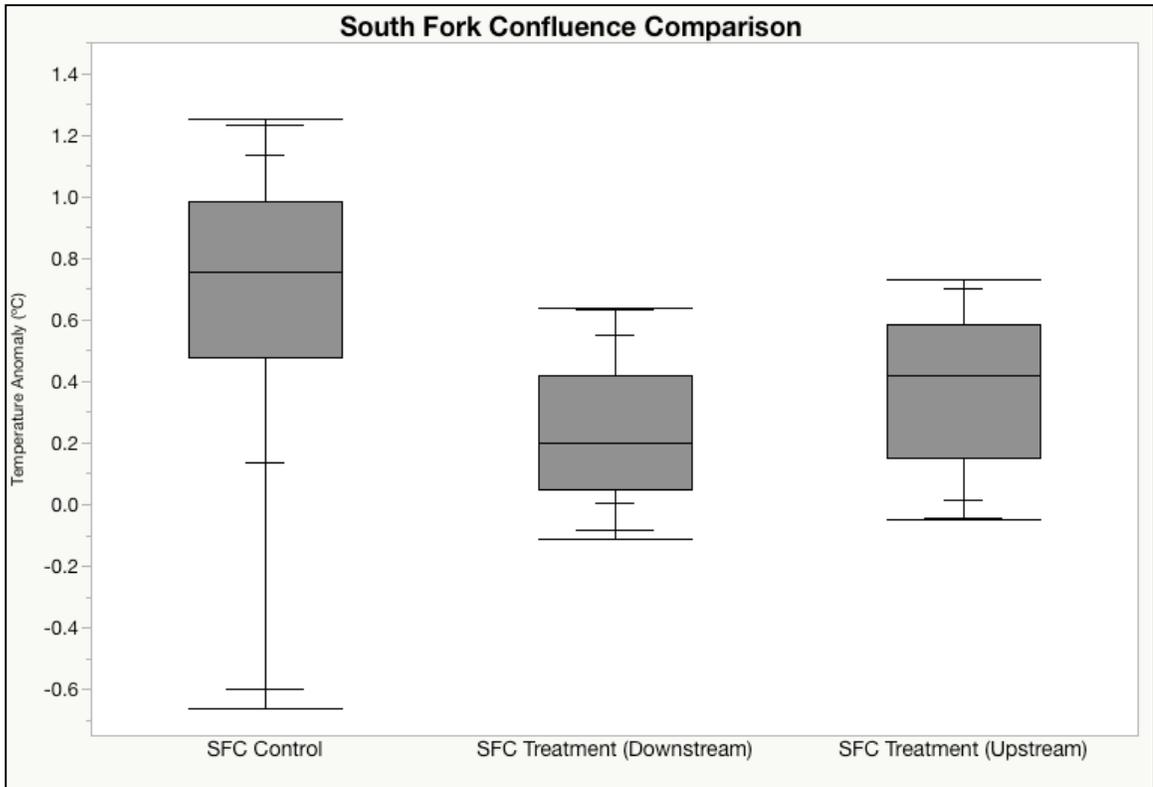
Figure 11: Shows box-and-whisker plots of temperature anomalies (°C) at each of the South Fork Confluence sites. Temperature anomalies are the difference in temperature between the water just below the streambed (10 cm) and the surface water. Anomaly values above zero indicate that the streambed was colder than the surface water and anomaly values below zero indicate the opposite. Includes results of surveys that were completed at the South Fork (SFC) control reach, South Fork Confluence (SFC) treatment (upstream) reach, and the South Fork Confluence (SFC) treatment (downstream) reach. The line in the middle of each box (interquartile range) represents the median (50th percentile). The upper boundary line of each box marks the 75th percentile and lower boundary marks the 25th percentile. The whisker lines from top to bottom mark the 100%, 97.5%, 90%, 10%, 0.5%, and 0% quantiles.

The results of the streambed temperature surveys at the three South Fork Confluence (SFC) sites found that the SFC control site had the greatest range of temperature anomalies followed by the SFC treatment (downstream) reach and then the SFC treatment (upstream) reach (Figure 11). A Kruskal-Wallis test showed that there was a statistically significant difference in average temperature anomalies between the different survey reaches, ($\chi^2(2) = 48.01, p < 0.001$). Post hoc comparisons using the

Steel-Dwass test indicated that temperature differences were significantly different between all the SFC sites: SFC control and SFC treatment (upstream) ($p = <0.001$), SFC control and SFC treatment (downstream) ($p = <0.001$), SFC treatment (upstream) and SFC treatment (downstream) ($p = 0.007$).

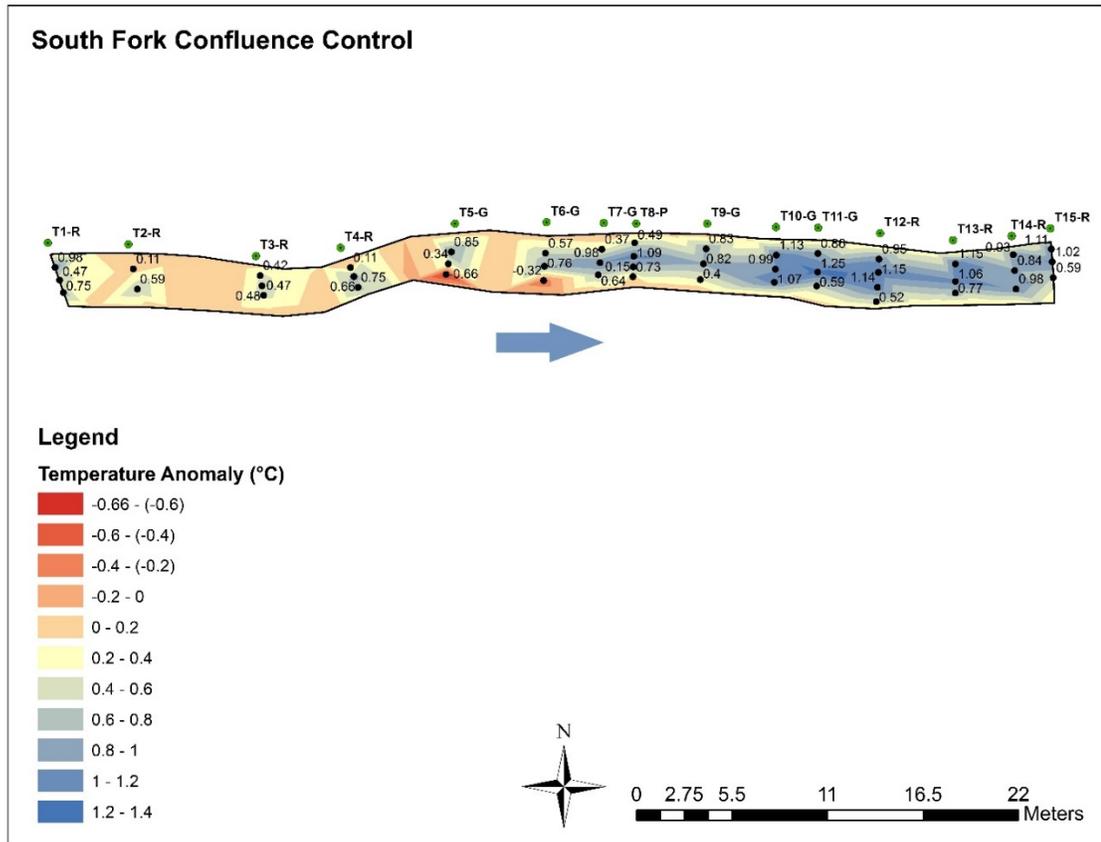
Figure 12: Plan-view map shows temperature anomaly patterns along survey reach and shows the average anomaly at each specific tube. Map also includes points, which are labeled with transect number (i.e. transect #1 [T1]) and also habitat type (pool (P), glide (G), and riffle [R]). The blue arrow indicates stream flow direction. Borders of stream reach indicate the approximate location of bankfull.

Total temperature anomalies (n=138) at the South Fork Confluence control reach averaged 0.69°C (SEM= 0.04°C). Temperature anomalies of 0.98°C, 0.76°C, and 0.48°C represent the 75th, 50th, and 25th percentiles, respectively (Figure 11). The largest anomaly value was observed at transect #11 (tube #1) with an average anomaly of 1.25°C (Figure 12). The next two largest average anomalies were observed at transect #12 (tube #4) and transect #13 (tube#1) with anomalies of 1.15°C. Transect #12 and #13 were

located along riffle habitats, whereas, transect #11 was located along the downstream section of a glide feature. The lowest anomalies were found at transect #2 (tube #1) and transect #4 (tube #1), with anomalies of 0.11°C and 0.12°C , respectively. Both of these transects were located in the riffle habitats. There were two locations, transect #5 (tube #1) and transect #6 (tube #1) where average streambed temperatures were warmer than surface water temperatures. Transect #5 (tube #1) had a negative anomaly of (-0.66°C) and transect #6 (tube #1) had an average anomaly of (-0.32°C) . Both of these transects were located along glide habitats.

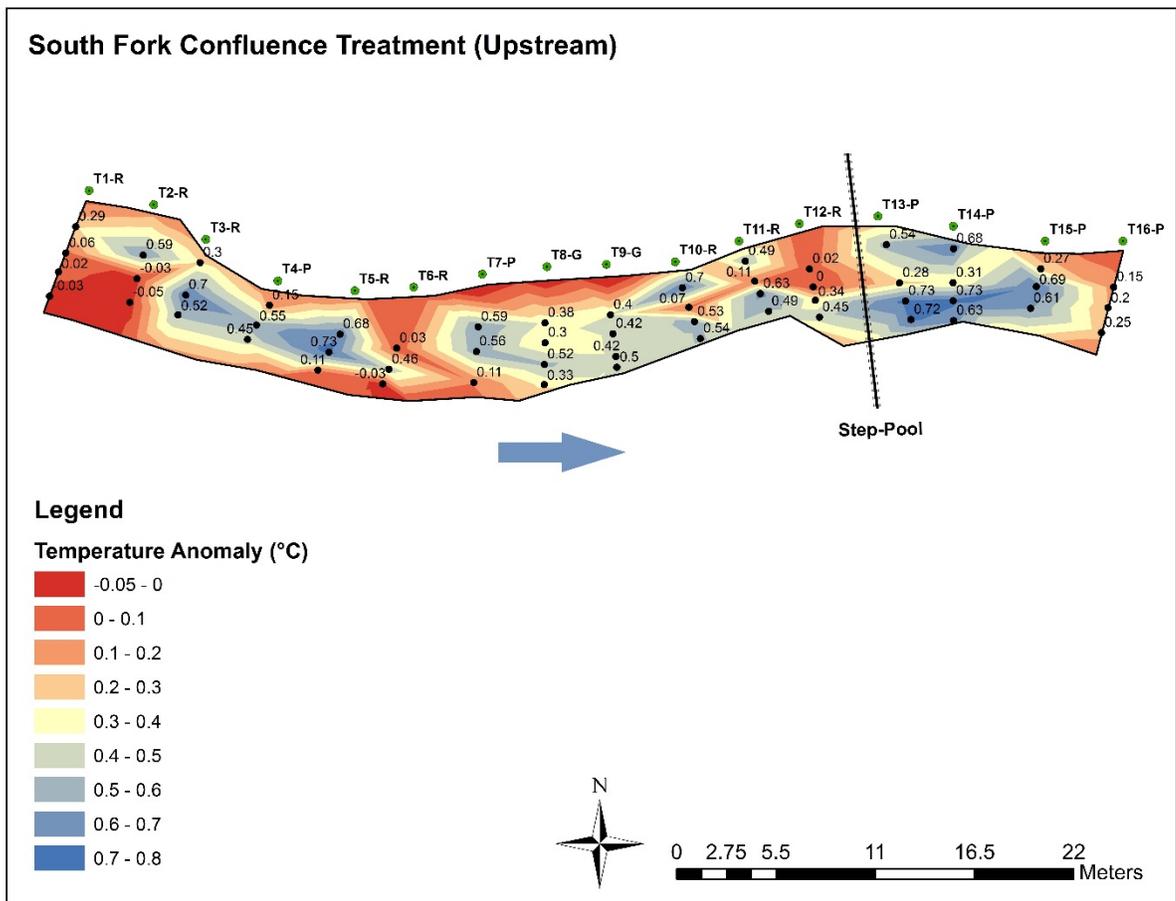
Figure 13: Plan-view map shows temperature anomaly patterns along survey reach and shows the average anomaly at each specific tube. Map also includes points, which are labeled with transect number (i.e. transect #1 [T1]) and also habitat type (pool (P), glide (G), and riffle [R]). Lines show approximate location of large restoration structures. The blue arrow indicates stream flow direction. Borders of stream reach indicate the approximate location of bankfull.

Total temperature anomalies (n=168) at the South Fork Confluence treatment (upstream) reach averaged 0.38°C (SEM= 0.02°C). Temperature anomalies of 0.58°C, 0.42°C, and 0.15°C represent the 75th, 50th, and 25th percentiles, respectively (Figure 11). The largest anomaly values were observed at transect #5 (tube#2), transect #13 (tube #3) and transect #14 (tube #3), both with anomalies of 0.73°C (Figure 13). Transect #5 was located in the middle section of a riffle, whereas both transect #13 and #14 were located just downstream of a step-pool feature. The lowest anomalies were found at transect #12

Both of these transects were located in the riffle habitats and towards the sides of the channel. Only 4 tube locations had warmer streambed temperatures than the surface water temperatures and all of these negative anomaly values were small (between -0.03°C and -0.05°C).

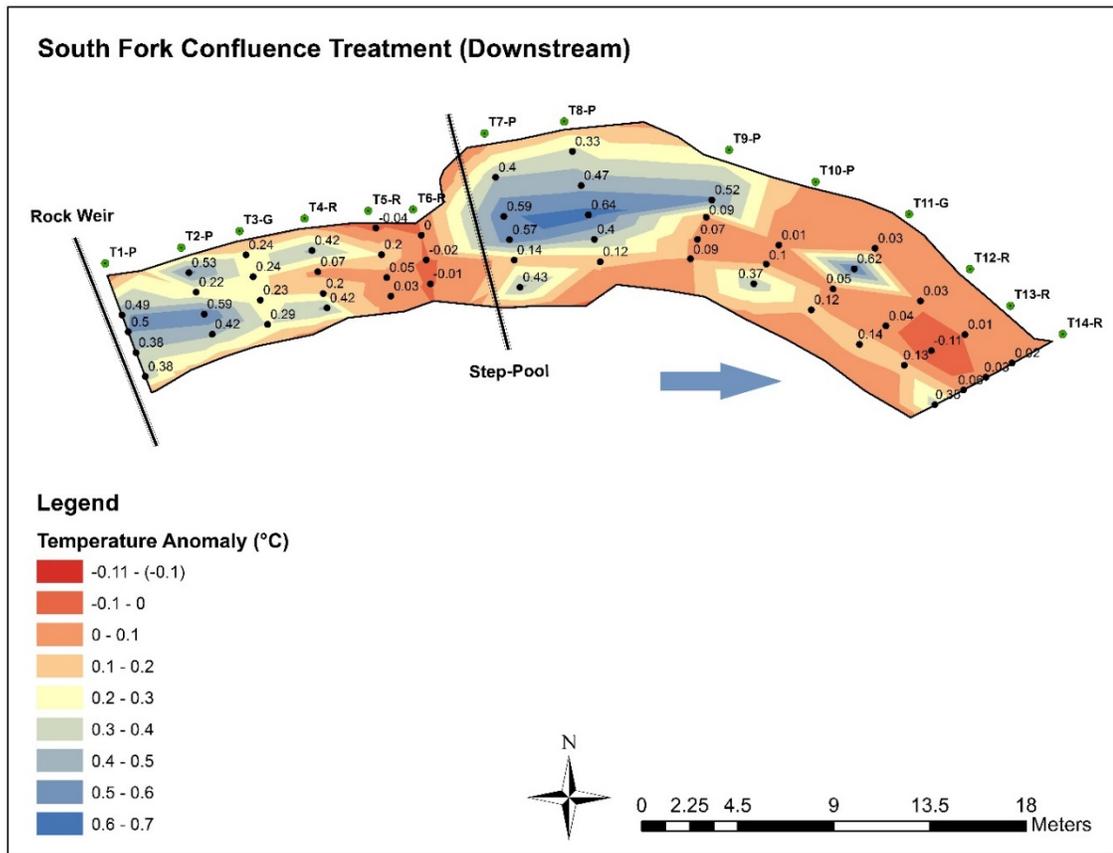
Figure 14: Plan-view map shows temperature anomaly patterns along survey reach and shows the average anomaly at each specific tube. Map also includes points, which are labeled with transect number (i.e. transect #1 [T1]) and also habitat type (pool [P], glide [G], and riffle [R]). Lines show approximate location of large restoration structures. The blue arrow indicates stream flow direction. Borders of stream reach indicate the approximate location of bankfull.

Total temperature anomalies (n=54) at the South Fork Confluence treatment (downstream) reach averaged 0.23°C (SEM= 0.02°C). Temperature anomalies of 0.42°C, 0.2°C, and 0.05°C represent the 75th, 50th, and 25th percentiles, respectively (Figure 11). The largest average temperature anomalies were observed at transect #8 (tube #3) and transect #11 (tube #1), with anomalies of 0.64°C and 0.62°C, respectively (Figure 14). Both of these transects are located in the middle and tailout sections of pools. The lowest average temperature anomalies were found at transect #13 (tube #2) and transect #6 (tube #1), with anomalies of 0.01°C. Both of these transects were located in the riffle habitats. There were four tube locations with negative anomaly values. The largest negative anomaly value was observed at transect #13 (-0.11°C), which was located along the middle portion of a riffle.

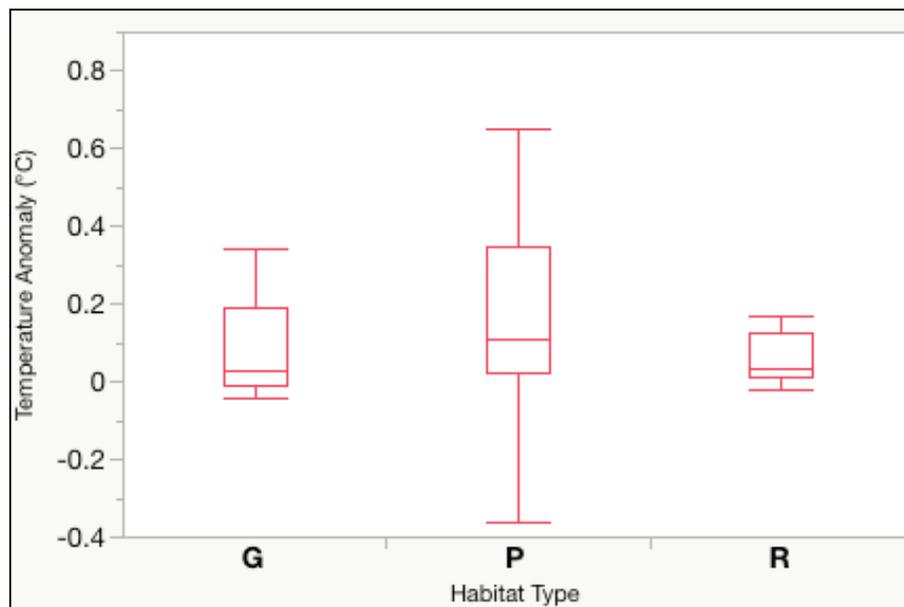
Figure 15: Shows spread of temperature anomalies among different habitat types [riffles (R), glides (G), and pools (P)] at the two Knickerbocker treatment sites.

The most common habitat type at the two Knickerbocker treatment sites were pools ($n=59$), followed by riffles ($n=36$), and glides ($n=19$). The highest average anomalies occurred along pool habitats with a mean value of 0.18°C ($\text{SEM}= 0.03^\circ\text{C}$), followed by riffles 0.10°C ($\text{SEM}= 0.03^\circ\text{C}$) and glides 0.07°C ($\text{SEM}= 0.03^\circ\text{C}$). Pool habitats also had a greater spread of temperature anomalies, followed by glides and then riffles (Figure 15). A Kruskal-Wallis test found that there was a significant effect of habitat type on average temperature anomalies ($\chi^2(2) = 8.46, p = 0.0146$).

Temperature anomalies at pool habitats were statistically different than the temperature anomalies at glides based on a post hoc comparison using the Steel-Dwass test ($p=0.032$). However, the temperature anomalies along riffles did not significantly differ from the temperature anomalies at glides ($p = 0.545$) or pools ($p= 0.096$).

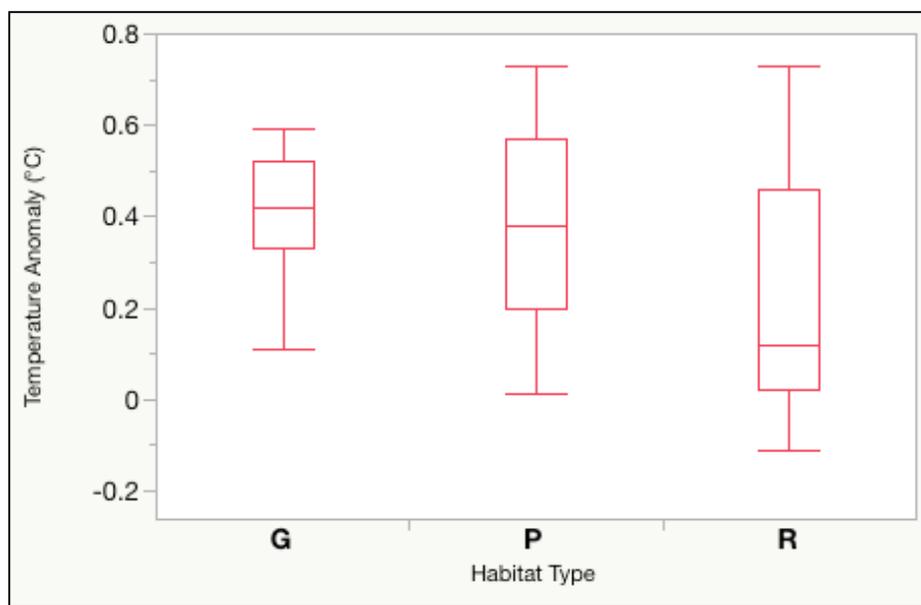
Figure 16: Shows spread of temperature anomalies among different habitat types [riffles (R), glides (G), and pools (P)] at the two South Fork Confluence treatment sites.

The most common habitat type at the South Fork Confluence treatment sites were riffles ($n=52$), followed by pools ($n=47$), and glides ($n=11$). The highest average anomalies occurred along glide habitats with a mean value of 0.41°C ($\text{SEM}= 0.04^{\circ}\text{C}$), followed by pools 0.37°C ($\text{SEM}= 0.03^{\circ}\text{C}$) and riffles 0.22°C ($\text{SEM}= 0.04^{\circ}\text{C}$). However, the greatest range of anomalies were associated with riffle and then pool habitats (Figure 16). A Kruskal-Wallis test found that there was a significant effect of habitat type on average temperature anomalies ($\chi^2(2) = 12.1836, p = 0.0023$).

Temperature anomalies at riffle habitats were statistically different than the temperature anomalies at pools based on a post hoc comparison using the Steel-Dwass test ($p=0.004$). However, the temperature anomalies along glides were not significantly different from the temperature anomalies at pools ($p = 0.817$) or riffles ($p = 0.067$).
