AN ASSESSMENT OF SUAV BASED AERIAL IMAGERY:  
MODELING FLUVIAL INTERACTION OF BANK ARMORING STRUCTURES IN  
RIVERINE SYSTEMS

A Thesis  
Submitted in partial fulfillment  
of the requirements for the degree  
Master of Environmental Studies  
The Evergreen State College  
June 2019

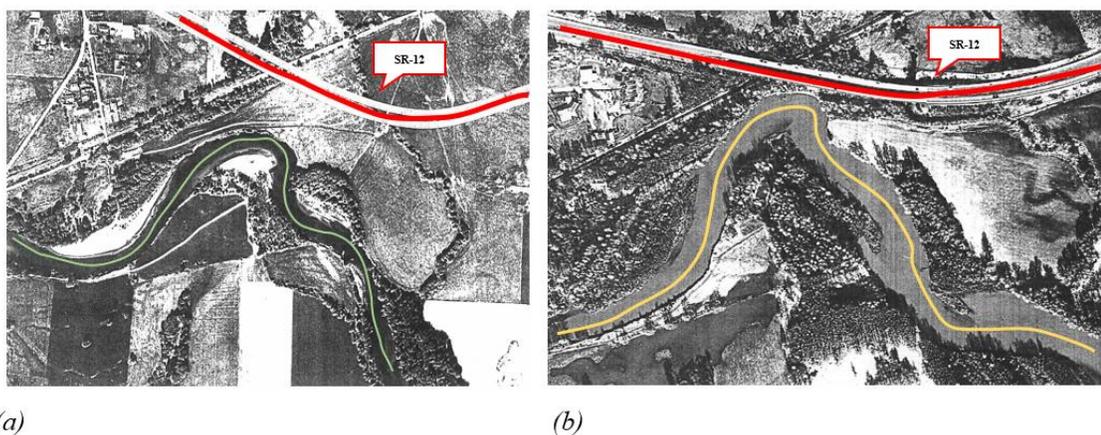
*Figure 5 (a) represents the channel migration shown in green and structure prior to the 1996 one-hundred-year flow event while (b) represents the newly formed channel shown in yellow encroaching northward towards State Route -12 near the mouth of Sylvia Creek..*

This reach was chosen for a bank armoring implementation project in 1997 due to a high scour from a 100-year storm the hydraulic season of 1996-1997. The storm put State Route 12 in jeopardy of imminent failure due to the erosion of nearby bridge piers. The SR-12 bridge was constructed in 1967 and the Wynoochee River channel was over 100m south of its current location (Figure 5 *a* & *b*). The location of the bridge was based on previous meander patterns and the knowledge of the rivers previous migration rate of less than two feet per year. The oxbow of the channel was fast approaching the bridge piers. The bank armoring installation was necessary to prevent critical scour and failure of the bridge piers. Washington Department of Transportation and Washington State Department of Fish and Wildlife developed an engineering goal to prevent further encroachment of the channel towards the piers.

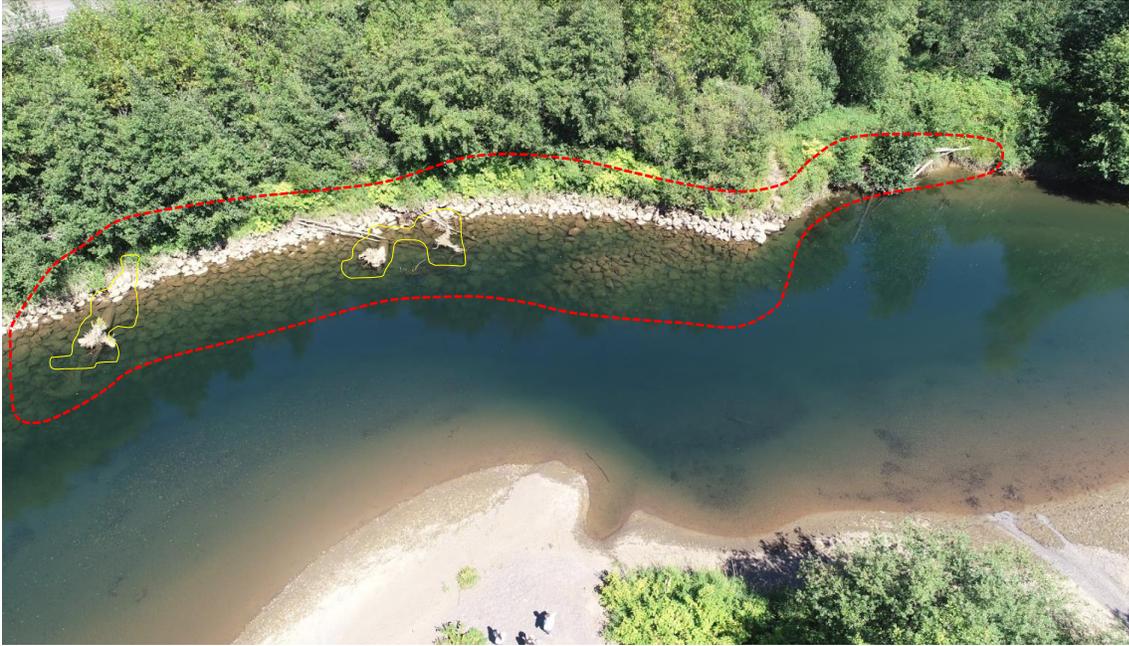
Figure 7 shows the rock dropped during the armoring implementation of 1997 shown in red and several of the remaining logs cabled into the structure (shown in yellow).

The structure implementation was a riprap rock drop graded back at a near 45° angle shoring up the left bank side nearest to the SR 12 bridge. The purpose of the armoring structure was to span the entirety of the oxbow completely armoring the bank to prevent further migration (Figure 6). The structure also had vegetation integrated into the riprap to create deposition or sediment drop zones. The large woody material and angular rock can be seen in the raw image flight captured by the sUAV in Figure 7. The intention of this method called “key logging” or “stacked log cabling” was used to increase the fluvial roughness in unison with decreasing the hydraulic approach velocity creating a space for sediment to drop. In addition, the sediment build behind these structures is meant to redirect the channel back towards the more southerly historic channel paths or the 1997 channel.

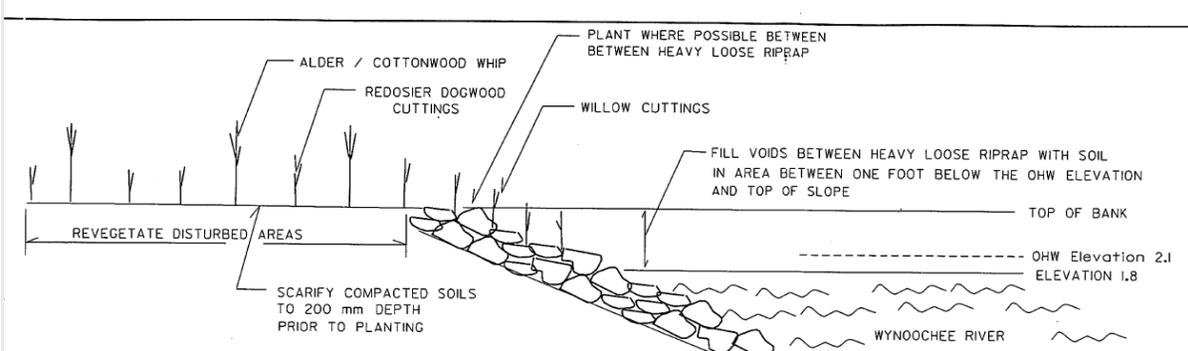
Figure 8 is an AutoCAD generated diagram of the initial engineering plans to integrate vegetation stakes into the bank armoring methodology. This diagram depicts the engineered slope of the rock placement up to the top of bank above water level where the plant stakes were placed.

This integrated proposal also included softer or “green” methods to ensure the bank stability behind the implemented rip rap. The engineering team from WDFW proposed a mixture of dogwood, alder, and live willows be staked behind the structure to increase bank complexity as well as increase root mosaic in the fine alluvial deposit from the years prior flood (November 1996 through January of 1997) (Figure 8).

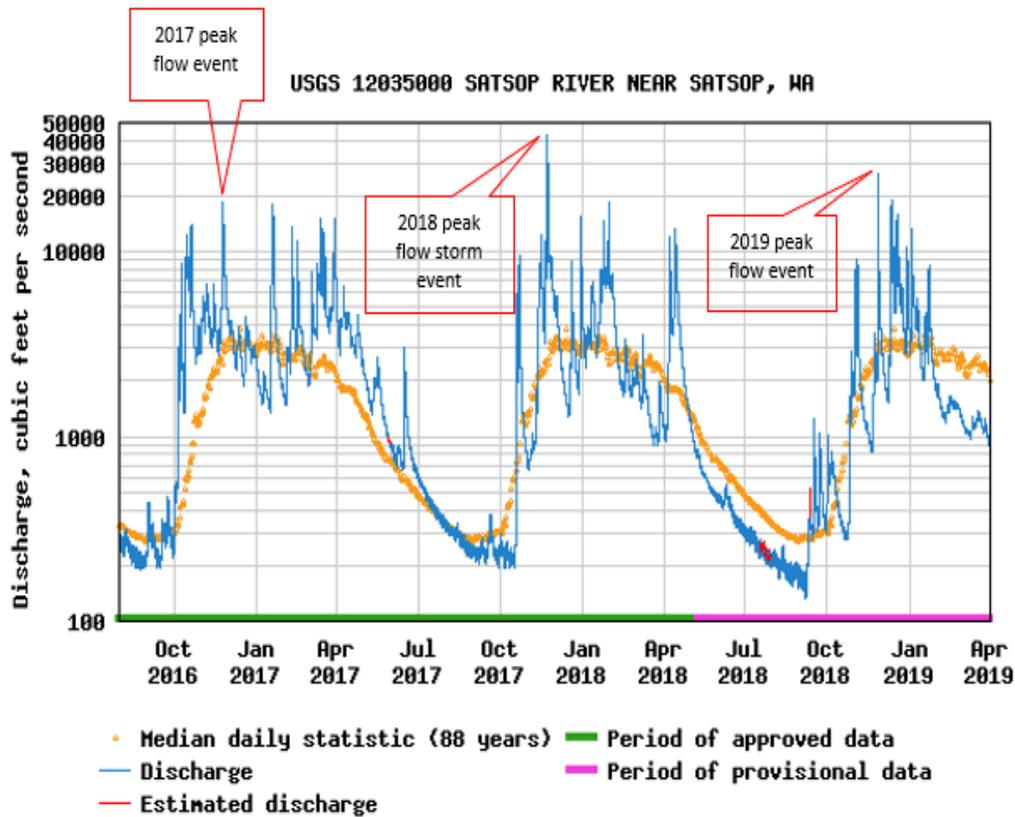
Figure 11 is a hydrograph showing the peak storm events in each water cycle during the years 2017-2019. The day to day data (shown in blue) represents the daily discharge recorded at the stream gauge station, while the median daily statistics over an 88-year period (shown in orange) are representative of a more averaged flow pattern.

The main stem Satsop River receives over 117 inches in precipitation and the basin drainage area influencing the target site is 295.31 mi<sup>2</sup> fed by many tributaries including the East and West Forks of the river (Figure 11). The target location is a low gradient reach of the river with a significant percentage of channel avulsions and past meandering scarification. The hydraulic cycles in the mainstem Satsop River have continued to exceed the mean annual flow patterns over the past 80 years as seen in the hydrograph in Figure 11.

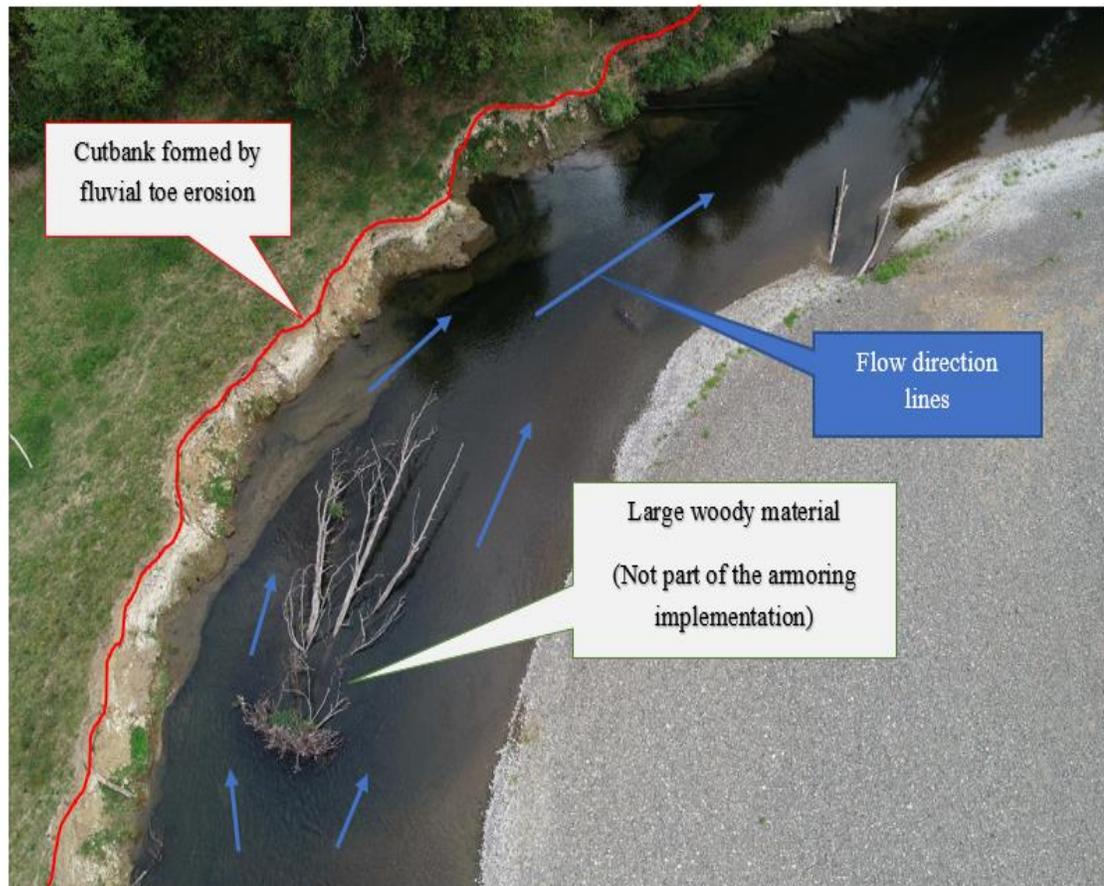
Figure 13 shows a raw sUAV image of the severe cutbank at site MS-SAT-GLICK. The length of this portion was measured at 68m with an average height of 3.2-3.5m in height.

Implementation type for this location was a bank armoring protection method using angular rock otherwise known as riprap and one LWM feature with a large root wad to generate fluvial roughness and a sediment deposition zone. As seen in the plan schematics in Figure 2.14, it was planned that the barb be placed directly into the thalweg and the LWM structure be anchored downstream from the bank protection. At time of research the large barb and rock structure was fully present but appeared to be experiencing toe erosion at the point and about 15m downstream of the barb. The LWM structure was not present and the bank downstream of the site was displaying signs of annual destabilization. Using ground survey collected data it was calculated that the downstream cut bank reaches a height averaging ~3.5m (Figure 13).

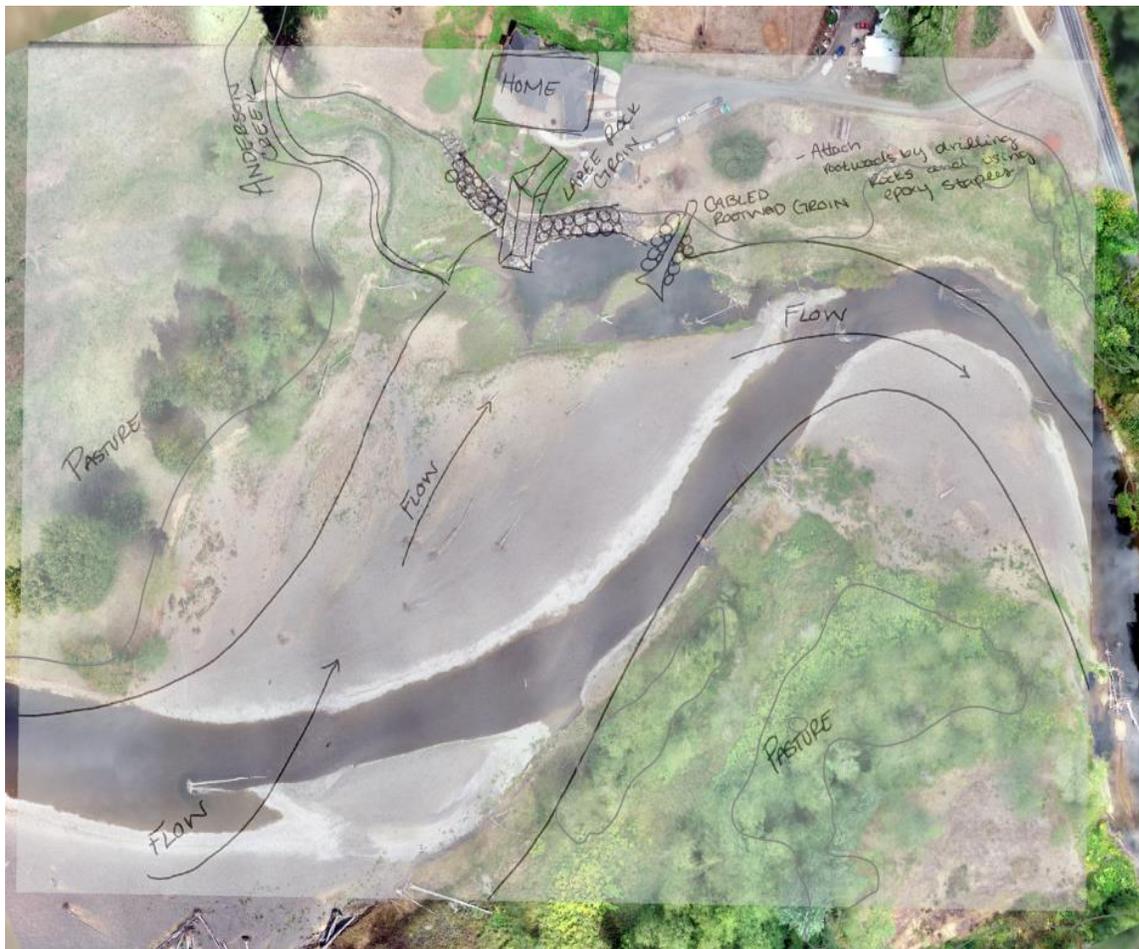
Figure 14 depicts the plan sketch done by the permitting biologist at the Department of Fish and Wildlife to save the landowners home. The sketch was used and built upon by the engineering team due to the limited time the department had to help save this landowners home. The base imagery for this figure is generated from the aerial imagery collected during the 2018 research flight. The engineering design overlay was manually georeferenced to conform to the location of the imagery, using ArcGIS Pro software tools.

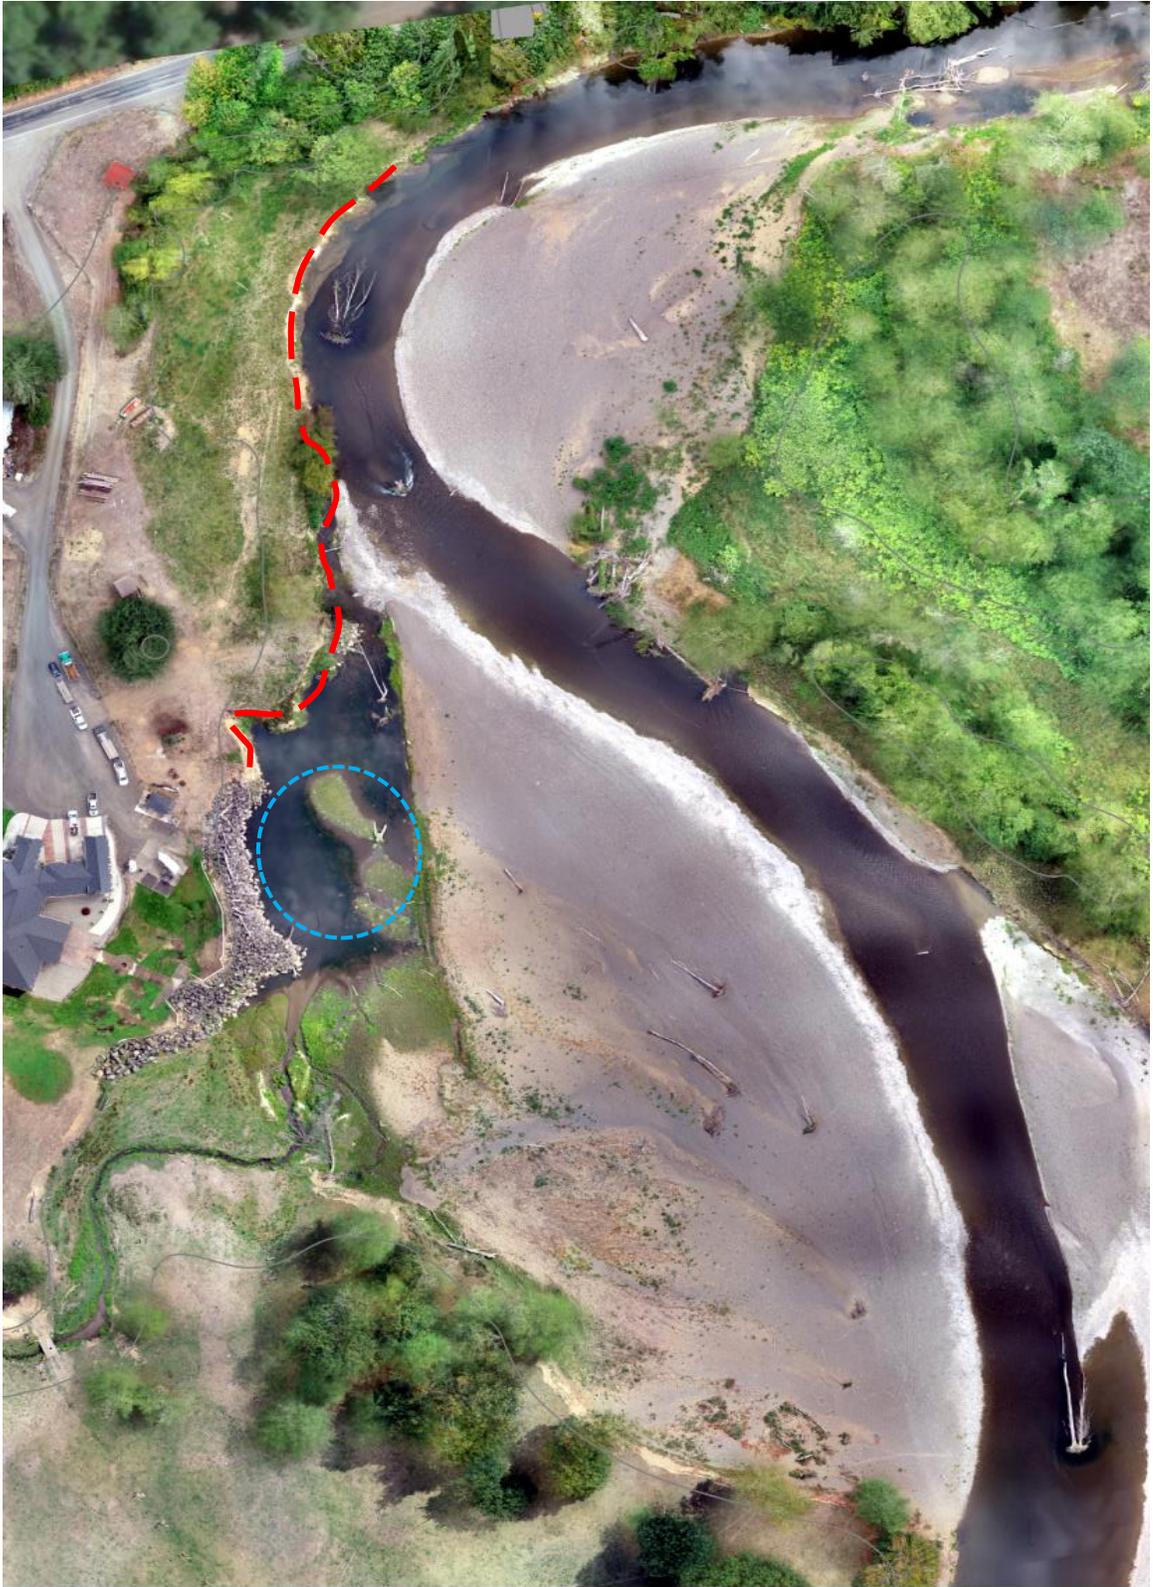
*Figure 15 shows the MS-SAT-GLICK site and the armoring structure. The extreme toe erosion (shown in red) and the large scour pool (circled in blue) are potential effects of the armoring implementation and the fluvial interaction with flood waters each year.*

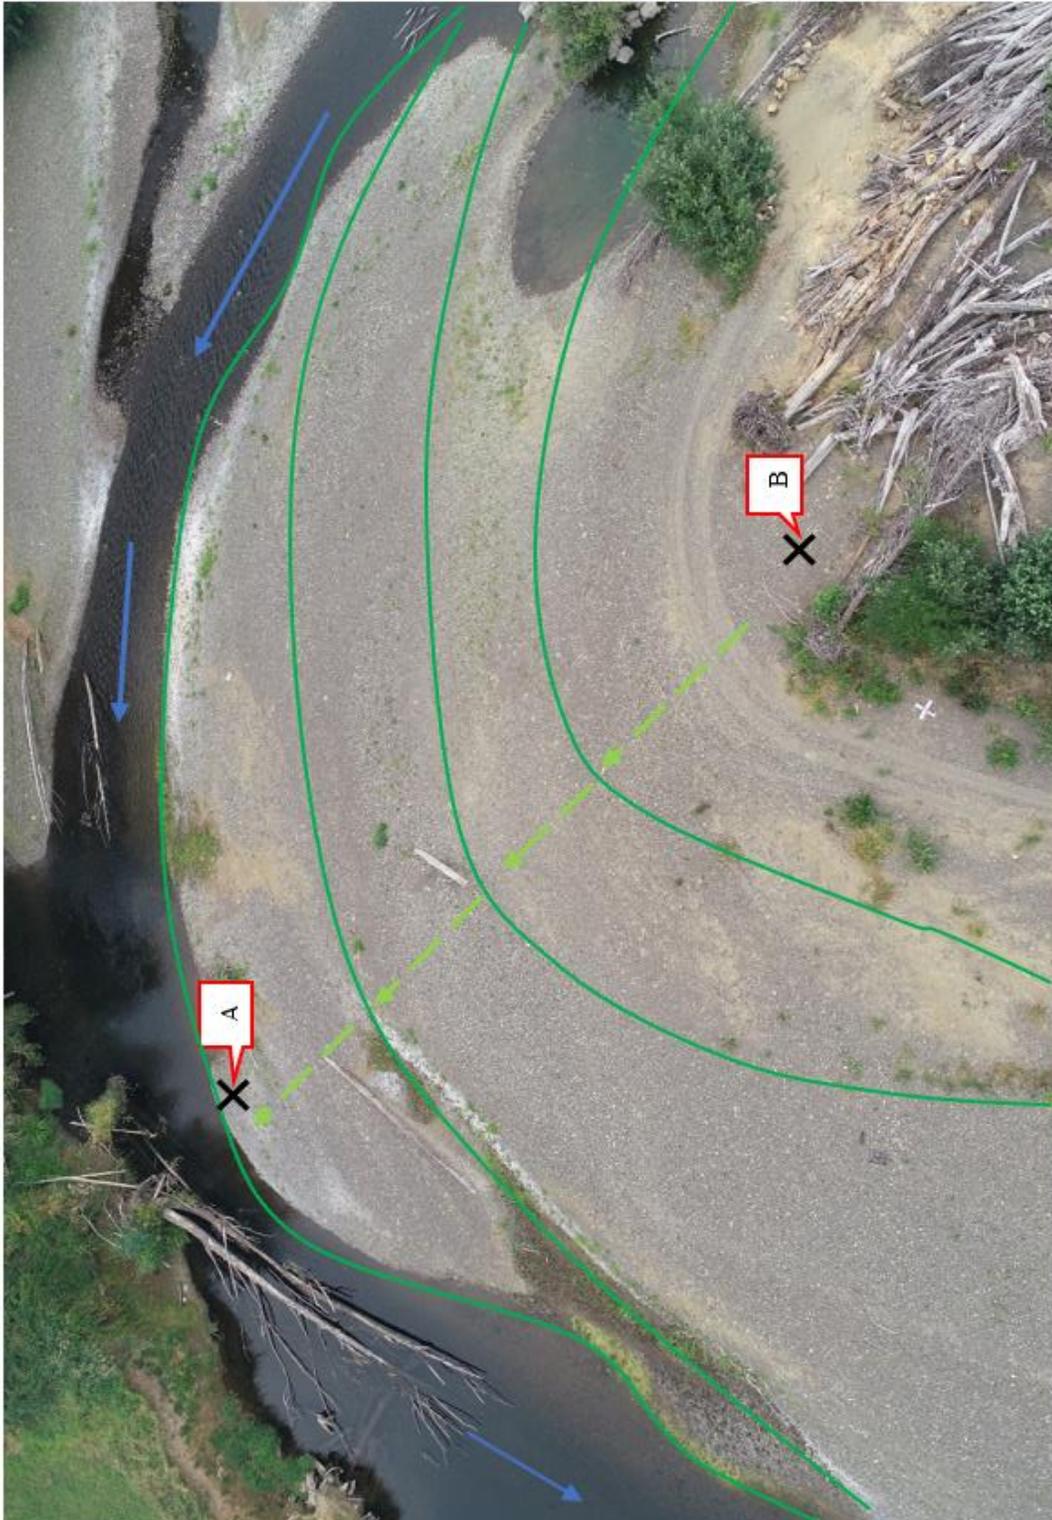
Figure 18 Shows the continually growing pointbar on the West Fork Satsop River. The flow (shown in blue) and channel of the river is pushed away from the pointbar continuing the erosion of the downstream bank due to the pointbars' gain in elevation or growth (shown in green). From point (A) to point (B) is a difference of 1.26m in elevation. Imagery captured during 2018 sUAV research flight.

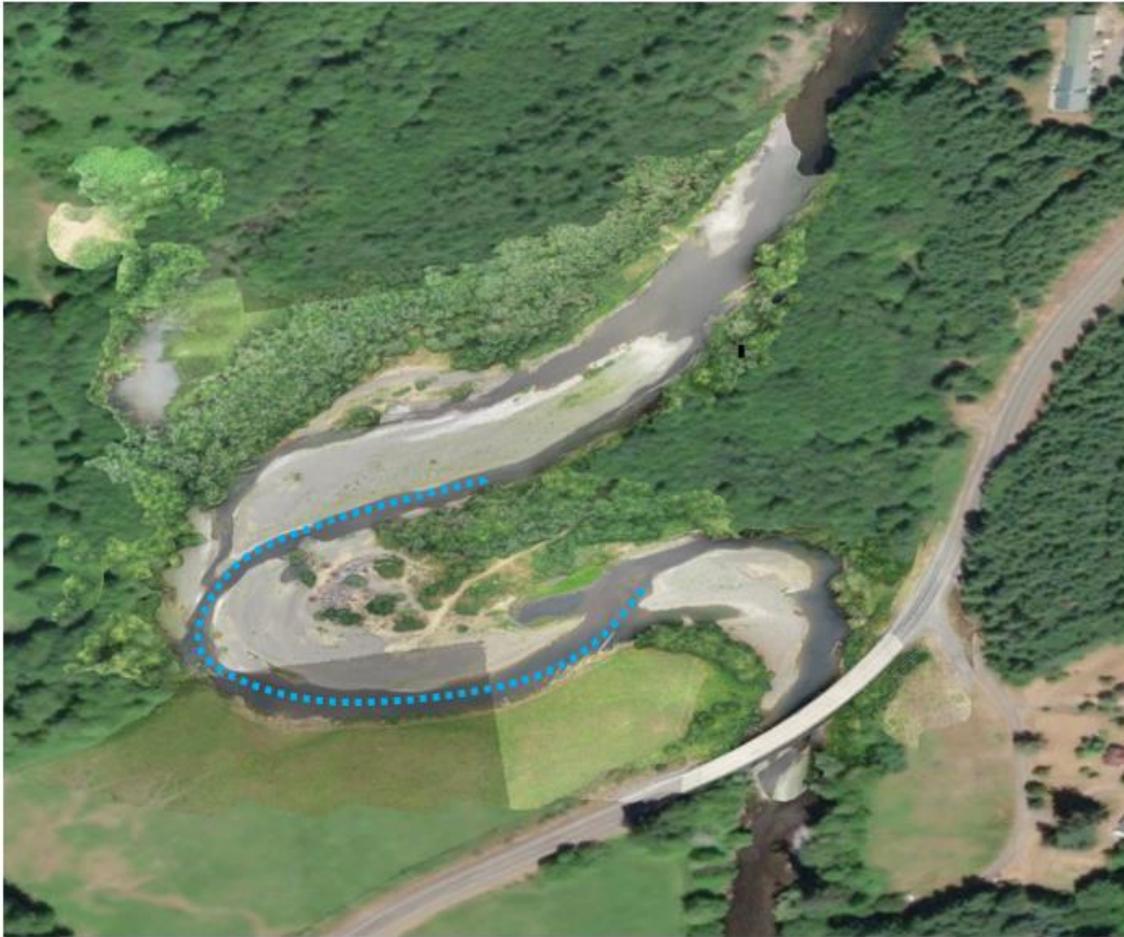
*Figure 19 is the full surface orthomosaic of the WF-SAT-BRIDGE location with generated during the 2018 research flights. The immense oxbow (shown in blue) formation continues to grow due to the bank erosion and lack of vegetative complexity. Underlay basemap World Imagery provided by Esri, DigitalGlobe, GeoEye, i-cubed, USDA FSA, USGS, AEX, Getmapping, Aerogrid, IGN, IGP, swisstopo, and the GIS User Community*

The WF-SAT-BRIDGE location was experiencing toe erosion and scour from a 100-year flood event the winter of 1995. The channel began to cut into the property owners hay field. Due to the lack of vegetative complexity from agricultural practice, the bank erosion increased during periods of the floodwater. The downstream effects were also threatening the Middle Fork Satsop Road Bridge.

The project goal for this site was to implement a hard-armoring structure on the oxbow of the channel to protect the landowners' field. This implementation goal was designed to re-channelize the river back towards its historic channel (Figure 15) away from the course it was currently taking. The structure implementation was intended as a bank stabilization method using angular rock and large woody debris cabled into place to create rock barbs or groins (Figure 19).

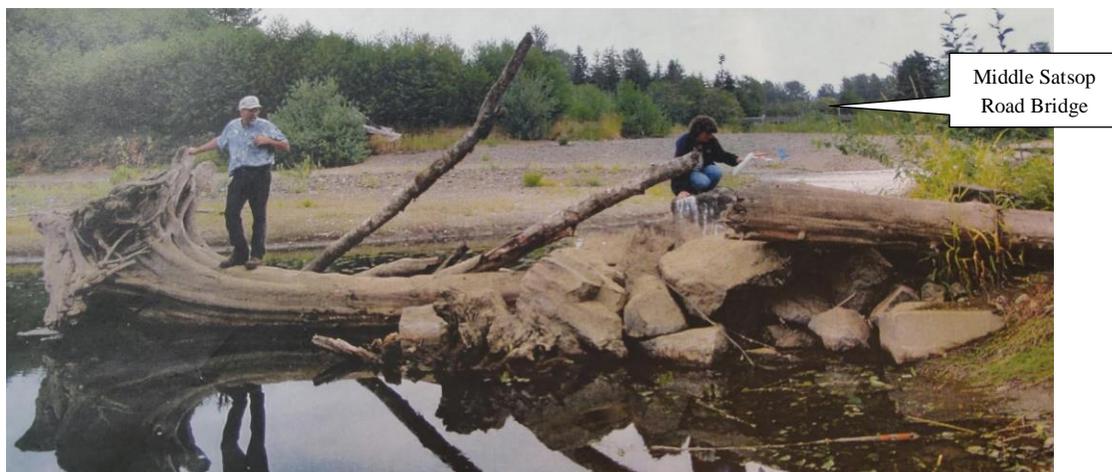
*Figure 20 (a) Large woody material cabled into a rock groin or barb in 1996 to redirect flow from a landowners' property and confine the channel from potentially destroying the Middle Satsop Road bridge. (b) Shows a more downstream angle of the rock groin and two more structures as well as LWM that was part of the implementation.*

The bank armoring methodology used to protect the Middle Satsop Road Bridge and the landowner's property was a rip rap rock drop with protruding groins and LWM integration in the design. The structure implementation was intended as a bank stabilization method using the angular rock and large woody material cabled into place (Figure 19). The engineering goal of this project was to create deposition zones behind the groins for sediment to build and later protect the bank. The implementation of the groins and the cabled woody debris did not prevent the river from continuing its intended

path. Figure 20 depicts the overlay of the engineering plans developed in 1995 before construction in 1996.

The structure was designed to redirect the flow of the channel away from the armoring structures and develop a deposition zone for sediment to drop behind the large structures in the channel. The sediment deposit in these locations would then theoretically generate a new pointbar, thus redirecting the channel in an opposing path.

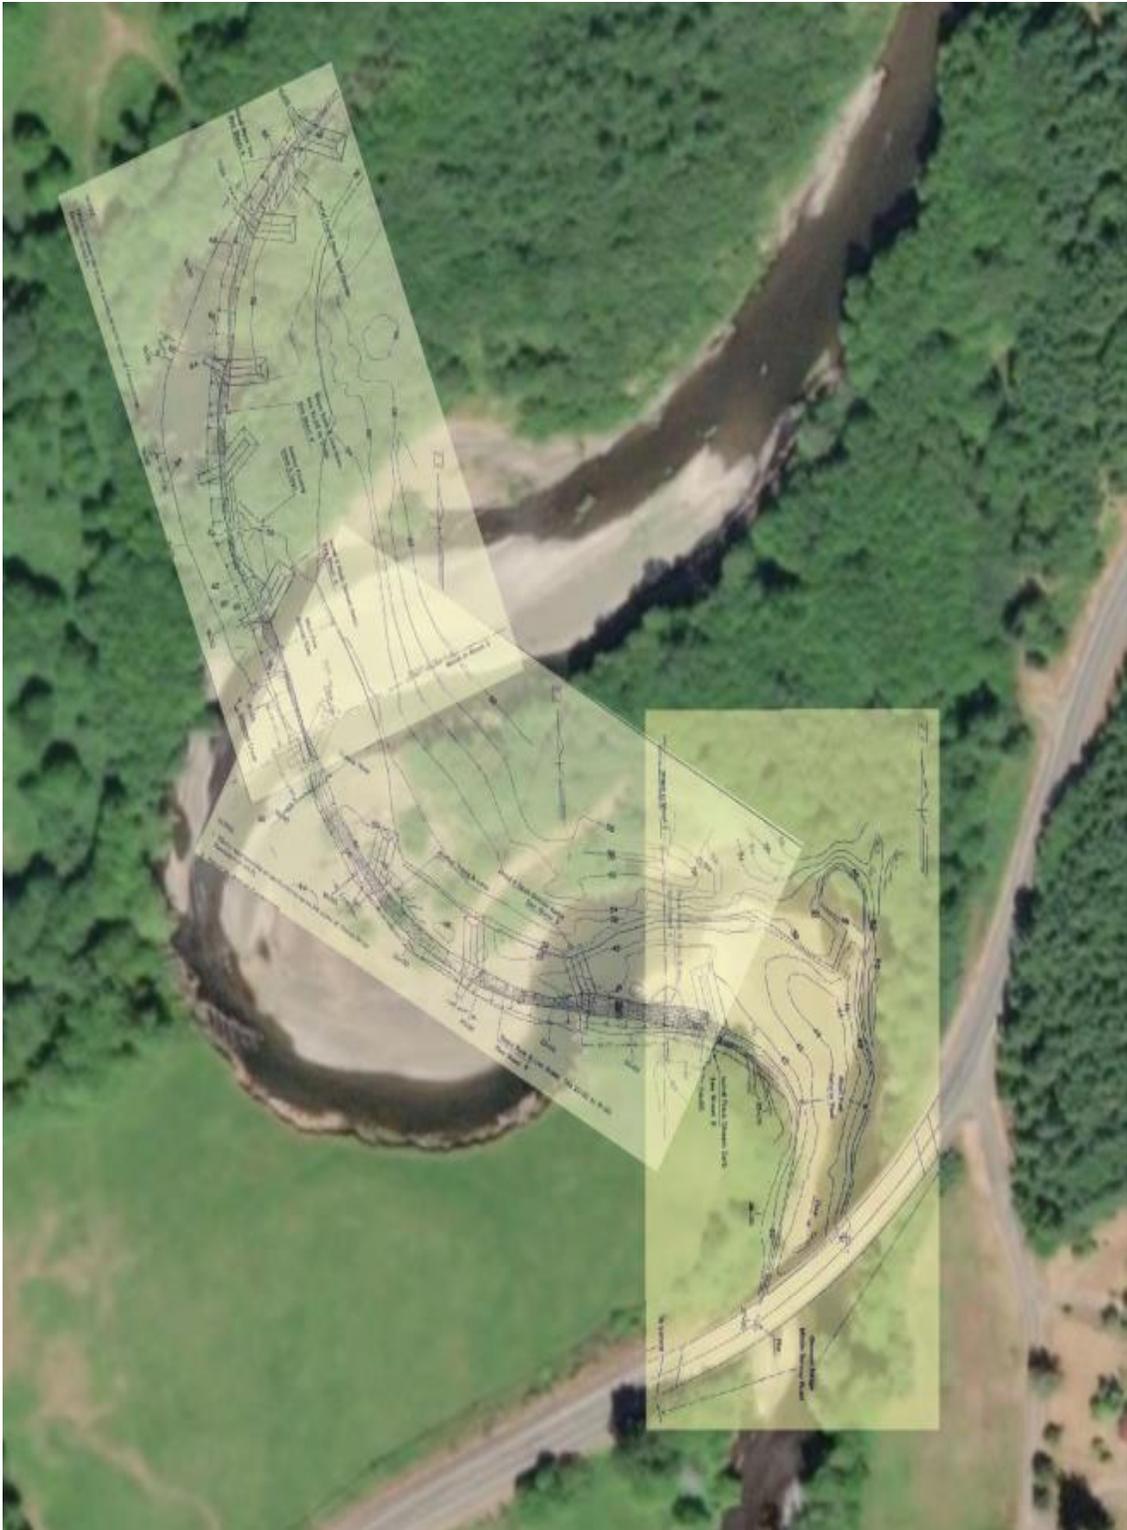
*Figure 21 shows the engineering plans for the bank armoring structure developed and implemented on the West Fork Satsop River in 1995 and 1996. . The engineering design overlay was manually georeferenced to conform to the location of the imagery, using ArcGIS Pro software tools. Underlay basemap World Imagery provided by Esri, DigitalGlobe, GeoEye, i-cubed, USDA FSA, USGS, AEX, Getmapping, Aerogrid, IGN, IGP, swisstopo, and the GIS User Community*

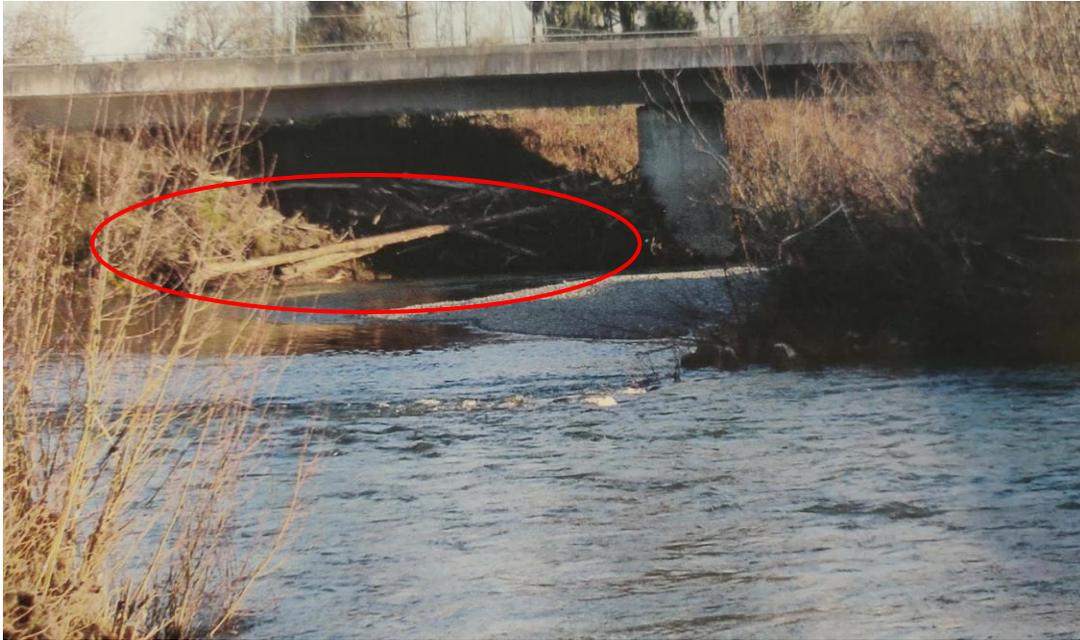
Figure 22 depicts the aftermath of the debris pile up downstream of the structure implementation near the Middle Satsop Road bridge the after the winter storm surge of 1996. The LWM (circled in red) used for the armoring structure has been uplifted by the floodwaters and is stacked under one of the bridge footings.

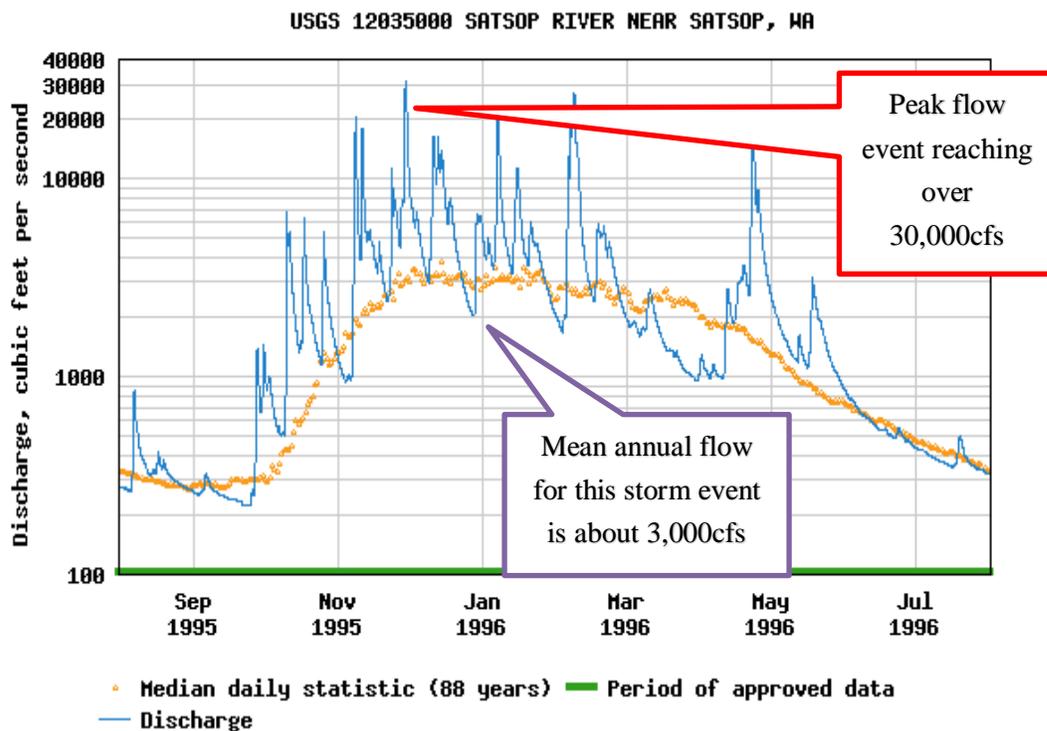
Figure 23 is a hydrograph generated using the historical hydraulic data provided by USGS to show the high flow event that the Westfork Satsop river experienced the year after implementation in 1995.

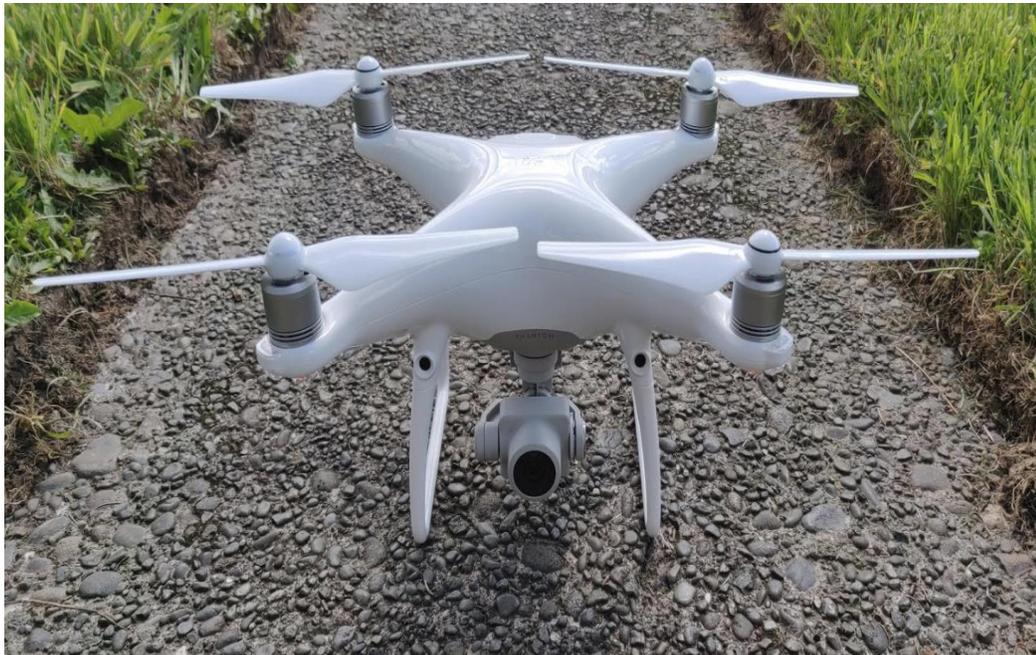
*Figure 24 A store bought DJI Phantom Pro 4 equipped with a 20-megapixel camera and a 3 axis (pitch, roll and yaw) gimble. This unit is also equipped with 5 obstacle sensors on the sides and top of the machine. The sUAV was controlled by an iPad mini 4 using PixCapture4D for grid pattern flights.*

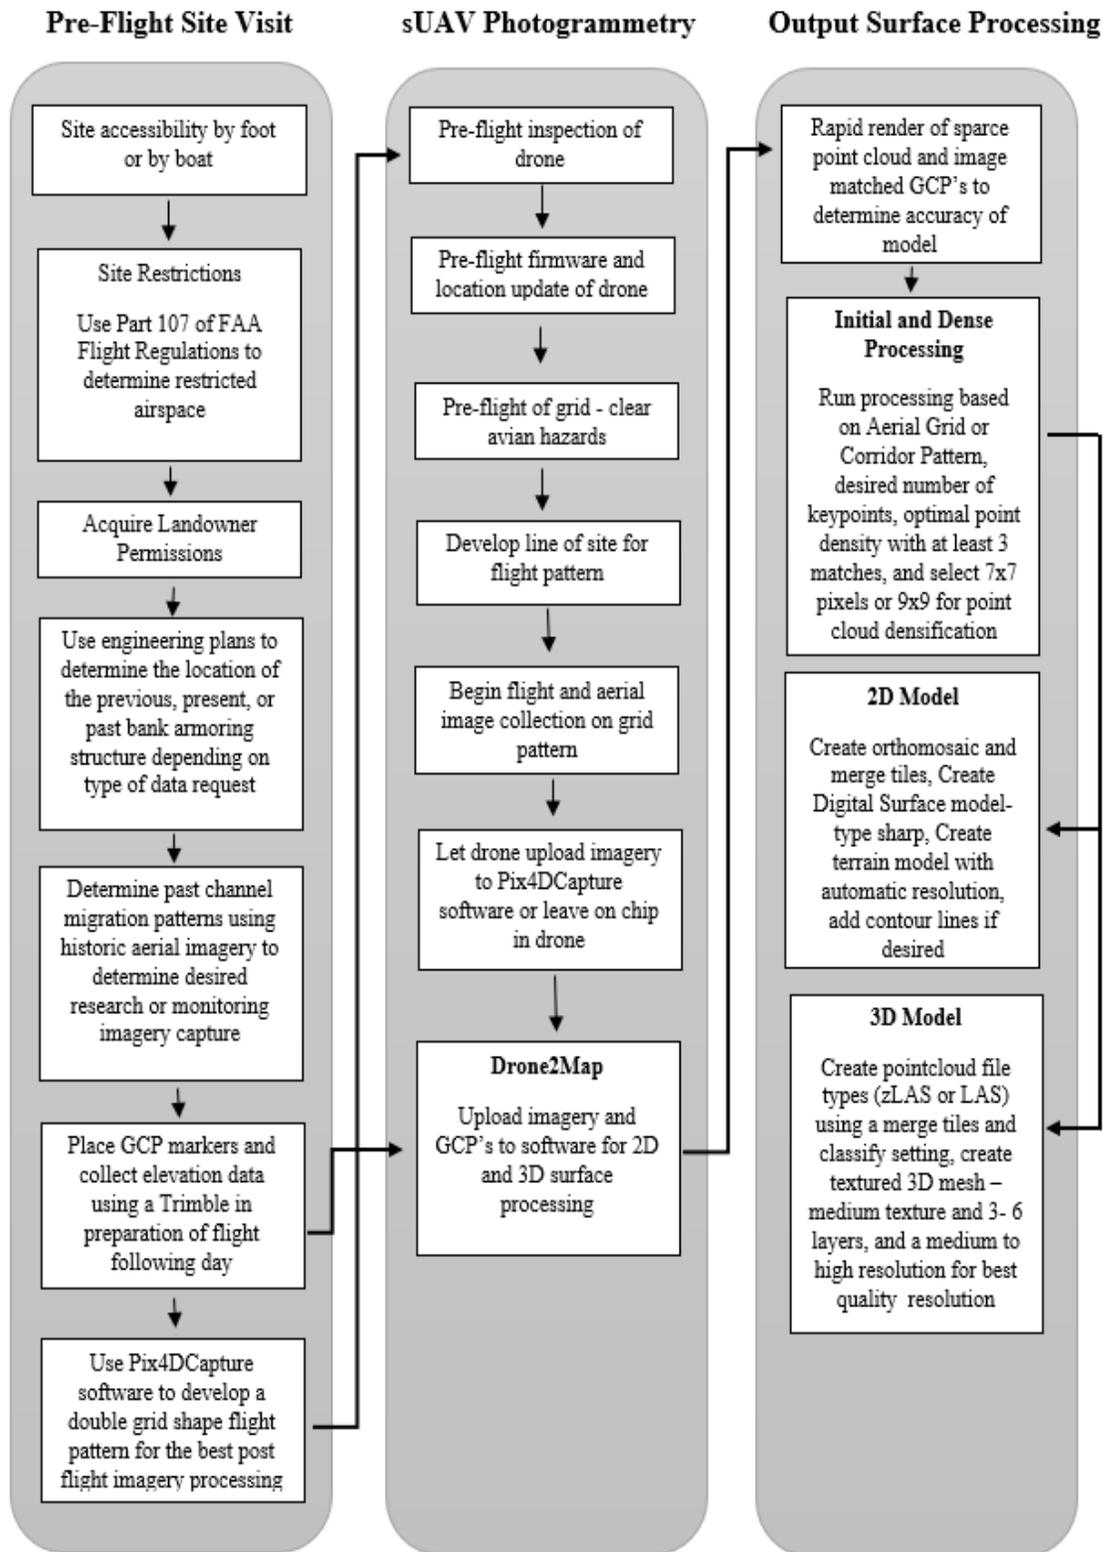
Figure 25 is a flow chart of the methodology developed for this research to determine pre-site accessibility and research viability, imagery acquisition, and post flight data processing. See Appendix I for additional details.

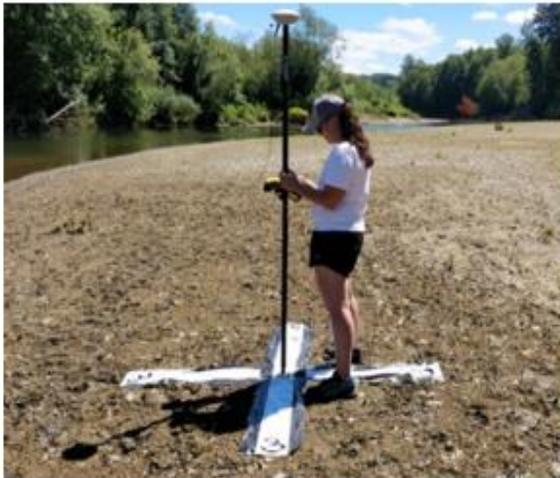
Figure 25 (a) A Trimble equipped with TerraSync Version 5.86 used to collect the elevation data at each research location for all ground control points or GCP's for each location. Figure 25 (b) is a ground control point that has been staked to the ground. This method along with high visibility flagging tape was used to correlate flight data to aerial imagery.

During the pre-site visit I collected the high accuracy elevational data using a Trimble GPS system. The Trimble data aided the elevational data capture by locking onto at least 10 satellites and concluded that a minimum of five ground control points or GCP's was the an optimal amount of elevational points for post processing. The GCP's were then corrected in the post processing stage using differential correction to reduce their errors to a minimum of 5cm of accuracy. See Table 2.3 for the number of GCP's used for each site.

- a. Using the Trimble seen in Figure 25 (a) generate at least 12-15 ground truths throughout your study reach to determine the morphological differences in platform dynamics of the reach.
  - b. TerraSync Version 5.86
  - c. Lock into satellites available
  - d. Begin point capture data collection process
    - i. You want at least 5-16ft of stated accuracy on the Trimble display screen, for best results wait for 1” accuracy if available.
  - e. Stake, “X” using ground truth material, or flag each ground truth location so that it can be seen from the flight pattern seen in Figure 25 (b)
    - i. This will be how we later render the imagery and analyze the elevation data captured
4. After each location desired has been marked return to a flat location in the study reach with a firm line of site for your flight pattern.

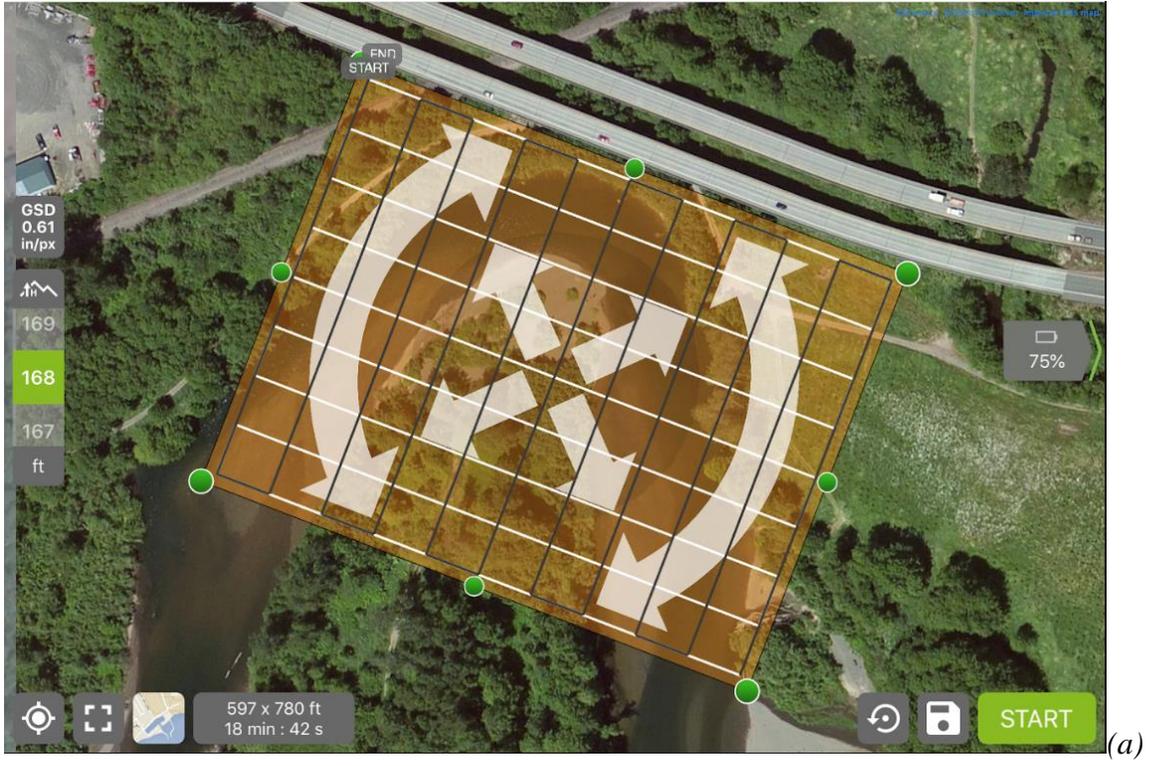
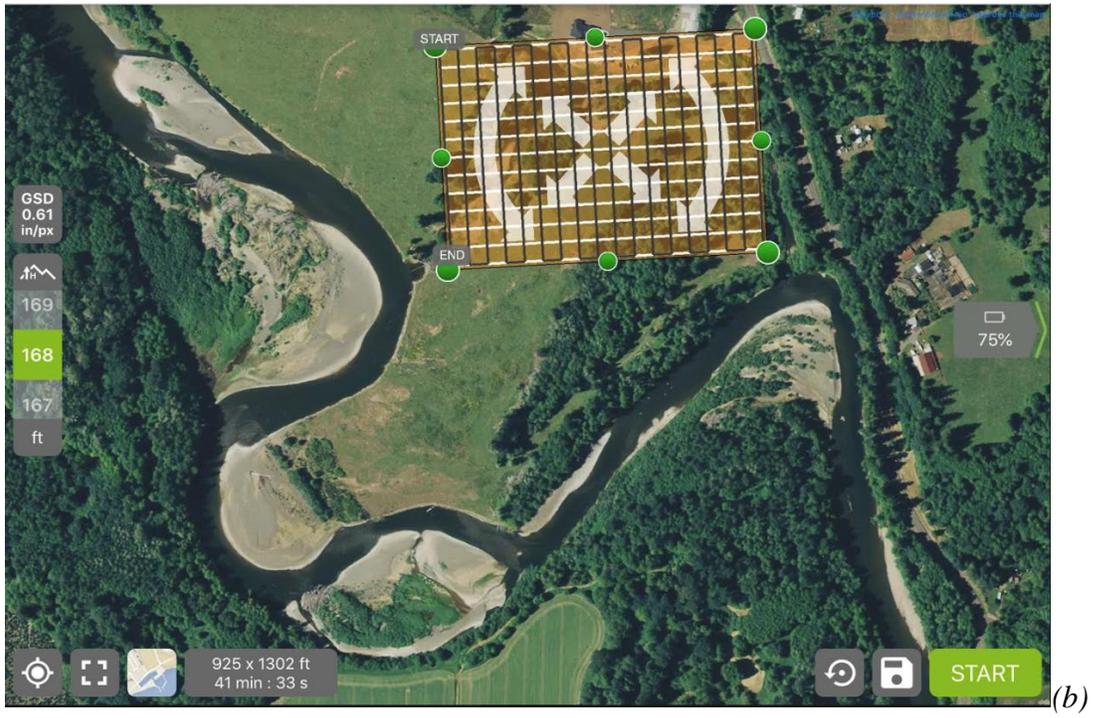
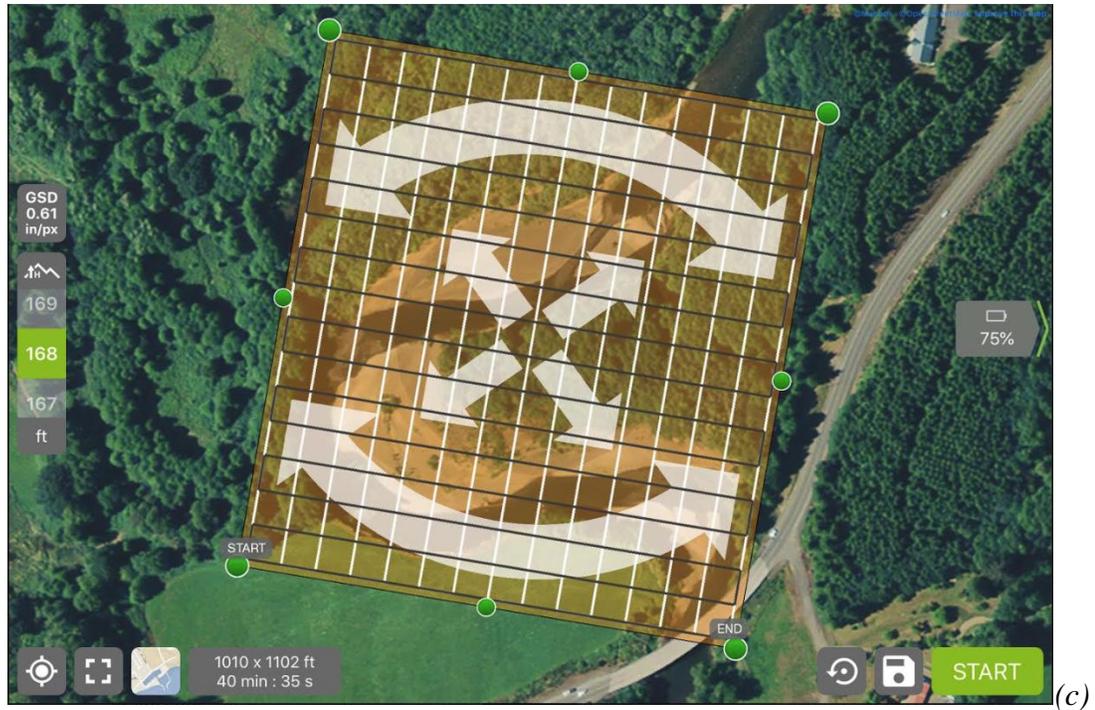
Figure 26 represents the predetermined grid patterns used for each sites flight pattern. The sites in order are as follows (a) WYN-SR12 (b) MS-SAT-GLICK (c)WF-SAT-BRIDGE.

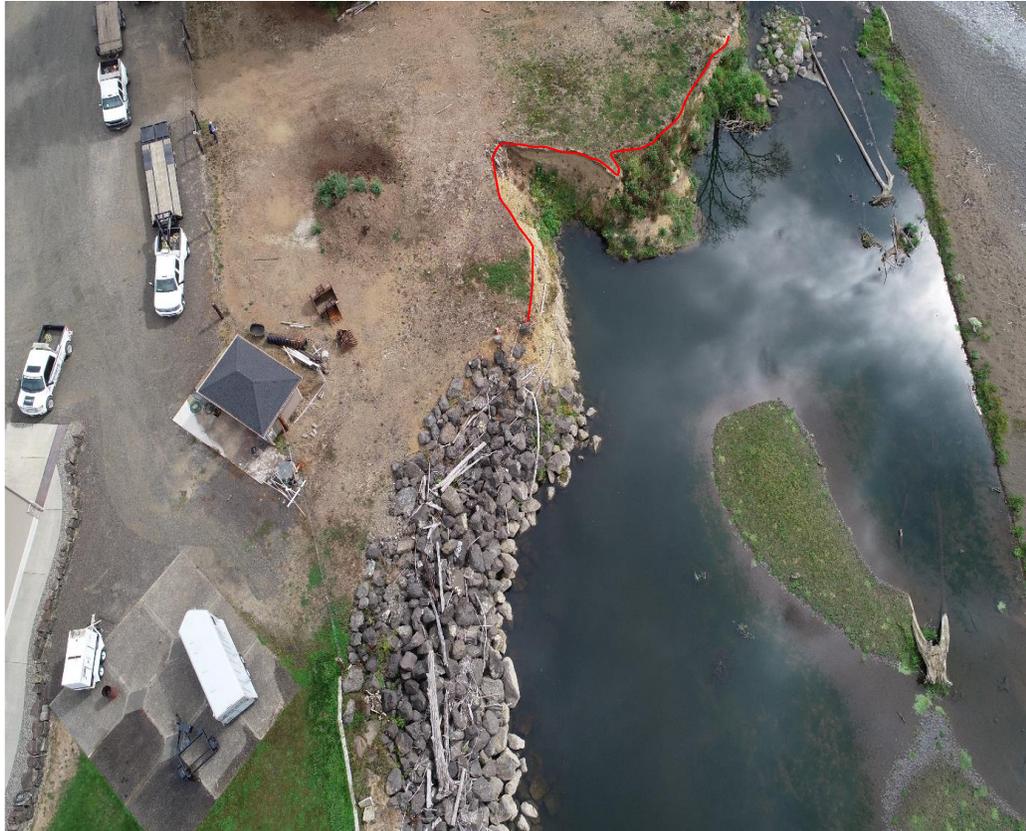
*Figure 27 represents a raw image file from the flight over site MS-SAT-GLICK. It shows the east half of the bank armor structure and the large cutbank (shown in red) developing where the rock structure ends.*

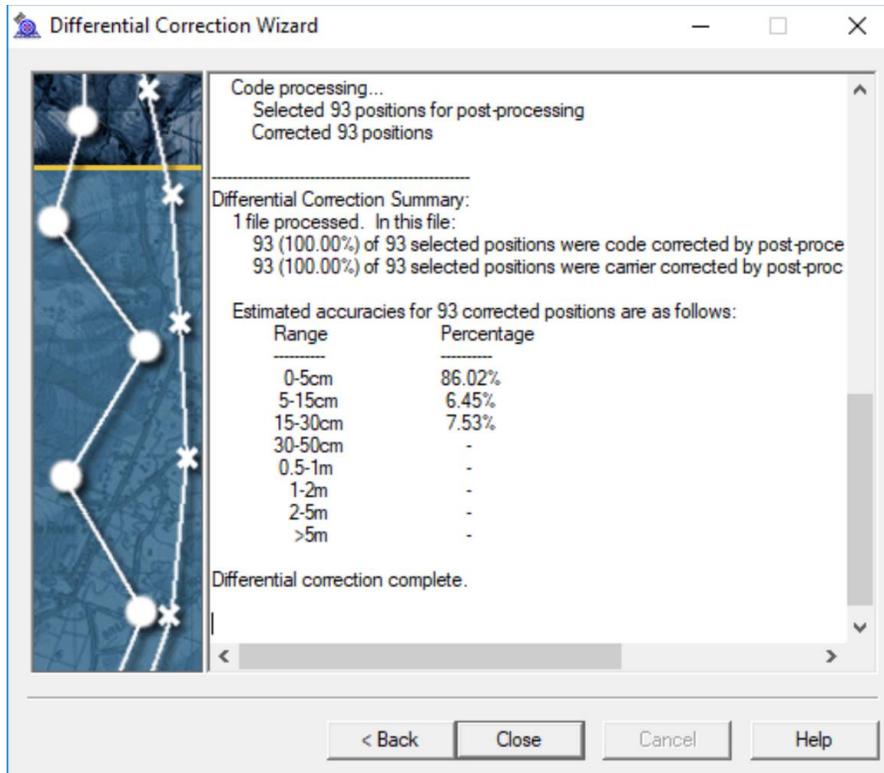
Figure 28 represents the ground control corrections using Trimble Differential Correction Wizard software to improve the elevational and spatial accuracy for the GCP data collected at each location. This specific correction achieved a 5cm accuracy for all points collected.
