AN ASSESSMENT OF SUAV BASED AERIAL IMAGERY:  
MODELING FLUVIAL INTERACTION OF BANK ARMORING STRUCTURES IN  
RIVERINE SYSTEMS

A Thesis  
Submitted in partial fulfillment  
of the requirements for the degree  
Master of Environmental Studies  
The Evergreen State College  
June 2019

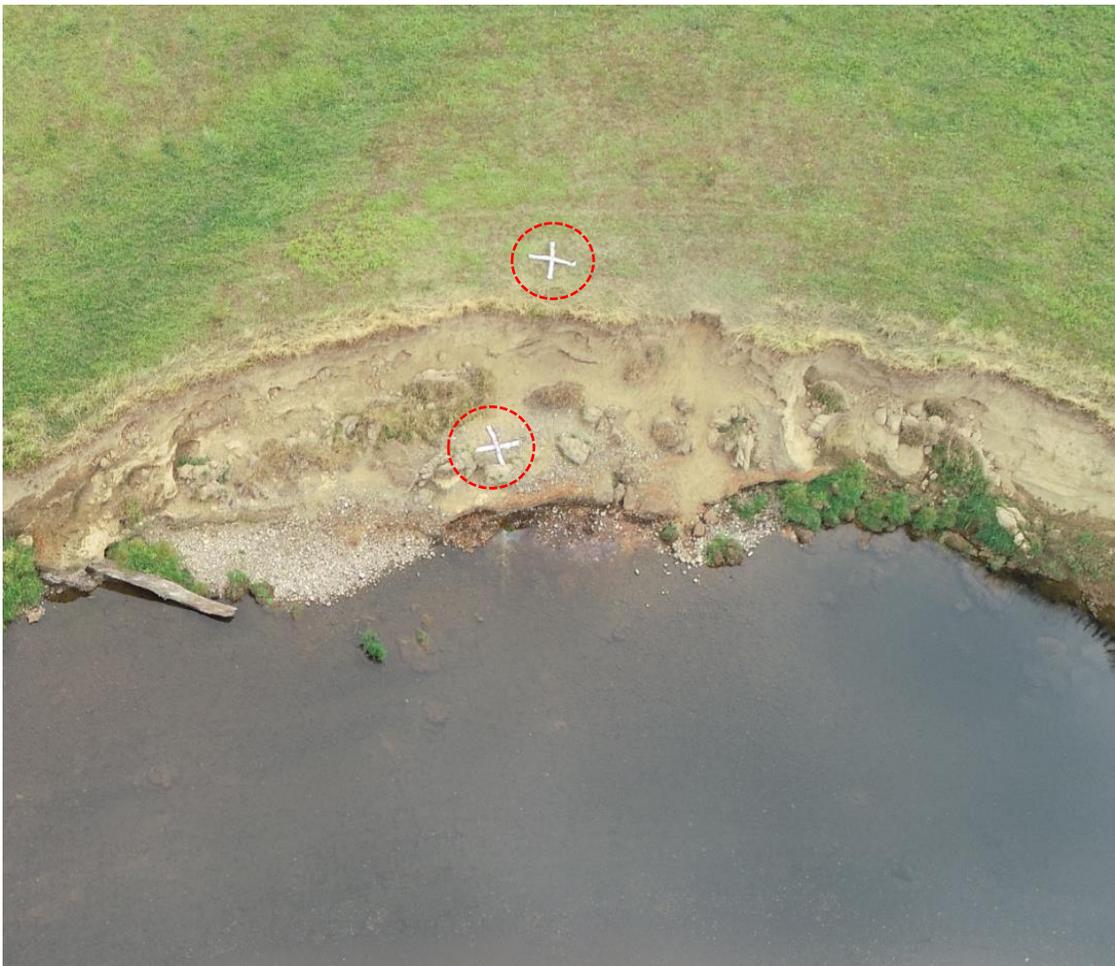
*Figure 31 shows 3 GCP's at the WF-SAT-BRIDGE research site. The two GCP's circled in red show a complex platform change of 1.56m (measured during pre-site visit). Imagery captured during the 2018 research flights.*

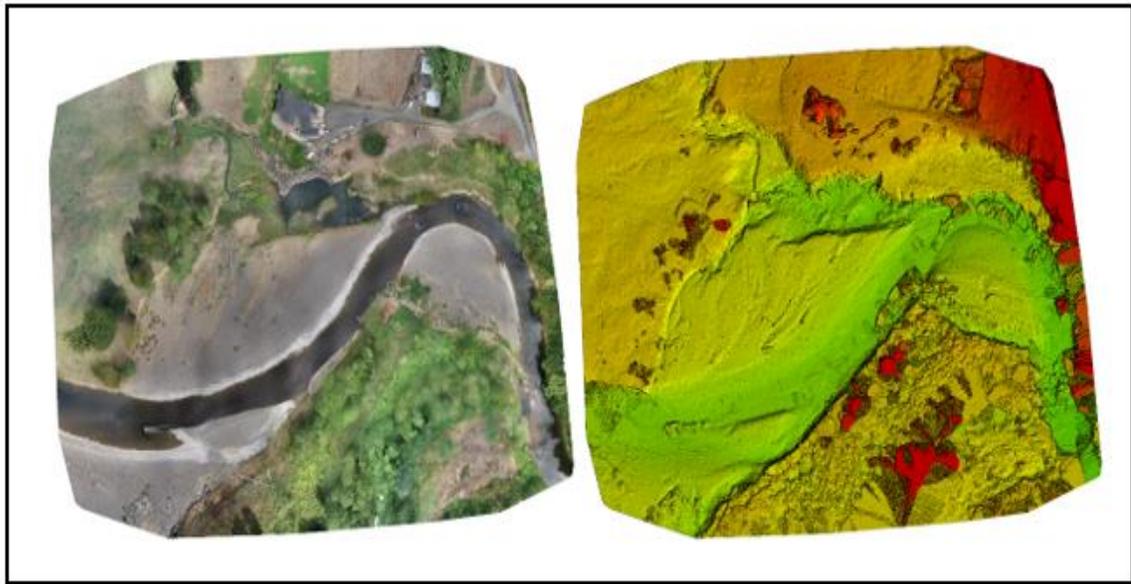
Figure 32 depicts two of the orthomosaics outputs of the mainstem Satsop River from the Processing Report in Drone2Map before densification. The ordinary colored surface layer on the left shows a stitched replica of the imagery collected during the flight, while the image on the right shows an elevation representation of the site with a color gradient to identify the low (green) and high (red) elevations of the site.

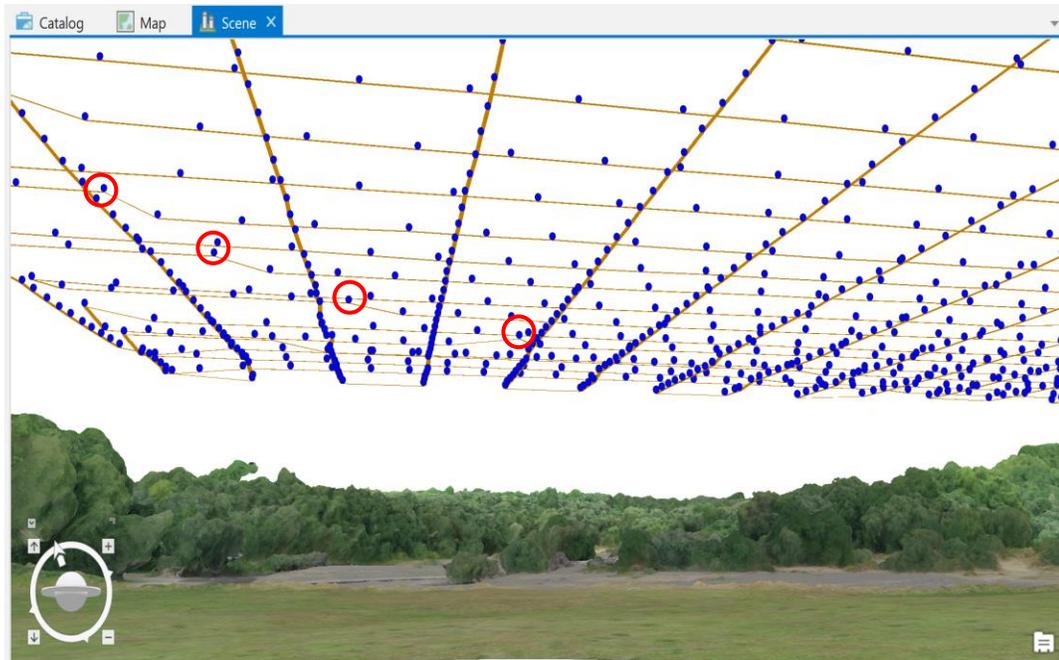
Figure 33 shows the modeled flight path in ArcGIS Pro after the 3D imagery has been processed in Drone2Map. Irregularities in the orange line represent wind uplift that the drone experienced during the gridded flight pattern. An uplift from wind (circled in red) can be seen in multiple areas of this flight pattern on the WF-SAT-BRIDGE flight.

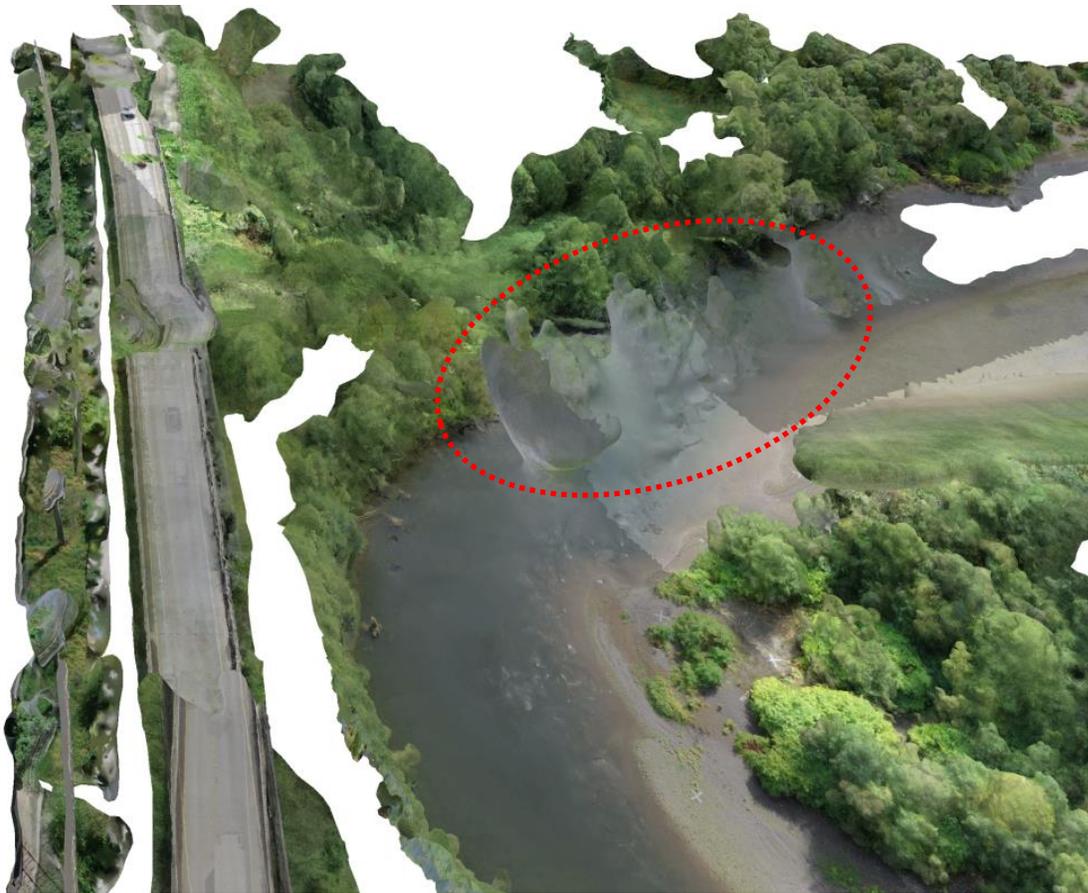
*Figure 34 is a rendering of the WYN-SR12 research location. The image above shows the distortions (circled in red) in the output imagery that was created by highly reflective water due to weather conditions and high sunlight hitting the water surface. This image was from the primary processed data that was run prior to using ground control points.*

In contrast, the diffused light during the WF-SAT-BRIDGE flight generated exceptionally clear data with minimal distortion in the 3D textured mesh layer (Figure 34). Weather conditions at the WYN-SR12 site and the WF-SAT-BRIDGE overflights showed uplift in the sUAV's flight pattern from wind influencing the elevation of the imagery capture flight grid (Figure 33). The WYN-SR12 site was highly contrasted in light and had severe reflections on the water surfaces due to an unexpected storm that came through during the flight. The timing of the flight was also early morning but due to the storm, there was clearing of clouds allowing high intensity light to project onto the water surface generating a highly reflective surface. The orthomosaic without GCP rectified data for this location was complete. The 3D textured mesh however, had several extreme distortions in the water layer resulting in large uplifts in the water (Figure 34).

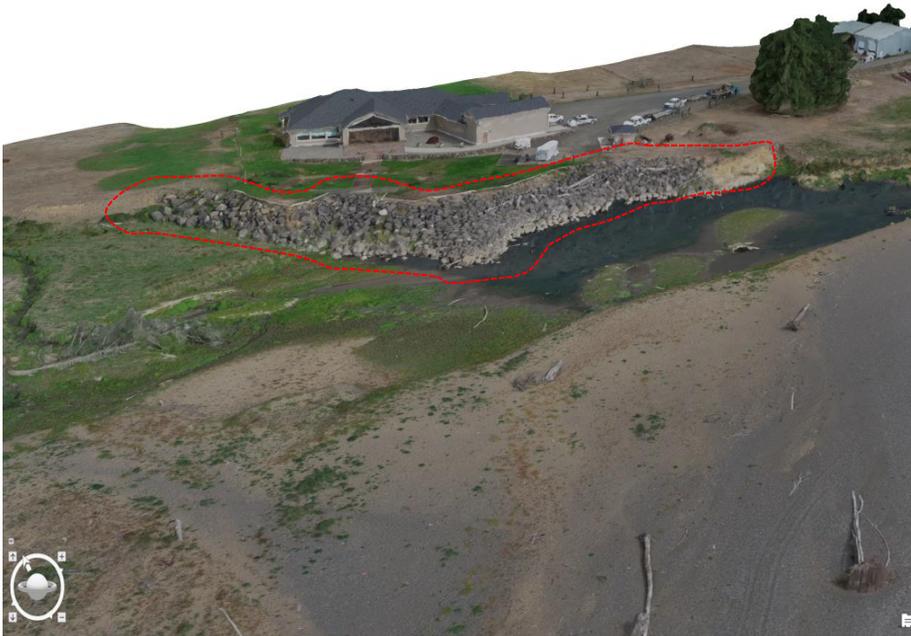
*Figure 35 Active Site Status - The armoring structure at site MS-SAT-GLICK (circled in red) that has been captured from the 3D model created using Drone2Map and ArcGIS Pro.*

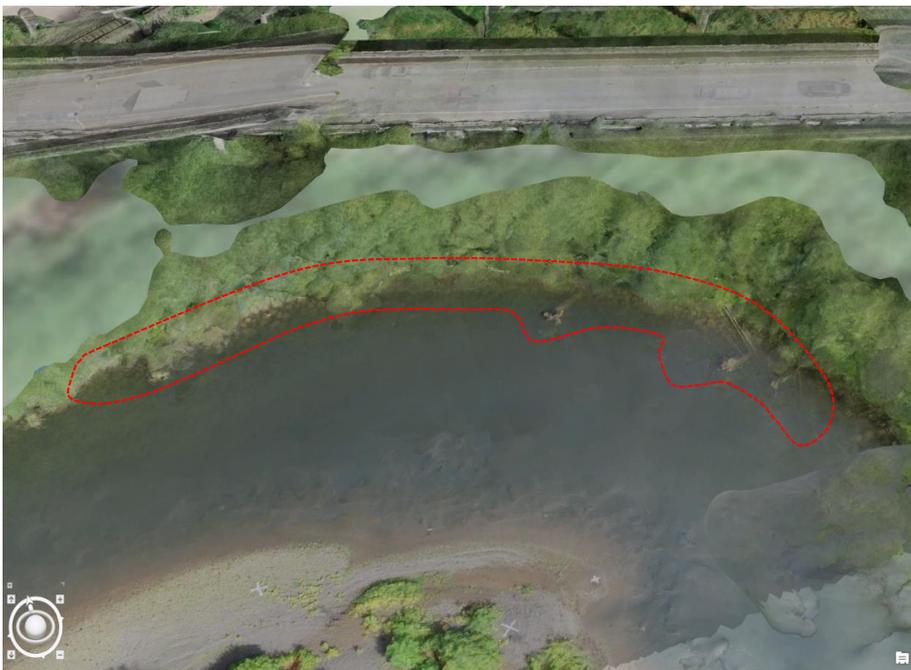
*Figure 36 Successful Site Status- The armoring structure at site WYN-SR12 (circled in red) captured from the 3D model created using Drone2Map and ArcGIS Pro.*

The WYN-SR12 location was determined as a successful bank armoring structure based on several observed variables. The 3D textured mesh surface layers in Figure 36 show bank protection implementation as structurally viable and present. It has withstood near two decades of hydraulic cycles and remains structurally paralleled to its original implementation design. The LWM is angled in its original implementation design, the rip rap is present, and the vegetation stakes have grown into full sized trees increasing bank stability. In addition, the WYN-SR12 location continues to meet its engineering goals keeping the channel from threatening the bridge pillars of State Route 12.

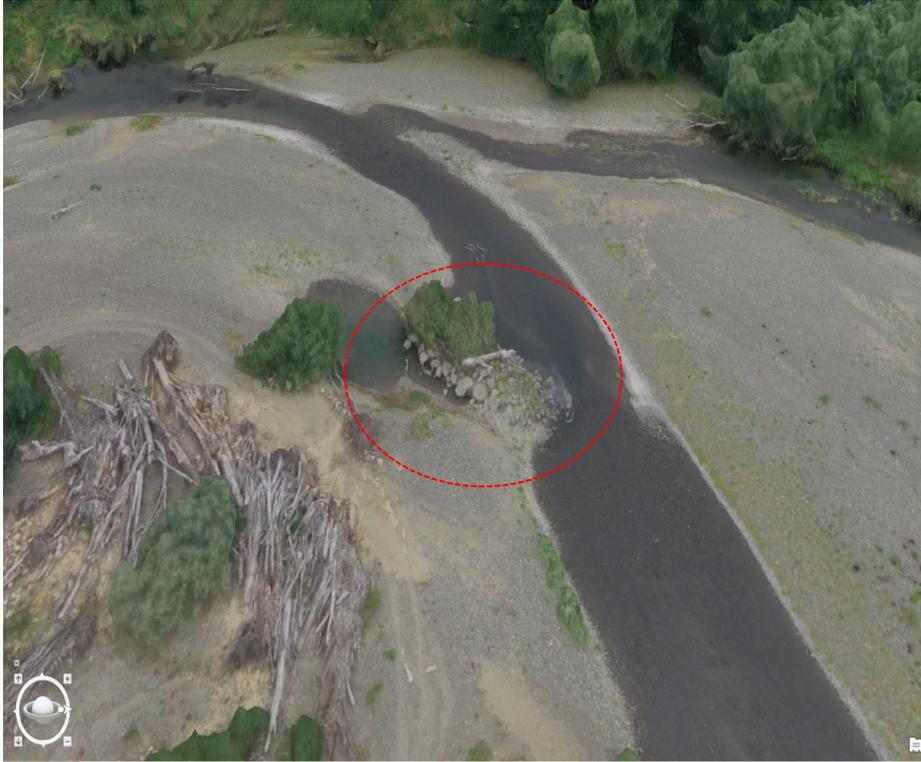
Figure 37 Failed Site Status - One of the remaining rock groins that was part of the 1997 implemented armoring structure at site WF-SAT-BRIDGE (circled in red) captured from the 3D model created using Drone2Map and ArcGIS Pro.

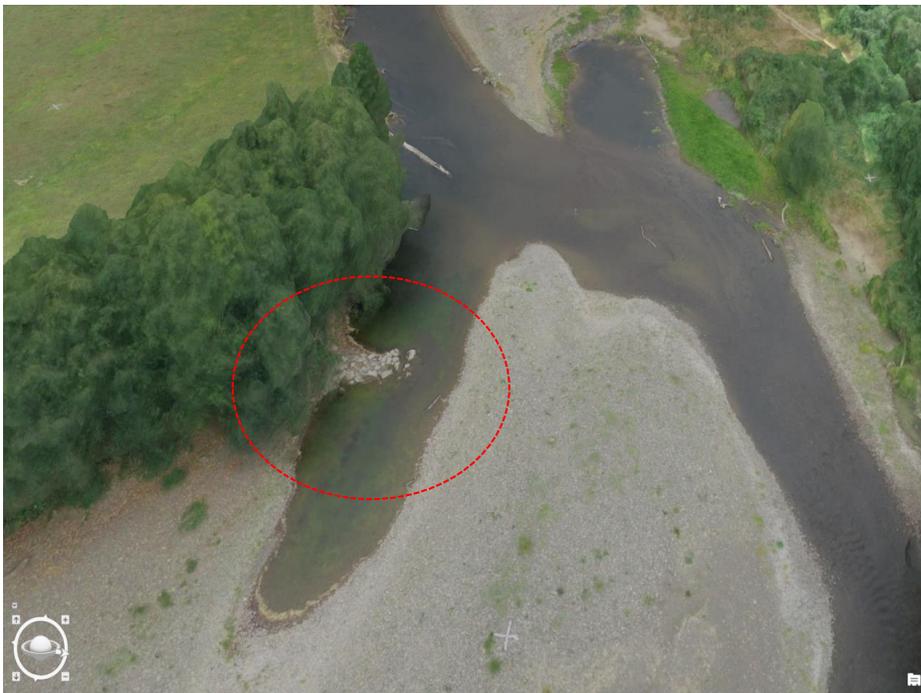
Figure 38 Failed Site Status- An additional remaining rock groins that was part of the 1997 implemented armoring structure at site WF-SAT-BRIDGE (circled in red) captured from the 3D model created using Drone2Map and ArcGIS Pro.

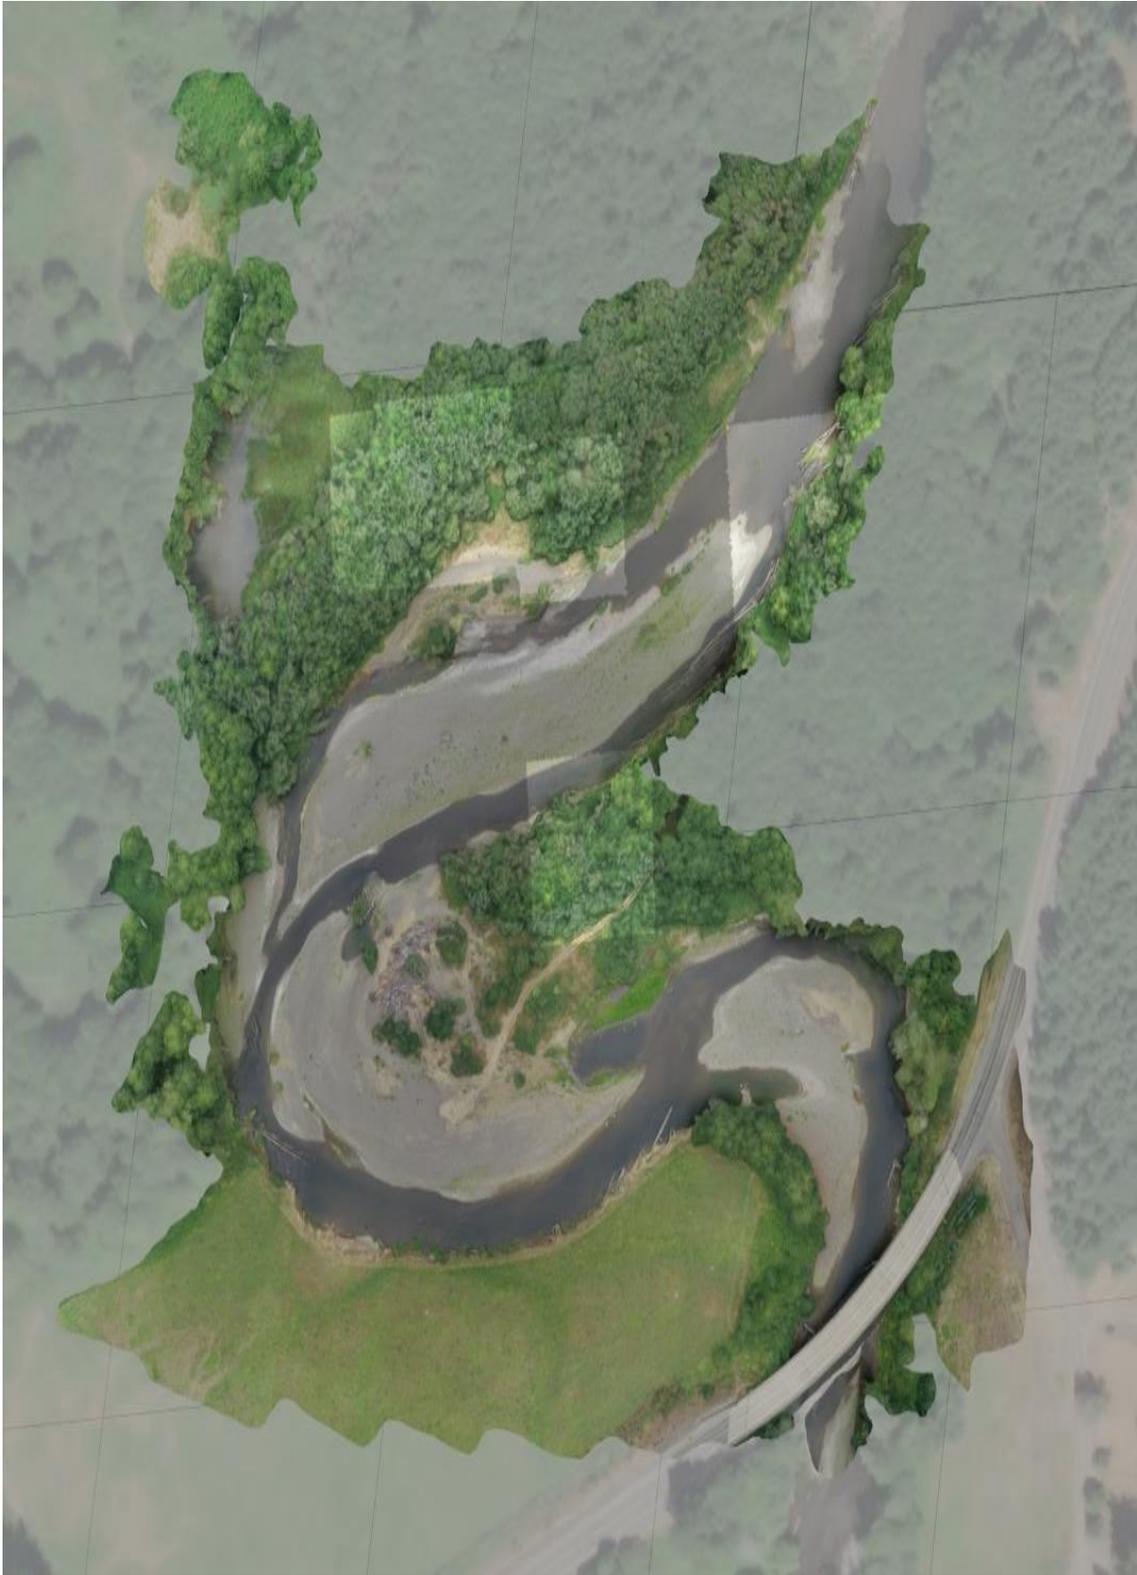
Figure 39 Shows the collective flight and 3D textured mesh surface layer generated in Drone2Map of site WF-SAT-BRIDGE. Underlay Basemap World Imagery- transparency set to 45% provided by Esri, DigitalGlobe, GeoEye, i-cubed, USDA FSA, USGS, AEX, Getmapping, Aerogrid, IGN, IGP, swisstopo, and the GIS User Community

The results from each research location were dependent on the light and the weather conditions experienced during each flight. The WF-SAT-BRIDGE site resulted in the best imagery out of the three sites flown (Figure 39). The primary variable resulting in the most accurate imagery was the dispersed lighting from highly overcast and smoky skies during the 2018 summer wildfires in British Columbia Canada. The MS-SAT-GLICK site produced the second-best imagery due to the early morning flight time (Figure 41). The weather that day was predicted as sunny with high light intensity. The determination was made to start the flight early when the skies were still overcast with the marine layer that is present in Grays Harbor County on summer mornings.

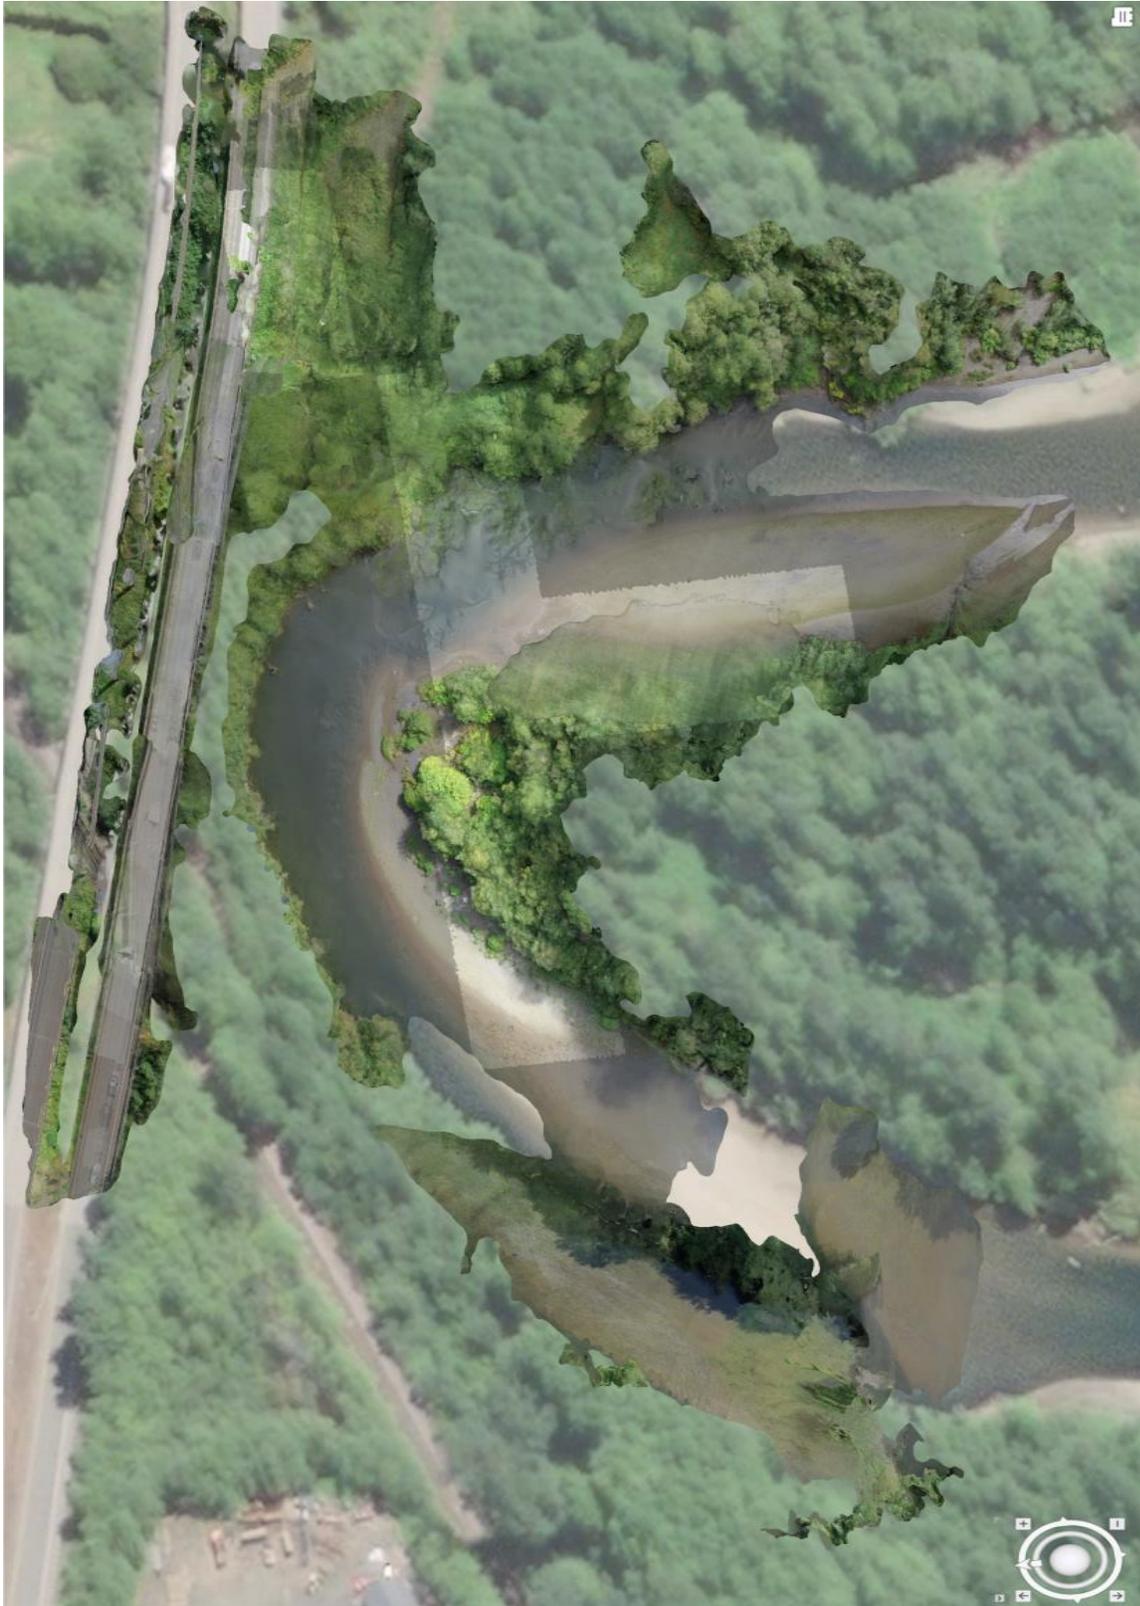
Figure 40 Shows the collective flight and 3D textured mesh surface layer generated in Drone2Map of site WYN-SR12. Underlay Basemap World Imagery- transparency set to 25% provided by Esri, DigitalGlobe, GeoEye, i-cubed, USDA FSA, USGS, AEX, Getmapping, Aerogrid, IGN, IGP, swisstopo, and the GIS User Community
