NORTH BASIN SHORELINE EROSION CONTROL STUDY

CAPITOL LAKE

NOVEMBER 1990

ENTRANCO ENGINEERS, INC.

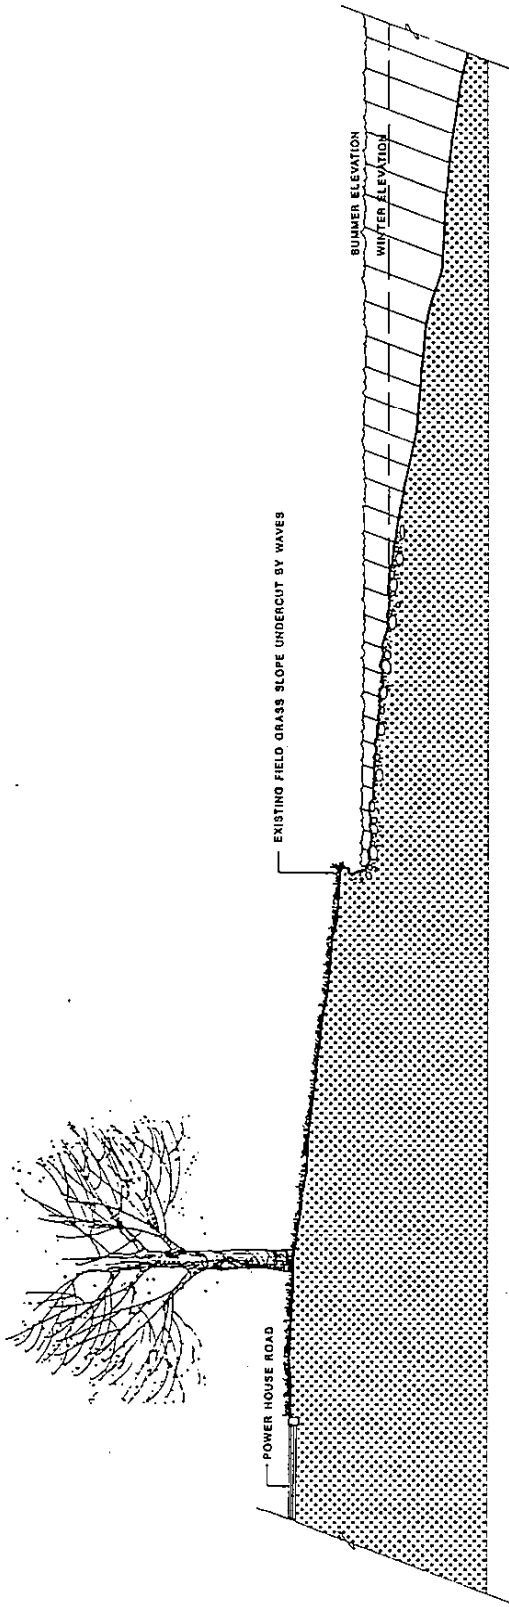
EXISTING CONDITION/ERODED BANK - WAVE UNDERCUT
AT ZONE 7

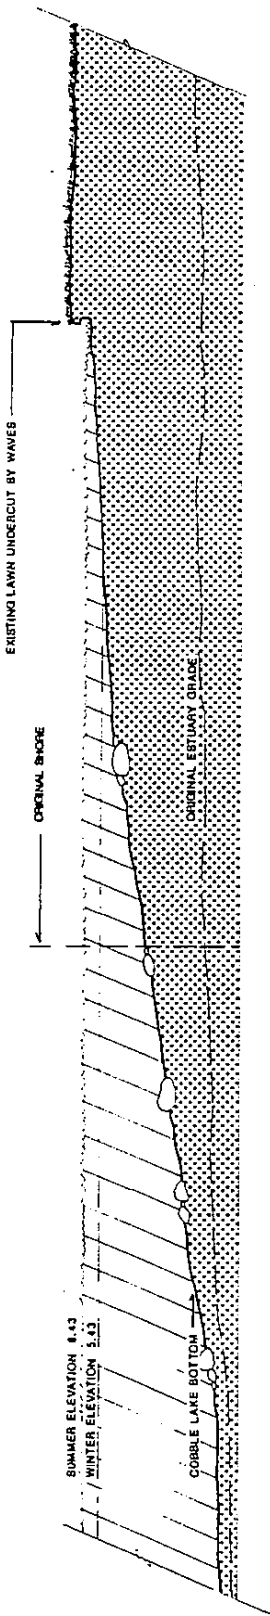
A.6

Existing Condition. The shoreline is characterized by an eroded grass or shrub bed upland, riprap sloped at approximately 3:1 to 4:1 dropping to a flat sand:mud bottom at a depth of about 10 feet (photo 1, Appendix B). The riprap adjacent to the eroded shoreline has been buried and shifted downslope and therefore is partially failing. Waves have overtopped riprap and eroded lawn (photos 2, 3, and 4). Over time the waves have continued to erode the shore by undercutting lawn resulting in a loss of approximately 30 to 40 feet of shoreline.

**MARATHON PARK EXISTING CONDITION
AT ZONE 1**
