THE SHORT-TERM PHYSICAL EFFECTS OF STREAM RESTORATION AT BIG BEEF
CREEK, KITSAP COUNTY, WASHINGTON

Submitted in partial fulfillment
of the requirements for the degree
Master of Environmental Studies
The Evergreen State College
September 2018

The short-term physical effects of stream restoration at Big Beef Creek, Kitsap County, Washington

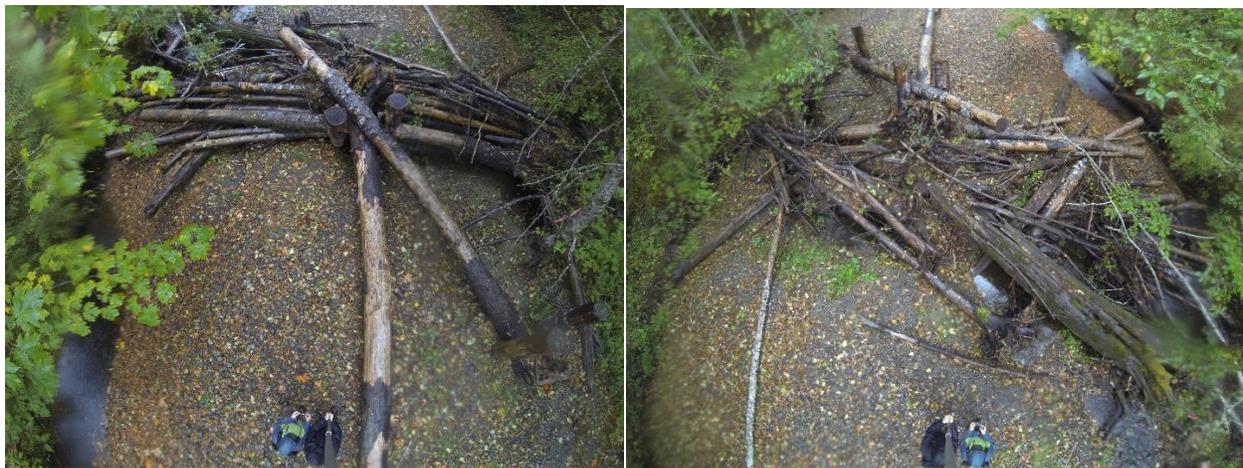
Figure 10. Example of wood structures built during phase 1 of the lower BBC restoration. This set of structures were built around posts driven into the streambed with a backhoe and included 'slash bundles' of smaller logs bound together with rope at their base (the complete restoration design may be viewed at PRISM 2018). Photographs are of the same structure depicted in the plan and were taken two years after construction in 2015 - facing upstream (left) and downstream (right). A backwater pool is present underneath the wood in the photographs and this structure has wracked additional wood since construction. Upper image (blue arrow indicates flow direction from McCullough 2015).

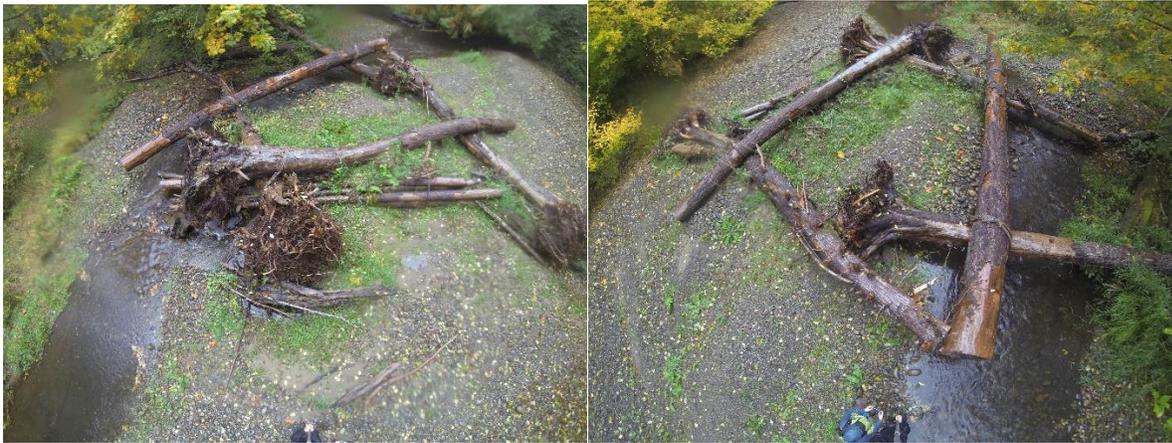
Figure 11. Example of wood structures built during phase 2 of the lower BBC restoration. This set of structures were placed by helicopter and included 'slash bundles' of smaller logs bound together with rope at their base (Seen best in center image on the left, the complete restoration design may be viewed at PRISM 2018). Photographs are of the same structure depicted in the plan and were taken one year after placement in 2016 - facing upstream (left) and downstream (right). The slash bundles associated with this structure is becoming buried in the sediment, a small pool is associated with the root wad in the middle of the left image, and aggradation of bed materials around the structure contributed to the activation of a previously abandoned channel reach (black arrow upper image). Upper image (blue arrow indicates flow direction from McCullough 2015).

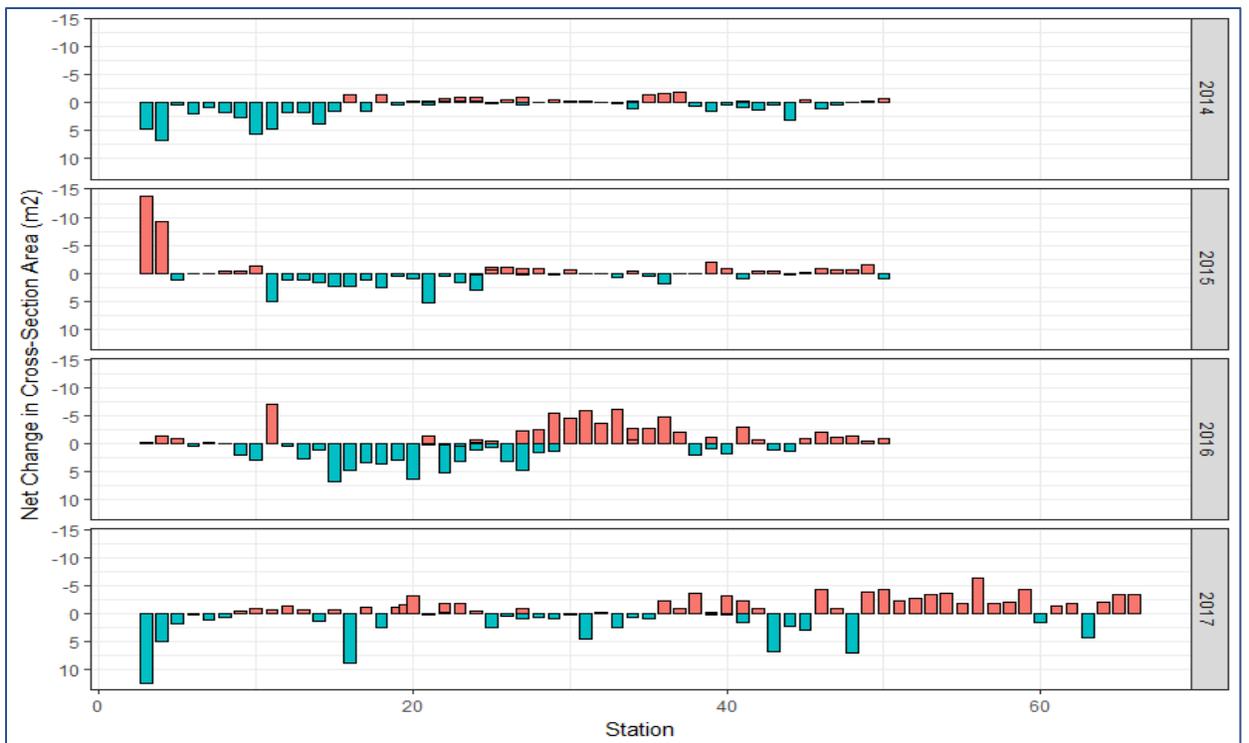
Figure 21. Summary of Net change in cross-sectional area of the main channel (and 3 side channels) at lower BBC, WY's 2014-2017. Red = Net streambed aggradation (negative values), Blue = Net streambed degradation/bank erosion combined (positive values).

Change in channel cross section area was affected due to management activities at stations 3 and 4 during water year 2014 when about 535m³ sediment was excavated from around the weir. The resulting knickpoint in the streambed facilitated positive change in channel cross-section area for some distance upstream of the weir during WY2014-15 (Figures 20-21). As this knickpoint moved upstream, areas above and below the weir (stations 3 and 4) aggraded in response indicating that streambed sediments were freely moving through or over the weir pickets during times of high stream discharge (Figures 20-21).

Notable channel aggradation occurred at stations 27-40 during WY2016, however most of this reach became net degradational during the following WY (Figures 20-21). Bank erosion at stations 18 and 44 was associated with wood placement at or near these locations (Figure 21). Similarly, streambed degradation (resulting in net change) at stations 16 and 48, was directly associated with wood placement (Figures 20-21).

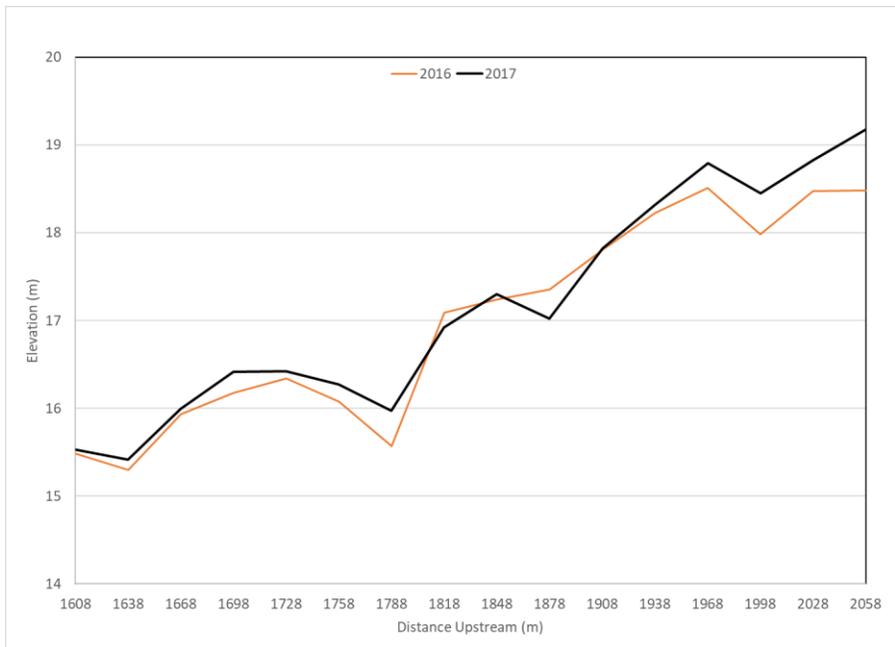
Figure 24D. Changes in the thalweg profile of sub-reach 4 (stations 51-66) at lower BBC, 2016-2017. Phase 2 wood structures were placed within this reach up to 1728m in 2016. Noteworthy within this thalweg profile is the apparent aggradation of the streambed while retaining much of its original shape (as plotted).

Summary plots of changes to the main channel thalweg (by year and sub-reach) is provided in Figure (24 A-D). A general discussion of each, including a general description of wood placement is provided with each.

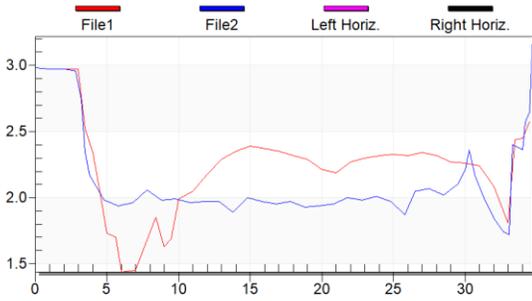
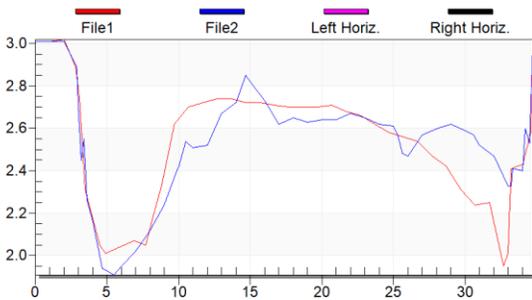
Station 3

Appendix A. Channel cross section plots analyzed within WinXSPRO for WY2014-17 (stations 3-50) and WY2017 only (stations 51-66).

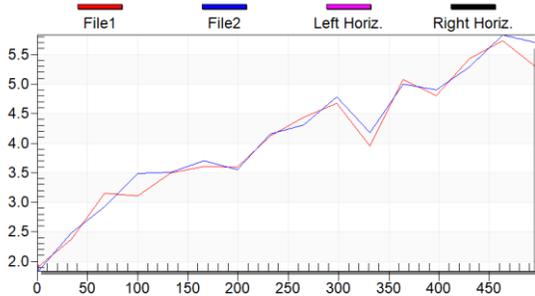
Sub-Reach 1

Appendix B. Data plots analyzed within WinXSPRO for changes in vertical thalweg profile, WY2014-17 (sub-reaches 1-3) and WY2017 only (sub-reach 4).
